Weld Bead Trench Artifact (C05_top)
Documented in results/geometry/LIMITATIONS.md L2

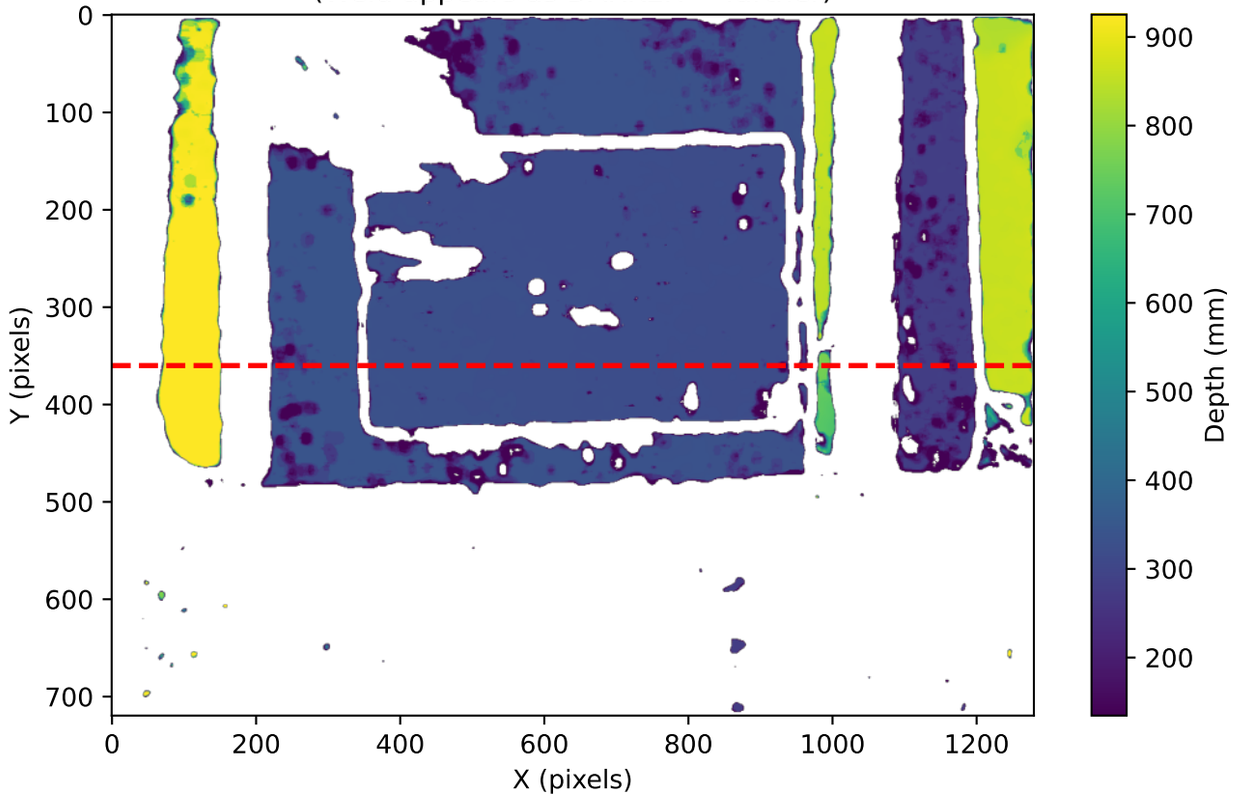
C05: Color Image
(Convex MIG weld cap visible)

C05: Depth Image
(Weld appears as DARKER = farther)

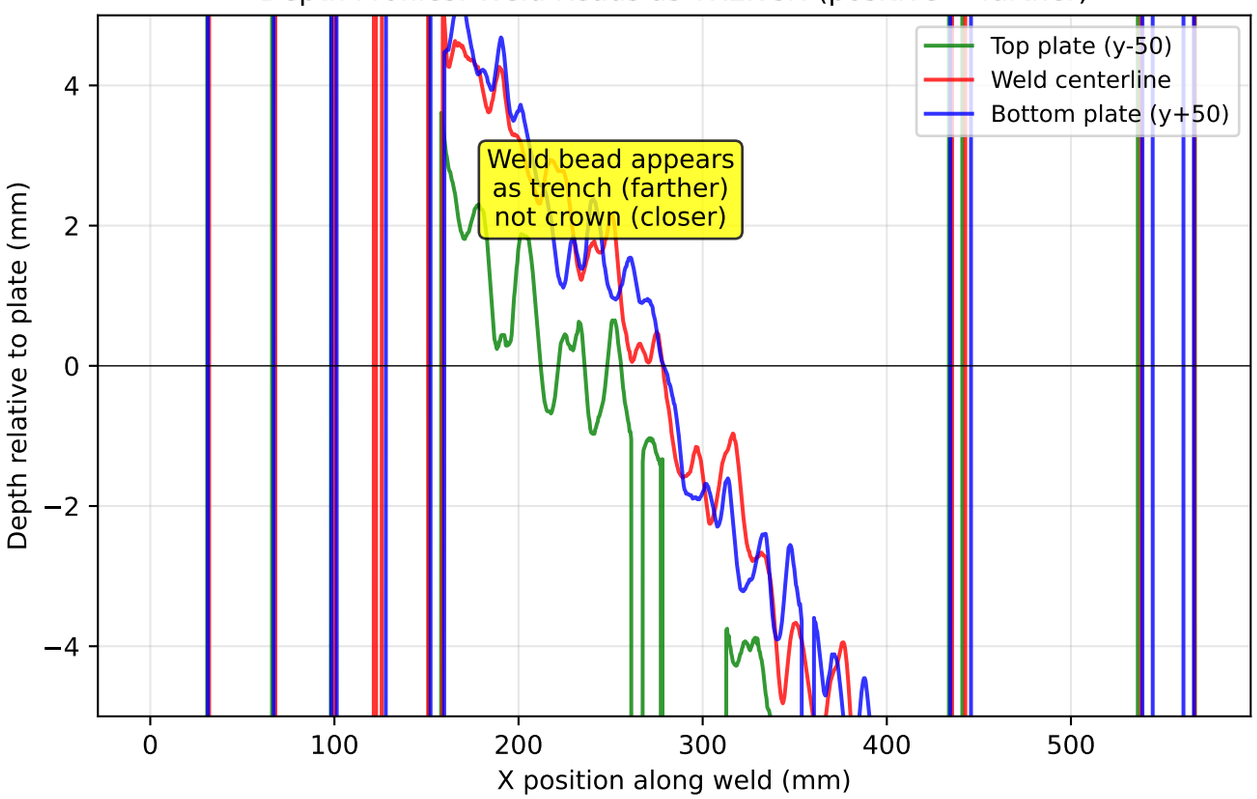
Depth Profiles: Weld Reads as TRENCH (positive = farther)

L2: Depth Sensor Artifact Explanation
