DATED 29 June 2021

LEASE OF THE SPORTS CENTRE AND SPORTS GROUND, BANK LANE, OFF PRIORY LANE, ROEHAMPTON SW15

TITLE	Building Survey Report
AT	Bank of England Sports Centre, Priory Lane London SW15 5JQ
REPORT DATE	23rd August 2019
REPORT NO.	01

Squash Courts
Bank of England Sports Centre, London
Engineering Services Review

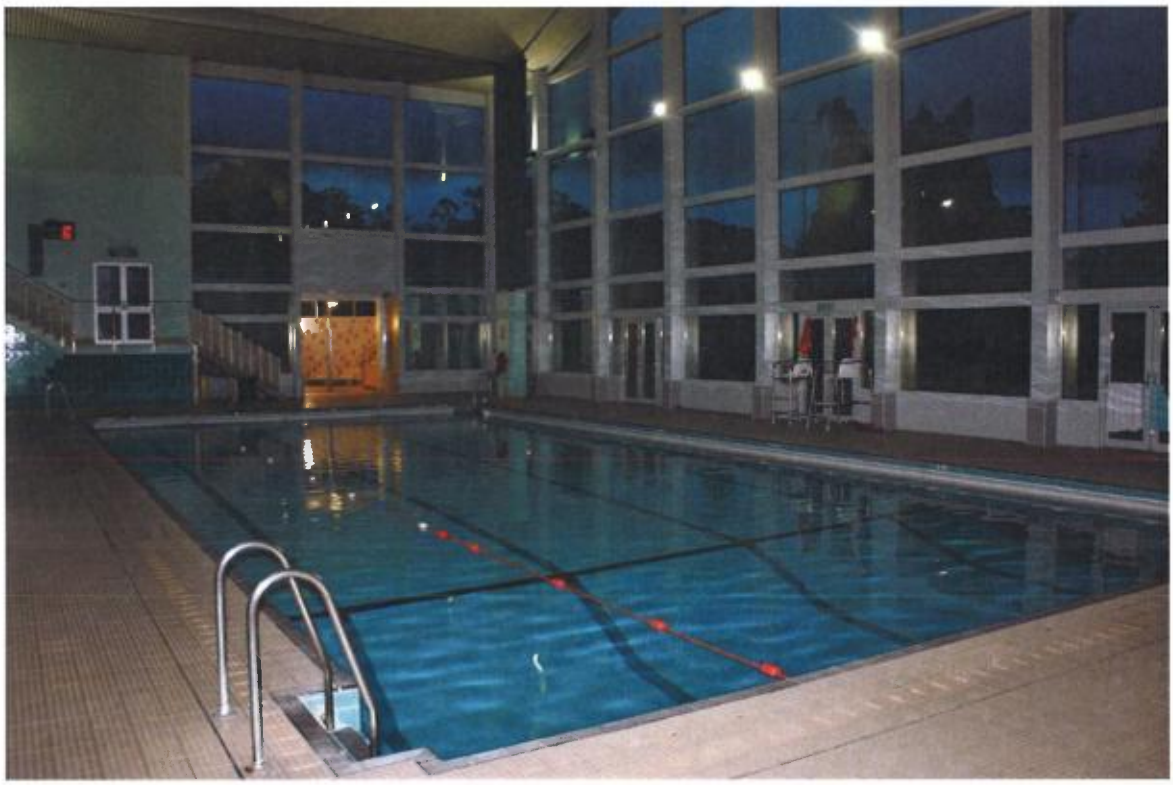
Photo 31 – Sports centre swimming pool.

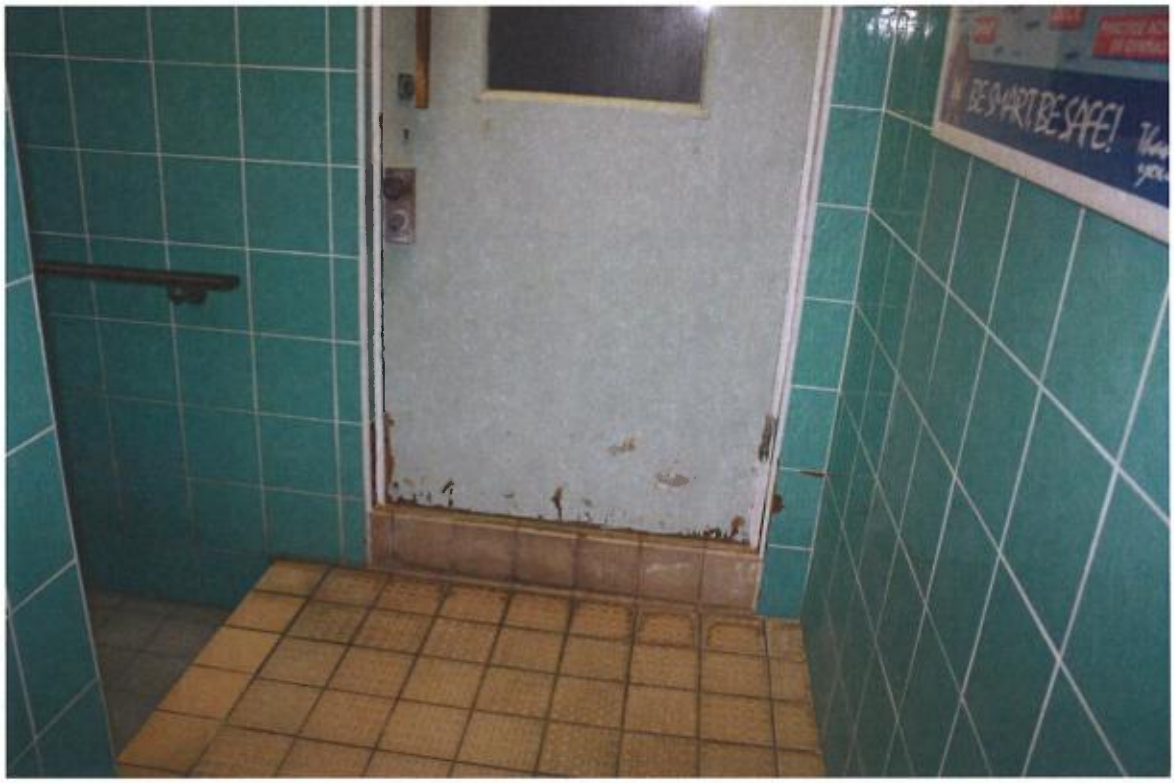
Photo 32 – Sports centre swimming pool. Changing area.

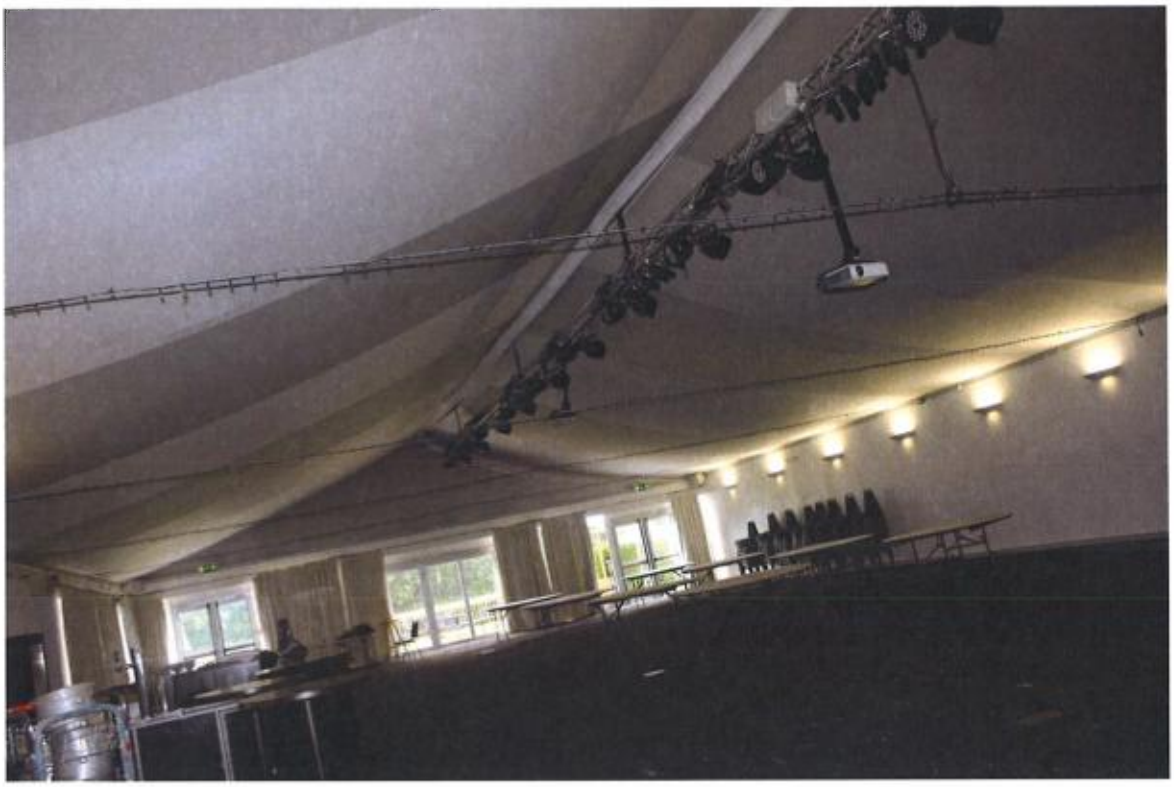
Photo 35 – Marquee.

Squash Courts 2 The roof coverings exhibit extensive patch repair and no doubt issues of past water ingress.	We recommend all pitched roof coverings, edge and parapet wall trim and all high level matching elevation cladding is now completely	23, 24, 25

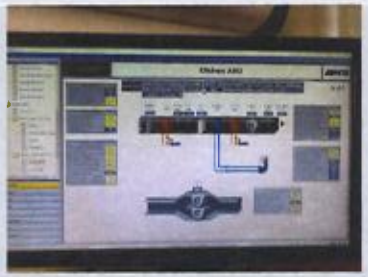
9.0	Building Management System		A Trend 963 v3.72 Supervisor Building management system provides overview and limited control to the AHU's, Boiler Plant, CT & VT LTHW circuits and HWS. Boiler and how LTHW.DHWS MCP panel is located to the basement main plant room has been upgraded to include IQ view touch screen and IQ4 controller. MCP 2 (kitchen AHU and extract fan) also requires updating. The connection between buildings is completed by microwave radio transmitters and receivers. This system appears to have been installed within the last 5 years. The BMS system has been partially upgraded in other buildings to accommodate the latest IQ4 controllers and IQ view front panels.

+ Consider refurbishment of the whole BMS system within the pavilion to IQ4 and IQ view displays on all MCP's. + Consider upgrading the head end Trend 963 software and PC to Trend IQ Vision. + Carry out control panel refurbishment to MCP 2.
