Disabling Automatic Updates and Troubleshooting

Recently, several customers have reported issues such as CSI cameras becoming unusable and automatic system updates occurring after OTA system upgrades. Solutions are provided below.

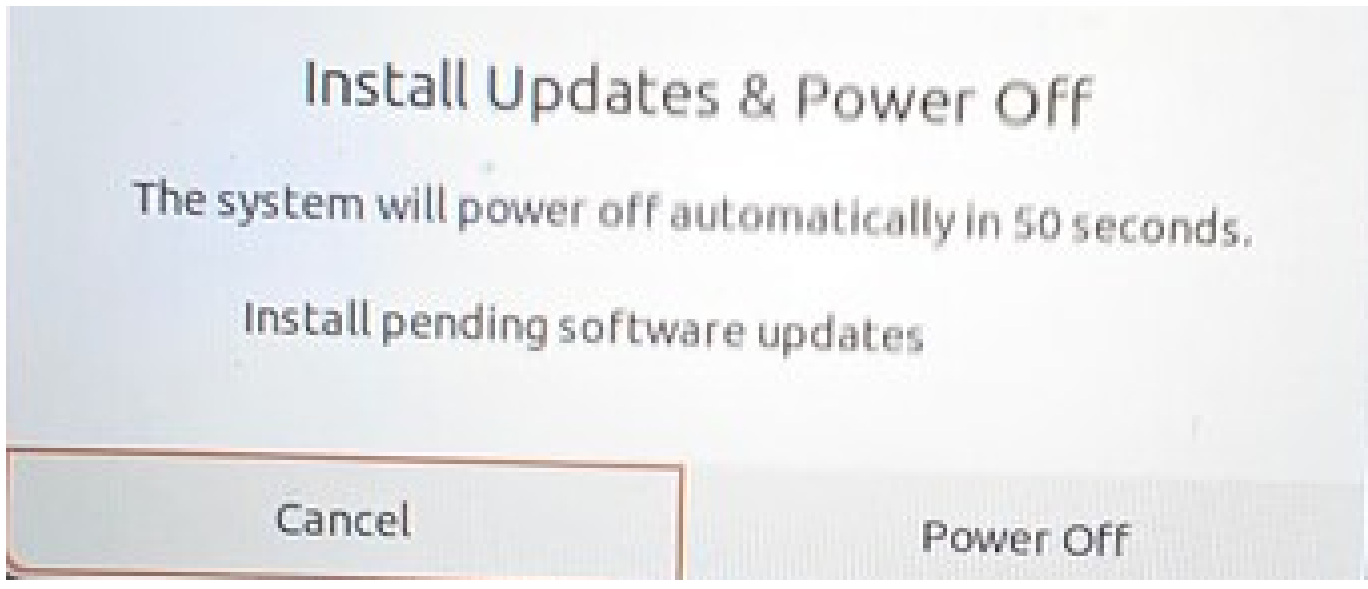
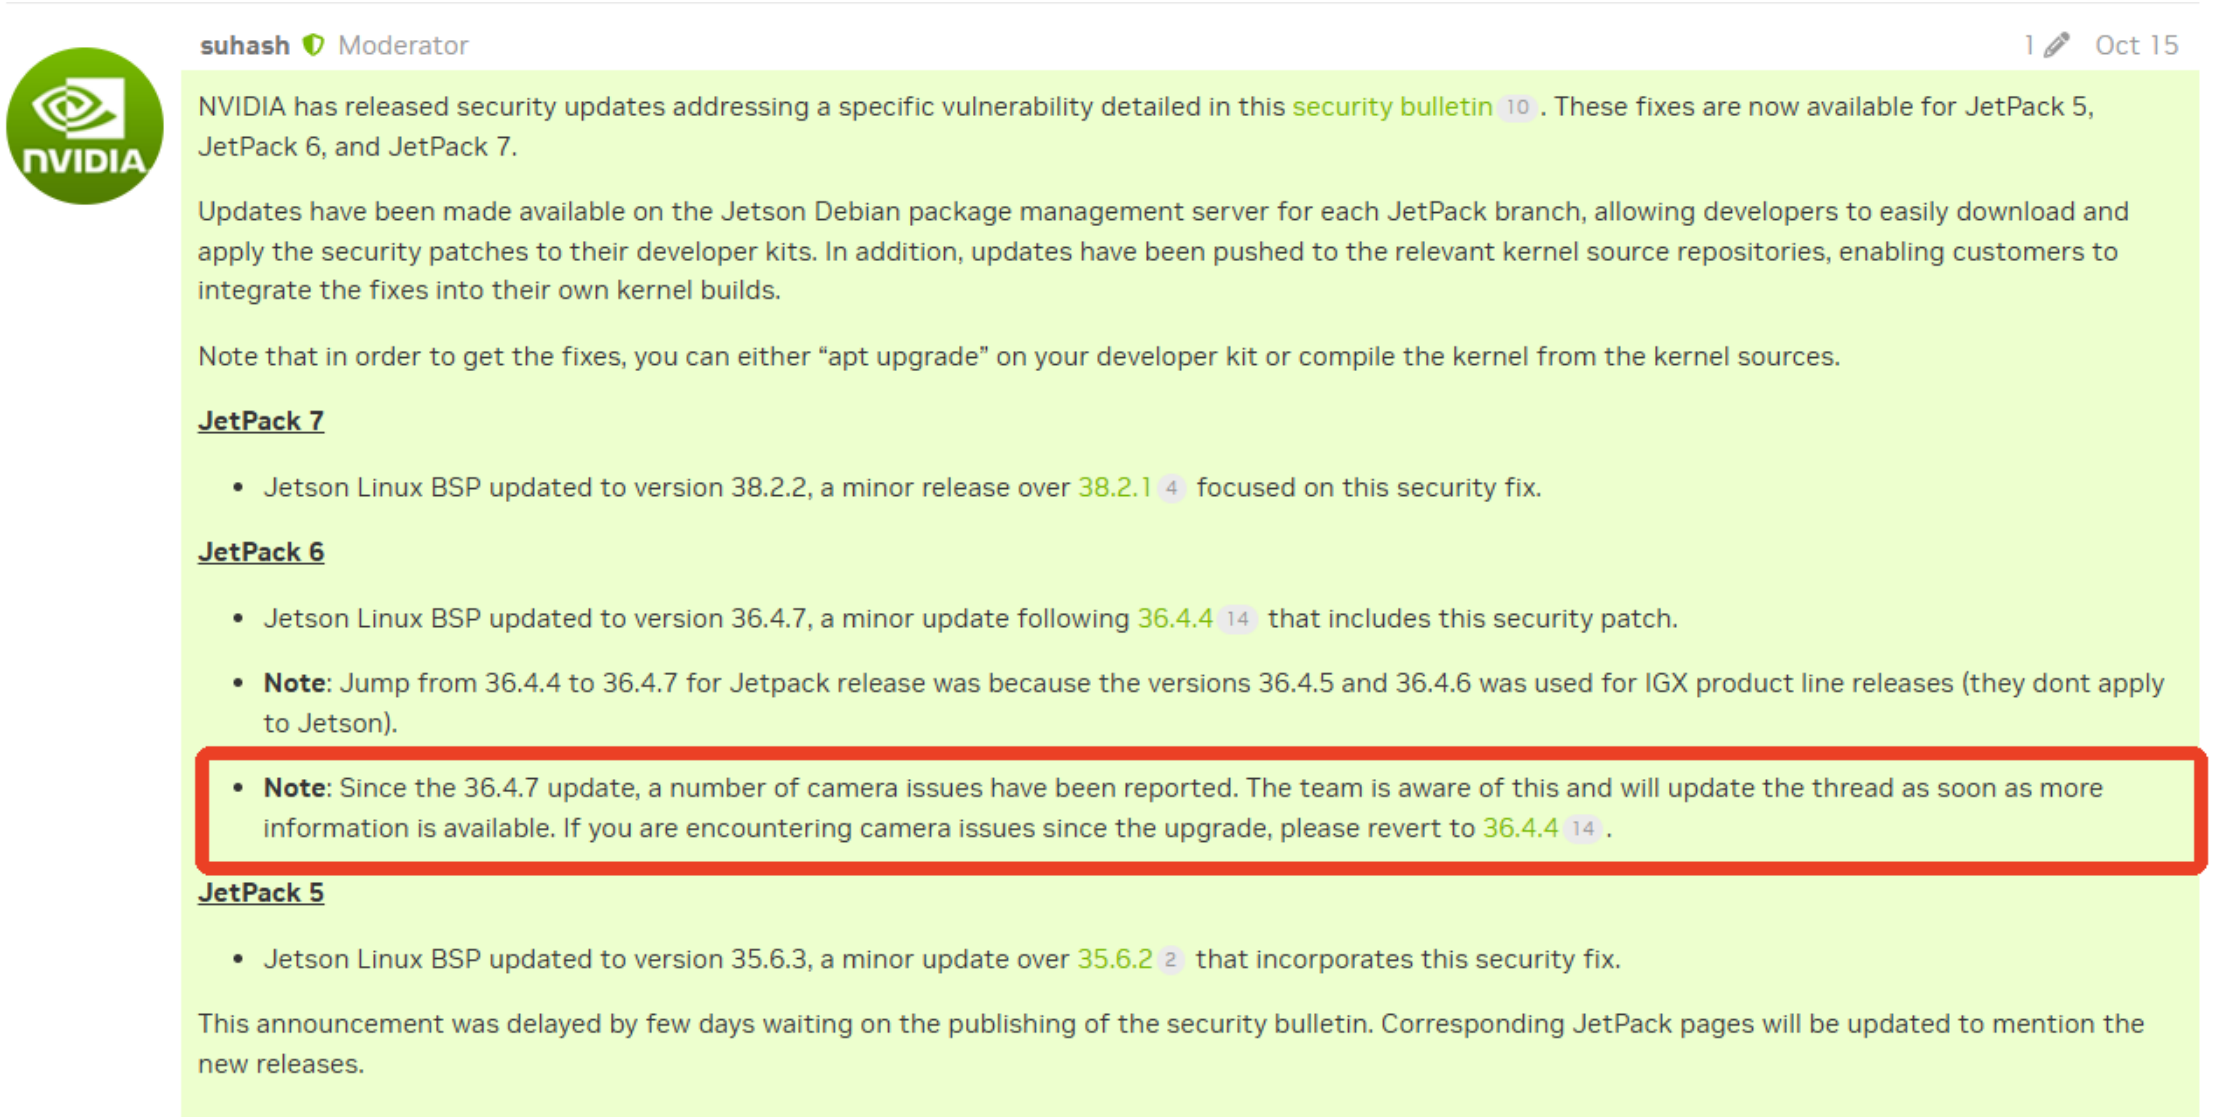
Currently, the Jetson Orin factory image version is R36 4.3, while the latest official version is R36 4.7. After upgrading, issues may arise such as CSI cameras not being found (awaiting official fix) or upgrade failures preventing booting. Users are advised to upgrade only as needed and avoid performing full system upgrades unnecessarily. Because Nvidia systems have built-in update checks, some users may be prompted to install updates and shut down upon shutdown. Therefore, it is necessary to manually disable automatic updates to prevent problems caused by updates.
