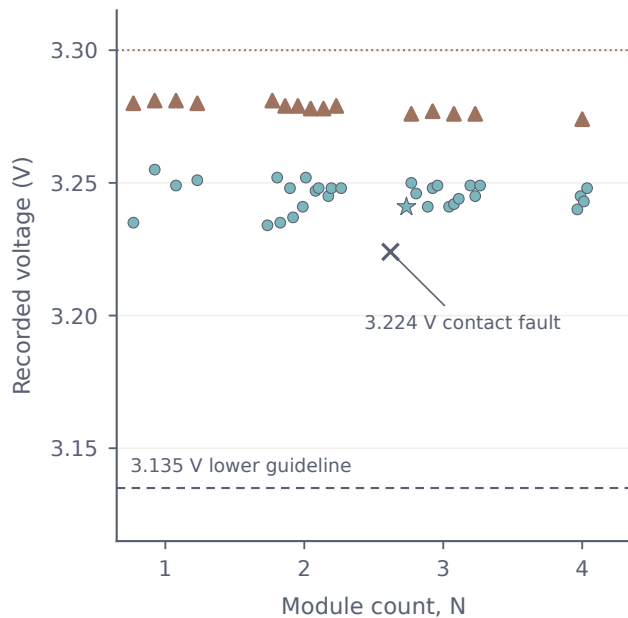
- ▲ Source main — Module DMM MIN-MAX × Historical contact fault
● Module main ★ M0 retest (3.241 V)

(a) Zero load

(b) Loaded (recorded)
