# Security Assessment Report CP-VNR-3104 NVR Firmware version B3223P22C02424

Version	Date	Author	Remark
1.0	27/11/2024	Yashodhan Vivek Mandke	First Draft

2.1 CP-NVR-01: First static RSA Key extracted (Reserved CVE: cve-2024-54849)

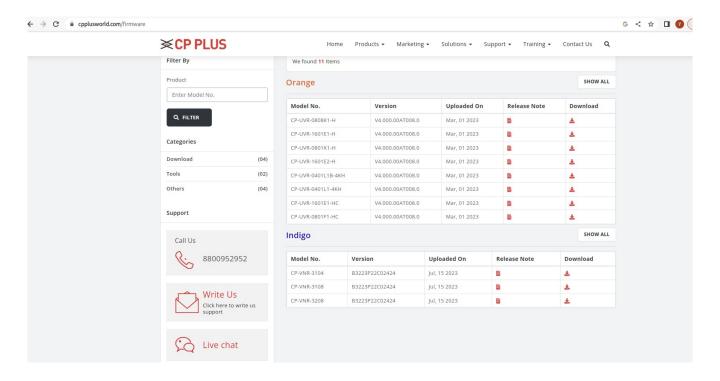
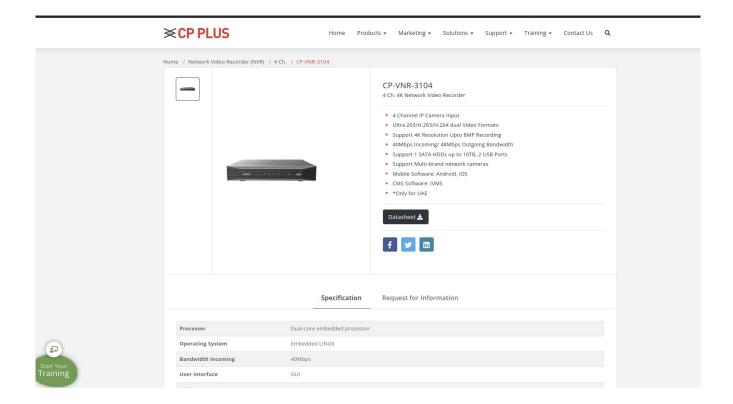
Potential Impact: High

During the assessment it was identified that the RSA private key was hardcoded available in firmware
