Quality Inspection & Test Report V4.8

Yeatru Sourcing

Lot: 500 pcs CHESYPORA Premium Microfiber Entrance Mat, 60 × 90 cm (Model PC0010), individually rolled in polybag with belly band, in a hexagonal gift box, 12 pcs per master carton; 42 cartons in total (41 full cartons + 1 last remainder carton – no marking identified the remainder carton). Inspection carried out on finished, packed goods at factory on 2026-10-14.

CHESYPORA Premium Microfiber Entrance Mat 60 × 90 cm (PC0010 / FNSKU X002NV3RHP) | Inspection date: 2026-10-14 | Page reference of the main QC report

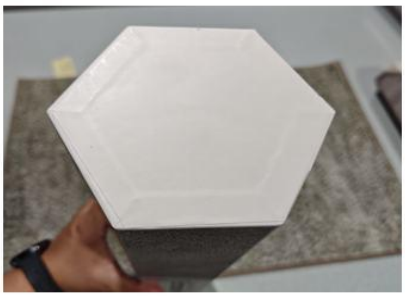
17. Inside master carton: 12 hexagonal boxes (4 × 3) with cardboard divider

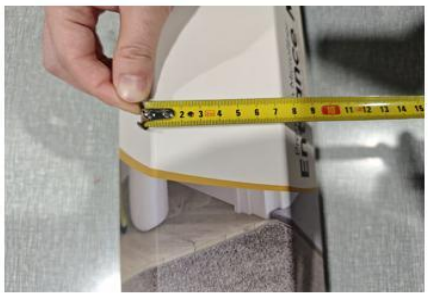
20. Unit box – alternative view

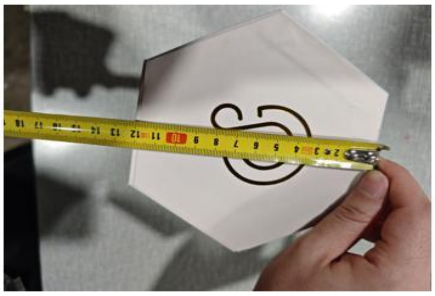
21. Box flat-to-flat width measured

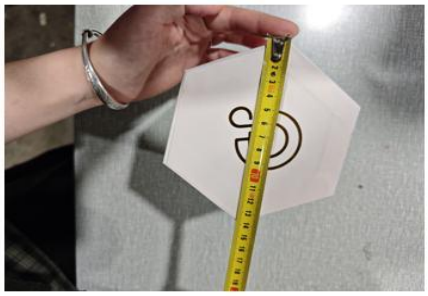
22. Hexagon point-to-point measured ≈ 12.5–13 cm

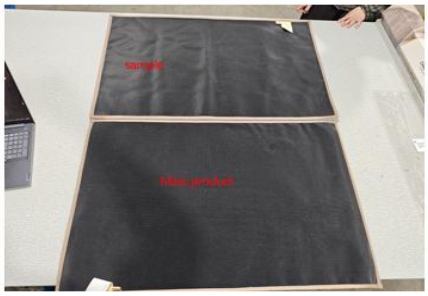
34. Approved sample (top) vs mass product (bottom) – overall appearance matches

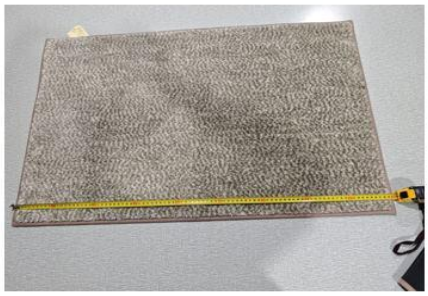
37. Sample vs mass product – overall comparison (view 2)
