Review

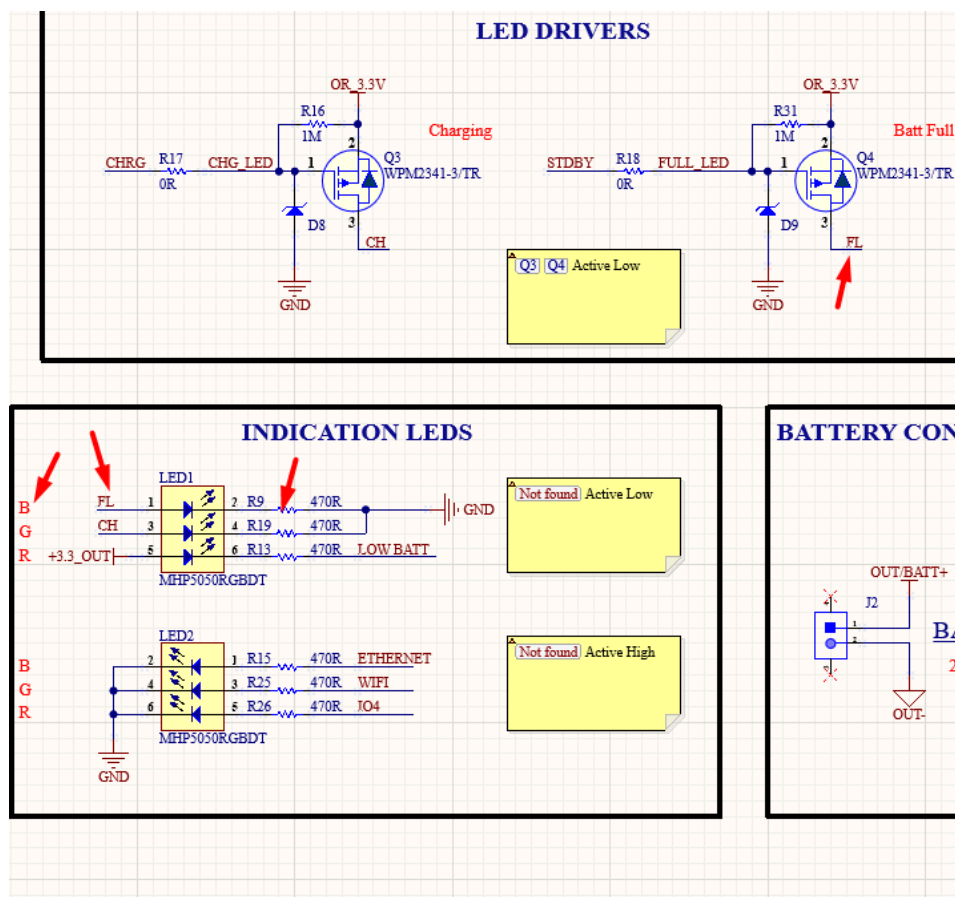
- LEDs current limiting resistors values are not correct. If the scheme is using MOSFETs then LEDs should be powered through 5V as blue color glow on 3V3 will be very less.

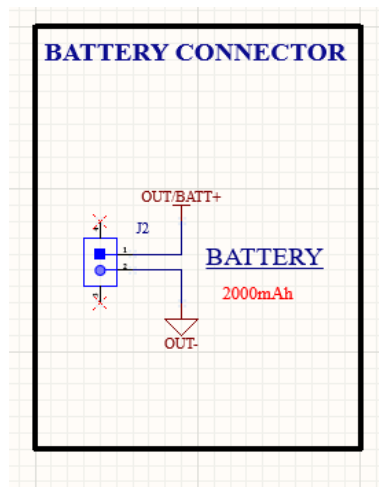
- Please confirm the battery connector pinout is correct as generally pin 1 is connected to GND.

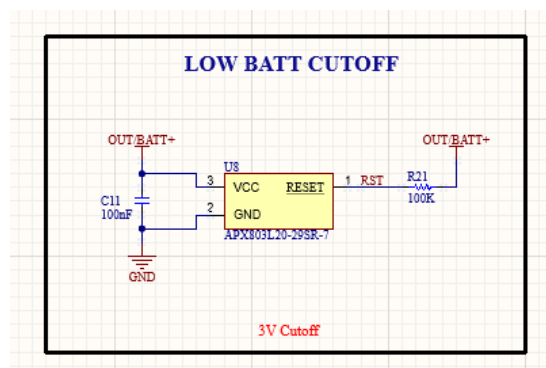
- Low battery cutoff might not be needed as we are using Fuel Gauge in this design. Even for the overdischarge protection, DW01 is already implemented.

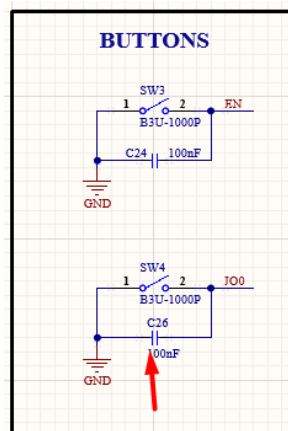
- C26 should not be used on IO0 as it will fail the USB auto download functionality.

- C27 should be used here as it is a Boot pin and also used as a clock pin.
