Incident (16 Sep) Report for NaviX AI Microgrid

Date: 16/09/25

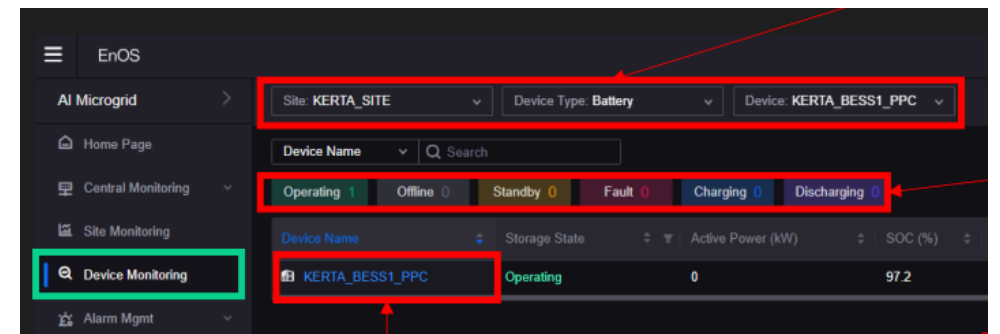
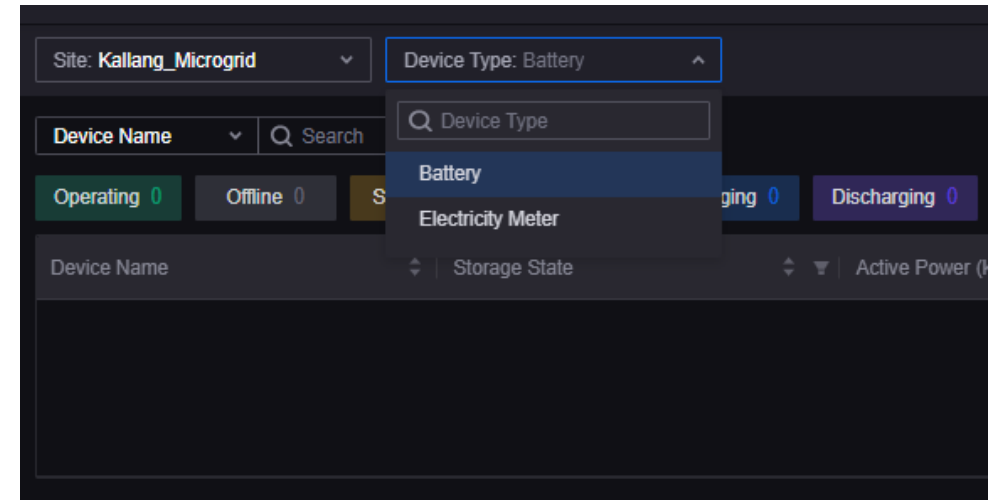
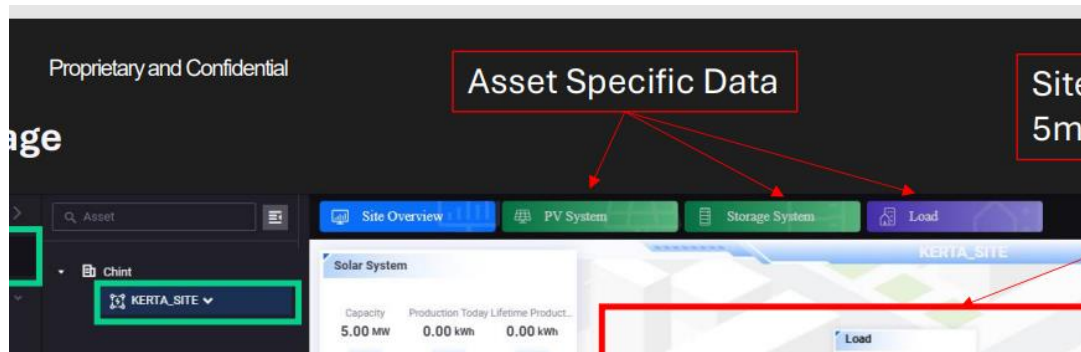
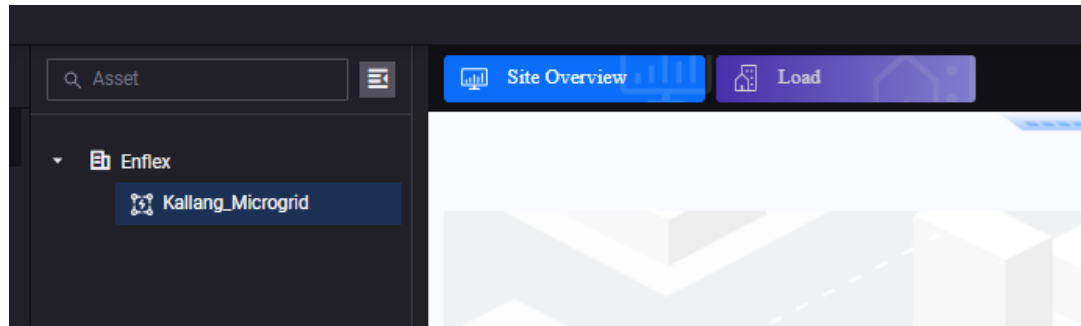
1. Missing Assets on EnFlex platform

Root Cause Identified: Improper connection of Univers Logger and PLC

Last data transmitted:
03/09/25, **13 days**
prior

Unable to ping devices
connected:
No Network Connection

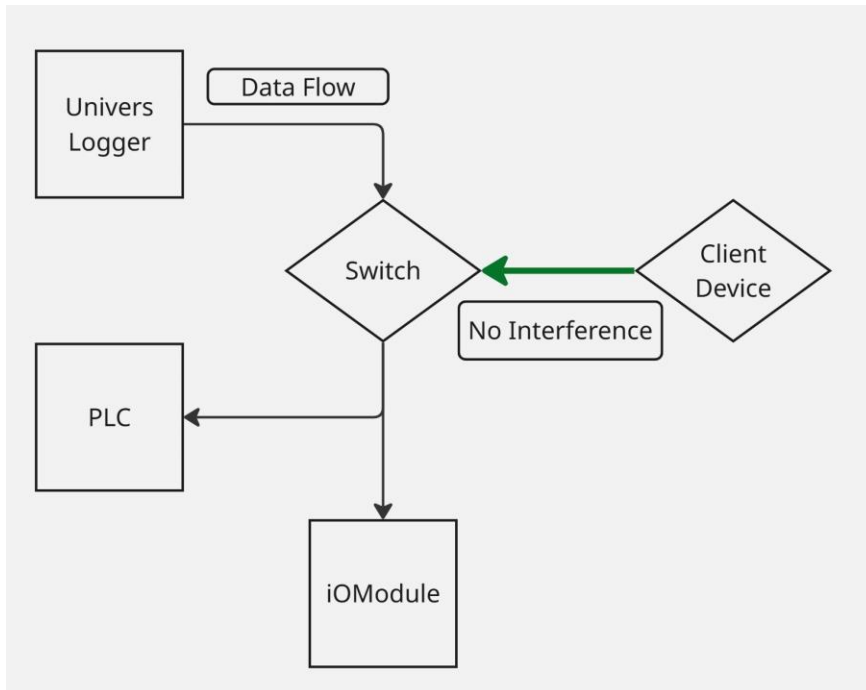
Network architecture:

1. All Modbus TCP connections are first connected to the blue switch
2. Logger is connected to blue switch to access data

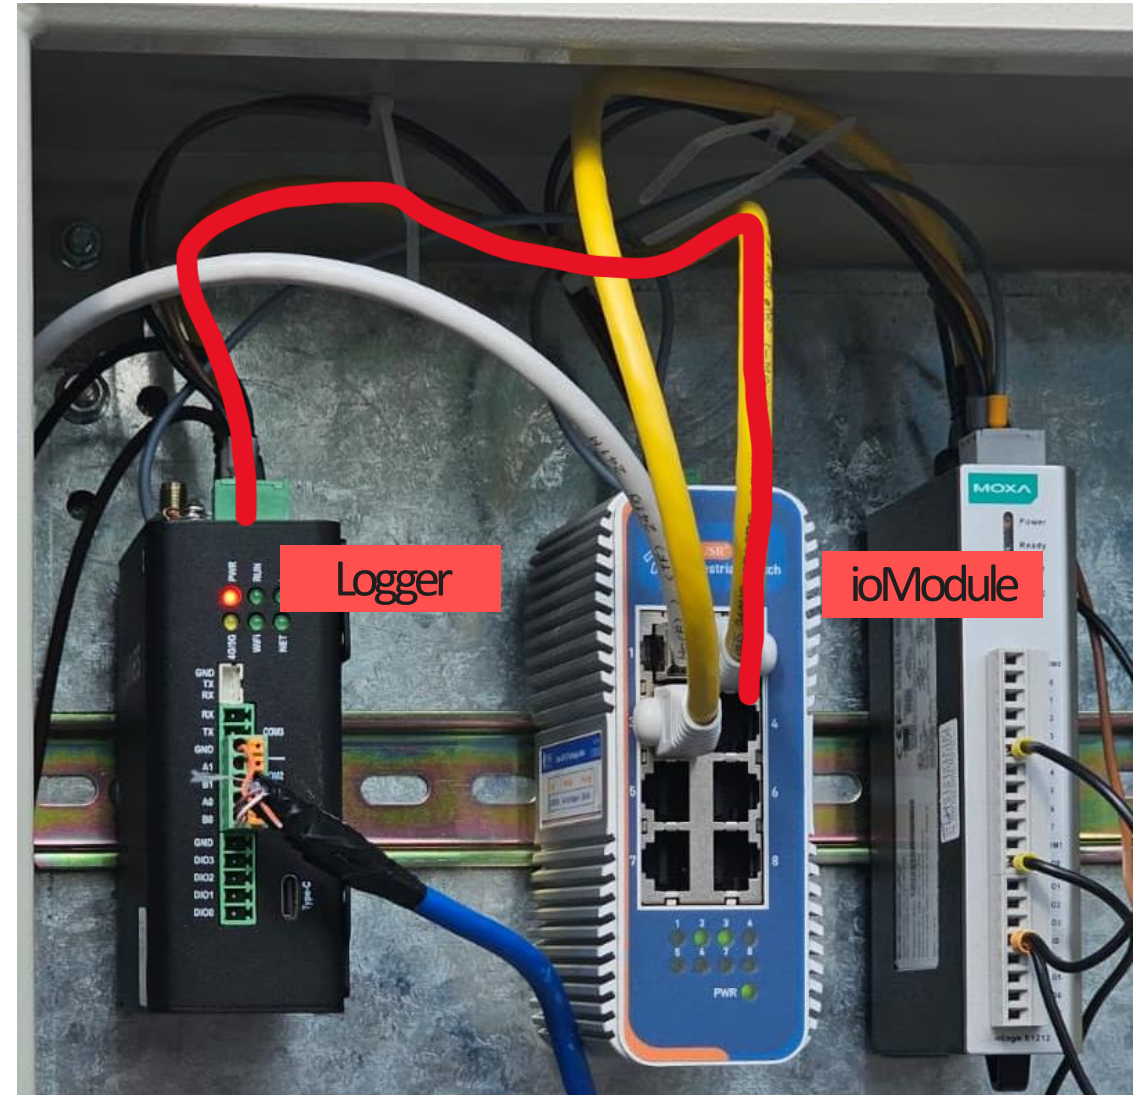
During delivery, devices were connected accordingly

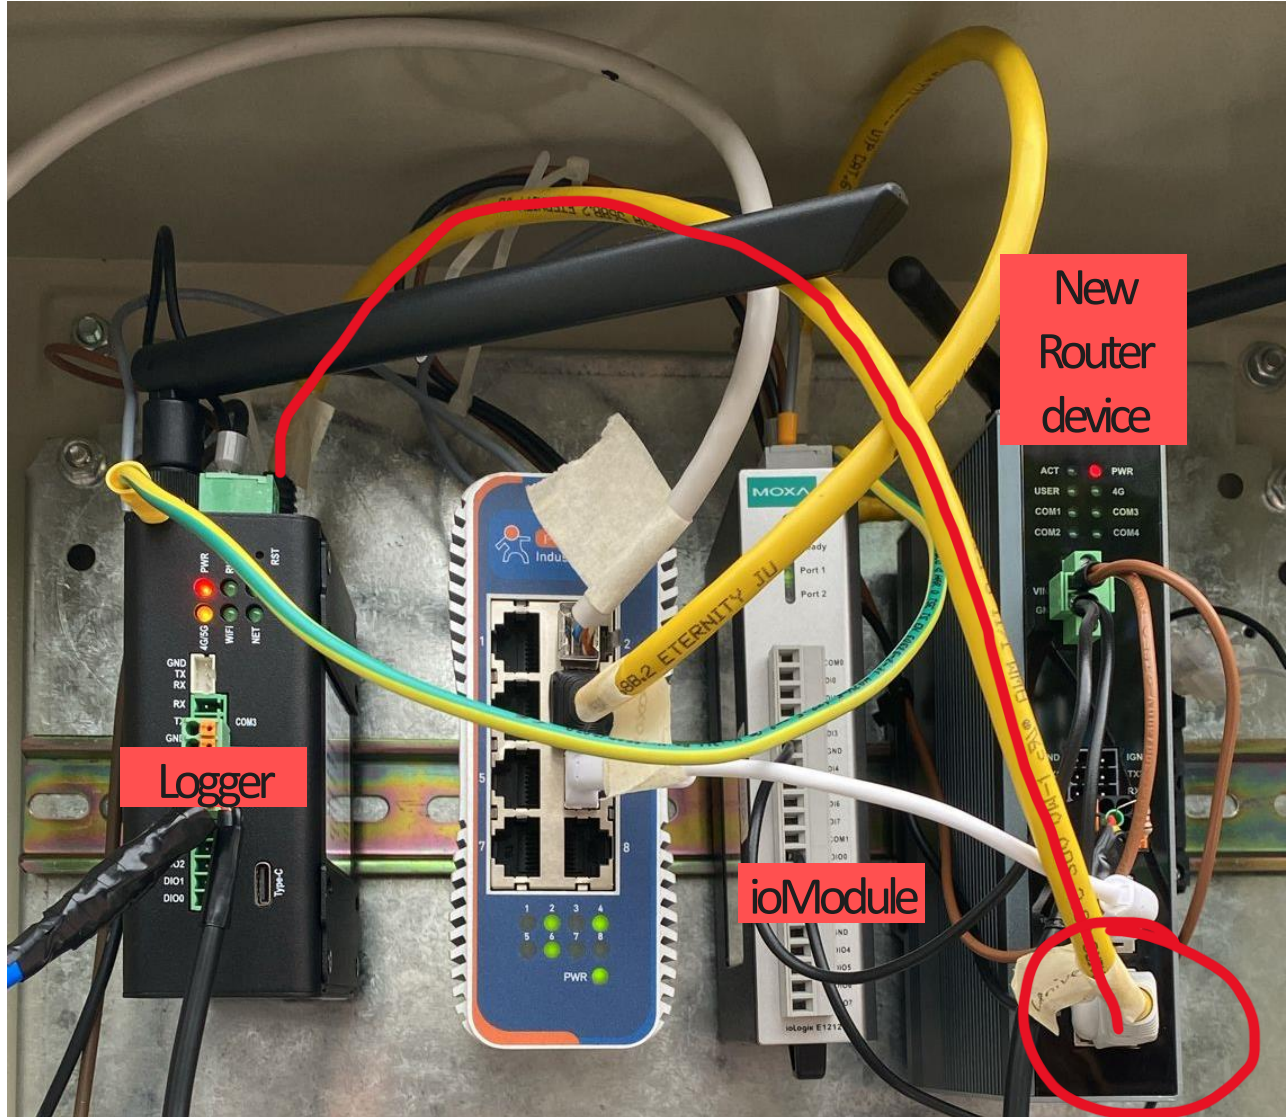
Issue 1: Missing Data (Panel photo on 16 Sep)

Based on photo provided by NaviX:

1. Logger is connected to external device (black box)

After correction, data returns as normal
