ADDITIVE MANUFACTURING · INDUSTRIES · DRAFT NOVEMBER 2026

Risk for human activities and structures

Risk per person and per hour · four classes of parts · failures of Class A structures

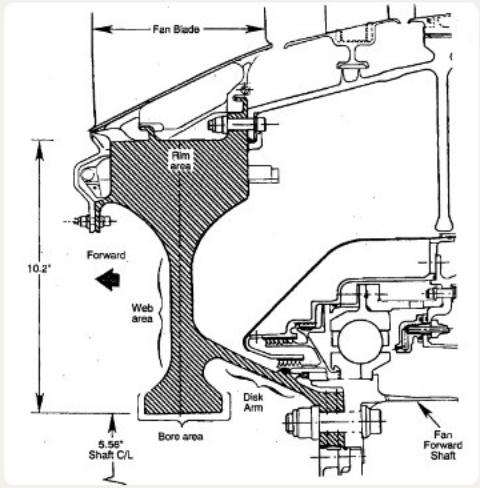
CF6-6 fan rotor and stage 1 fan disc section; disc height 259 mm, bore radius 141 mm (NTSB AAR-90/06, fig. 5, 17)

- 1971: a nitrogen-rich hard alpha inclusion forms while melting the titanium (double vacuum melt)
- A 1.4 × 0.4 mm cavity in the bore starts a fatigue crack, 31.5 mm long and 14.2 mm deep at failure
- Six inspections accepted the disc, the last one 760 flights before the accident

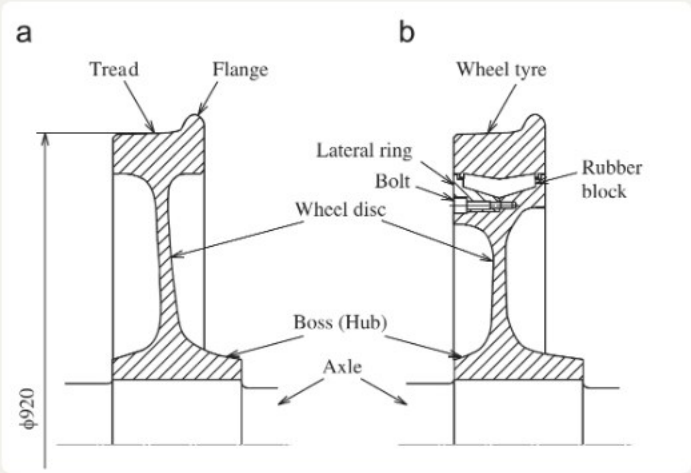
- 3 June 1998, ICE 884 Munich → Hamburg
- The steel tyre of a rubber-sprung wheel breaks by fatigue, peels off and pierces the floor
- 6 km later it catches a set of points: coaches derail and hit a road bridge, which collapses on the train

The accident site (Richard et al. 2005, fig. 1)

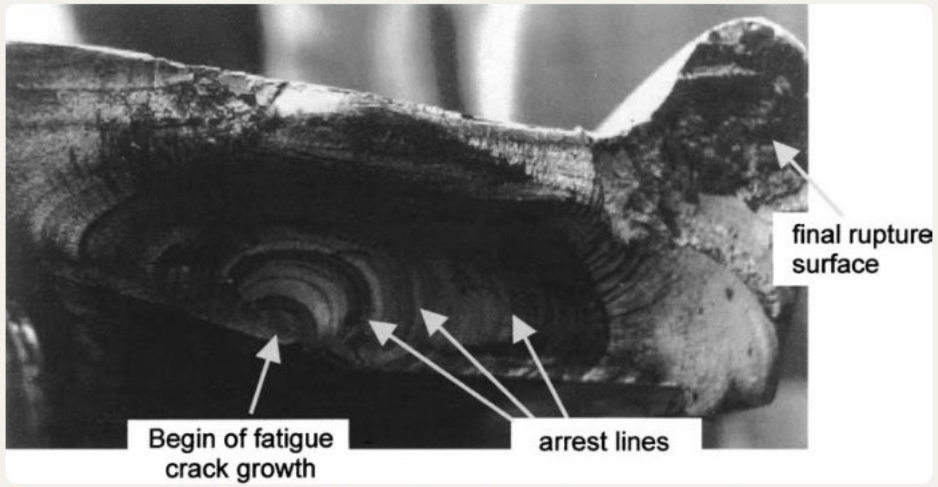
Fracture surface: origin on the inner face, arrest lines (Richard et al. 2005)

- Highest hoop stress on the hidden inner face
- A 1.5 mm crack grows slowly, with arrests, long before rupture

Lesson: the design margin looked sufficient; the missing barrier was an inspection able to see the inner face. **ICE 1 went back to monobloc wheels.**

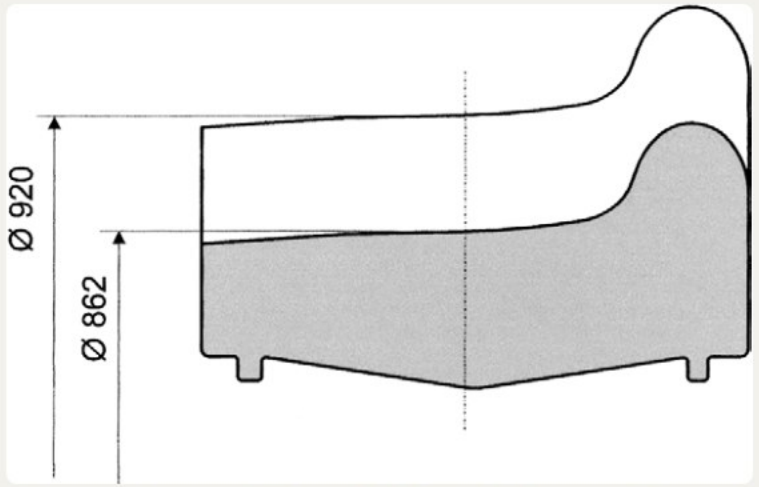
Wear and re-profiling: Ø 920 → 862 mm (Richard et al. 2005)

60 → 31 mm

tyre thickness by wear; scrap limit Ø 854 mm

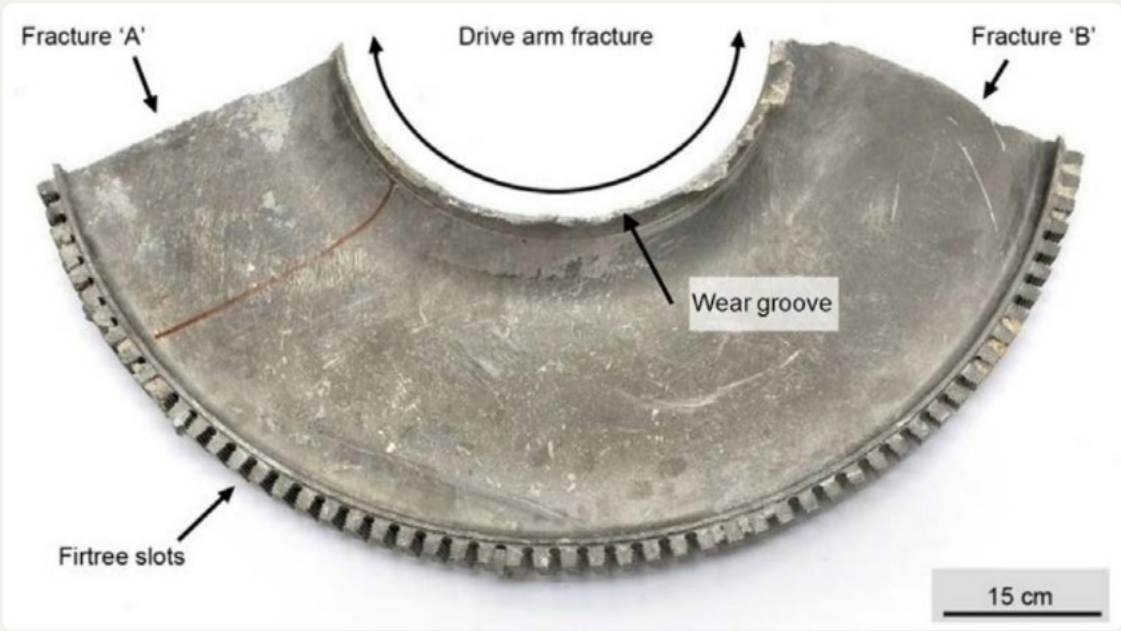
No. 2 engine, Rolls-Royce Trent 900 (ATSB AO-2010-089, cover)

IP turbine disc: 43 % of the disc, about 70 kg, found on Batam Island, Indonesia (ATSB fig. 38)

The disc fragment fell on a property on Batam; other debris pierced the wing and fuel tanks and cut wiring.

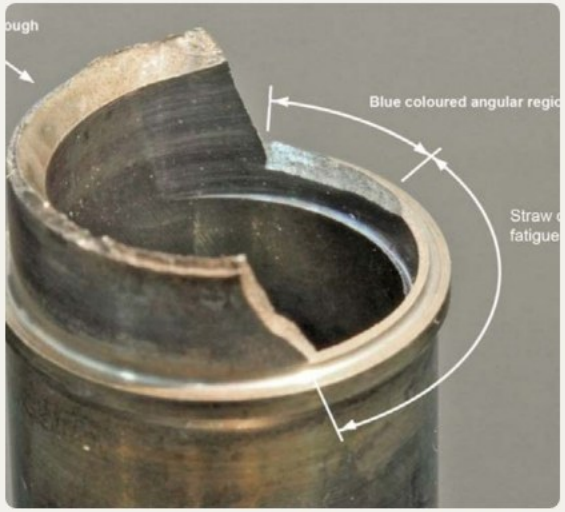
HP/IP bearing support, oil feed circled (ATSB fig. 29)

Fractured oil feed stub pipe (ATSB fig. 43)

0.35 mm
measured at the crack

The bearing hub moves about 6 mm at full thrust and bends the pipe on every flight.

Counter bore machined off-centre during manufacturing

Lesson: the failure analysis assumed that every part conforms to its drawing. A low-class part made out of tolerance started a chain that ended at a Class A part. **Classify along the whole failure chain, and match manufacturing control to the class.**
