5678 Easy Street | Example, TN

Property Workup

THIS REPORT IS USED TO DETERMINE THE FEASIBILITY OF THE REDRY SYSTEM.

5678 Easy Street, Example, TN

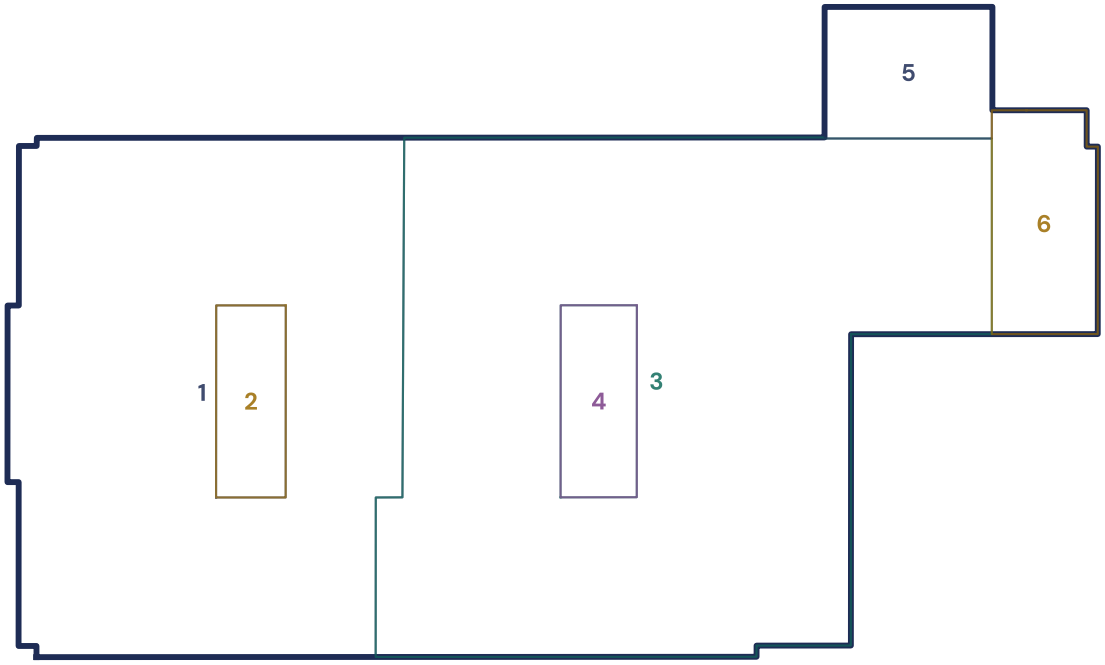
PROPERTY OVERVIEW

Roof area	**37,809 sqft**
Squares	**378.1**
Perimeter	**951 LF**
Sections	**6**
Section walls	**546 LF**
Grid squares to scan	**~426 | 10 x 10 ft**
Total ponding areas	**2**
Damp	**17.4% of roof**
Wet	**16.2% of roof**

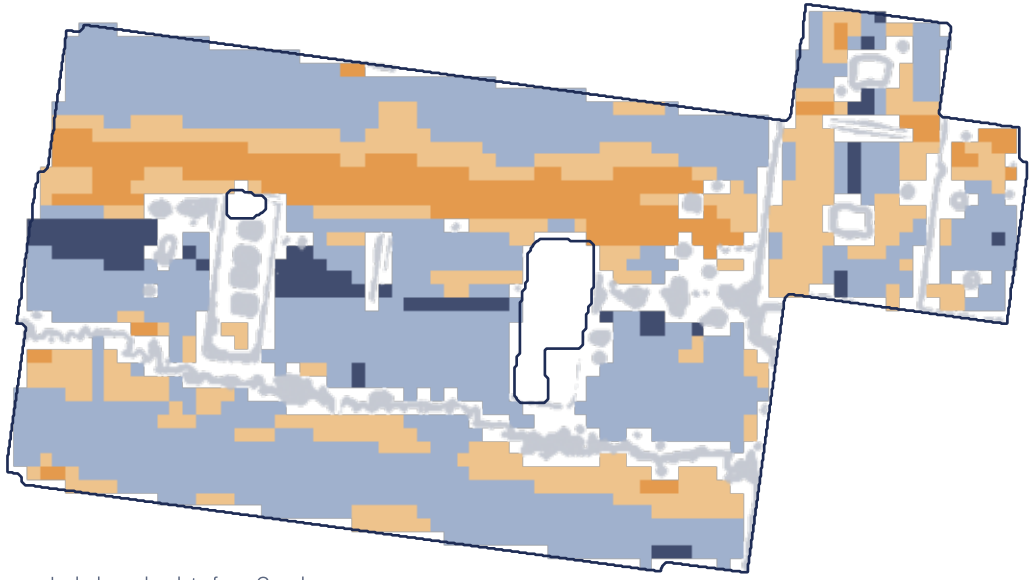
DRAINAGE GRADE

PROPER	ADEQUATE	POOR	FLAT
12%	24%	59%	5%

Graded by measured slope in 4 x 4 ft cells; Proper meets the 1/4 in/ft design minimum.
Percentages measured over the whole surface.

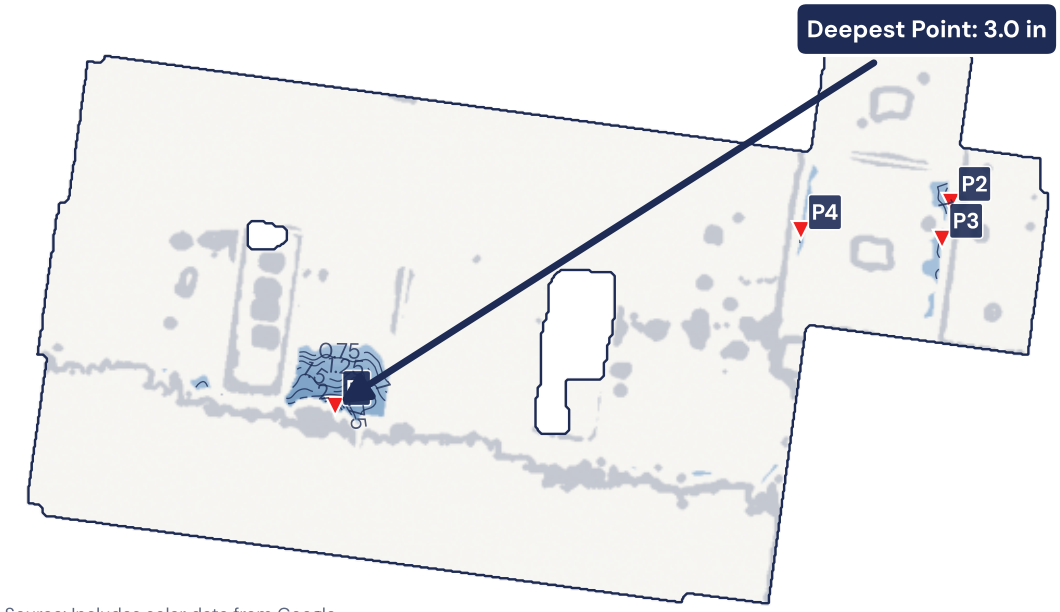
PONDING DEPTH

standing water depth, inches

Results are equivalent to the roof after a heavy rain.

P1 | 506 sqft in field	**3.0" max | ~452 gal**
P2 | 44 sqft in field	**1.8" max | ~21 gal**
P3 | 47 sqft in field	**1.0" max | ~19 gal**

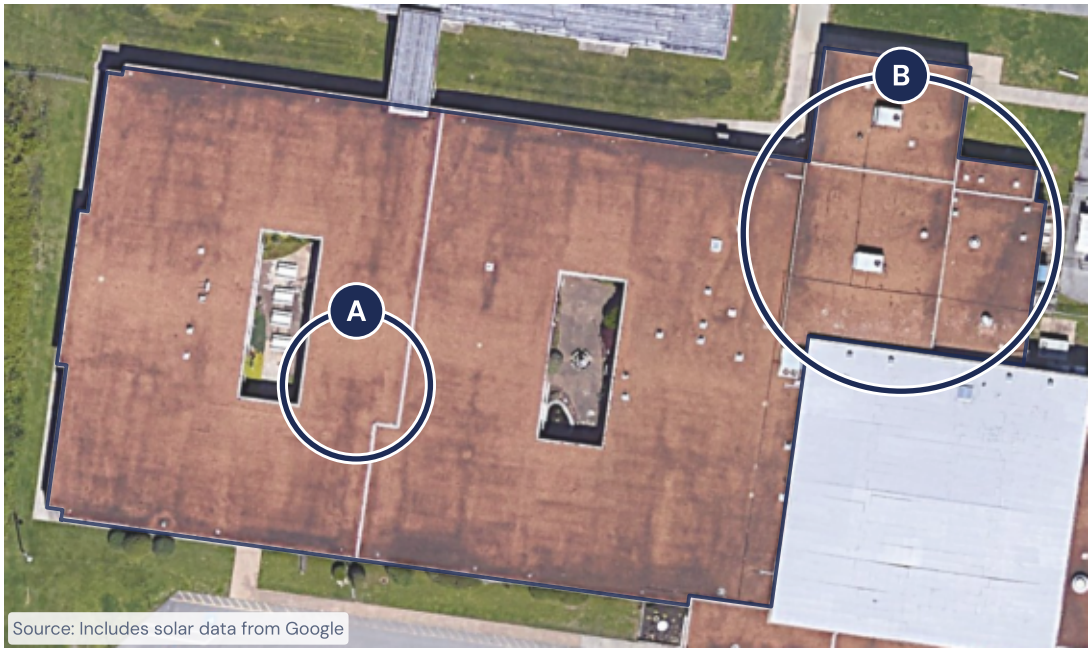
ACTION MAP

TAKE A LOOK HERE WHEN YOU'RE UP THERE

See if each area just has poor drainage or if it's ponding.

Area A	**506 sqft | deepest 3.0″**
Area B	**121 sqft | deepest 1.8″**

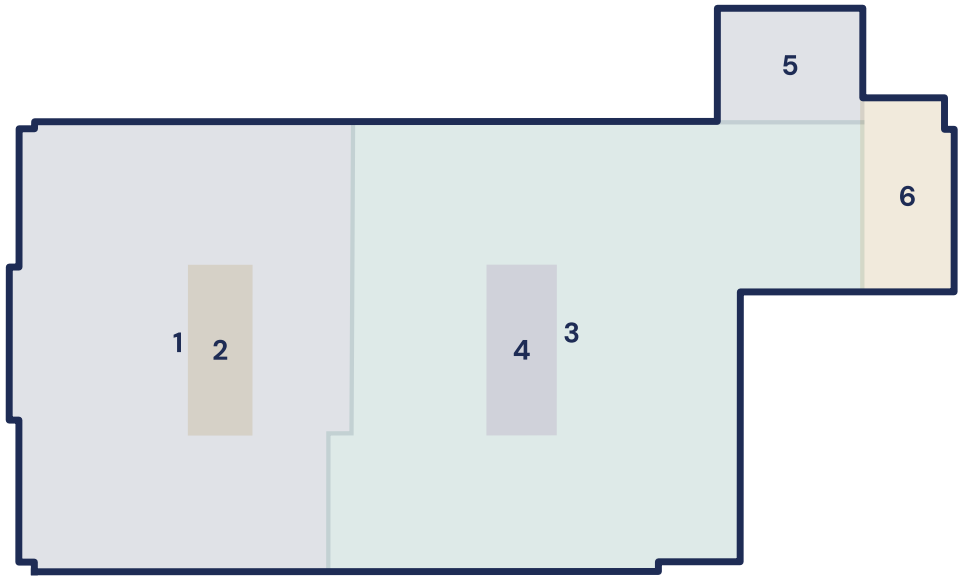
MOISTURE SUMMARY

Floor	**25 REL**
Pin Prick	**31 WME**
Calibration Point	**71 REL**

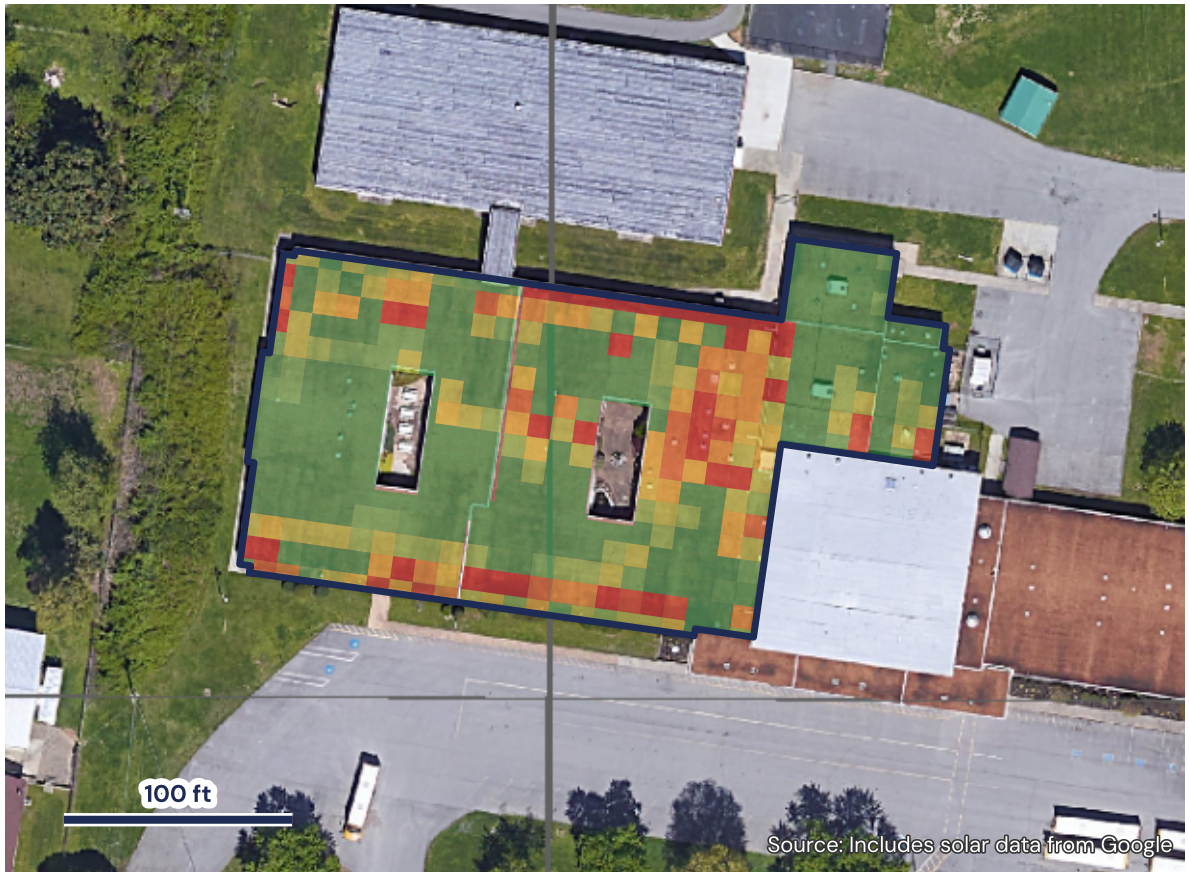
MOISTURE MAP

Cells read	**396 of 426**
Dry | 0 – 3	**253**
Damp | 4 – 6	**74**
Wet | 7 – 10	**69**
Damp share	**17.4% of roof**
Wet share	**16.2% of roof**

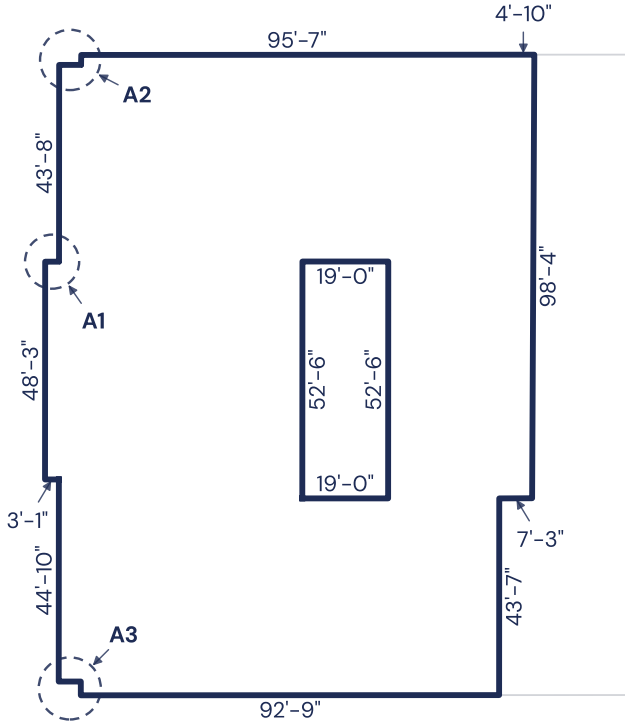
SECTION 1

Width x length	**108.5 x 142.1 ft**
Area	**13,725 sqft**
Squares	**137.2**
Perimeter	**643 lf**
Edges drawn	**20**

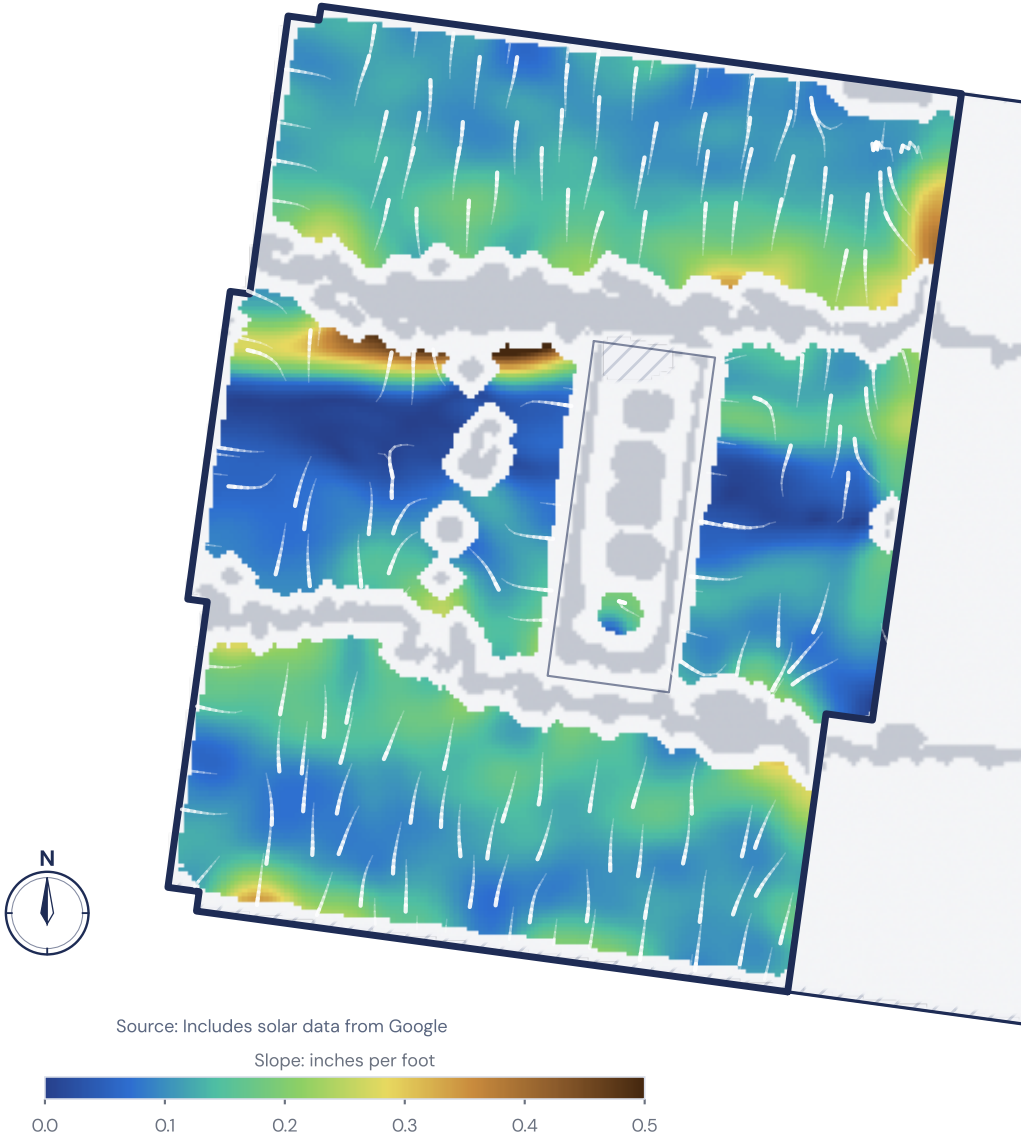
SLOPE DETAIL

Measured slope	**0.12 in/ft WNW**
Flattest tenth	**0.06 in/ft**
Steepest tenth	**0.18 in/ft**

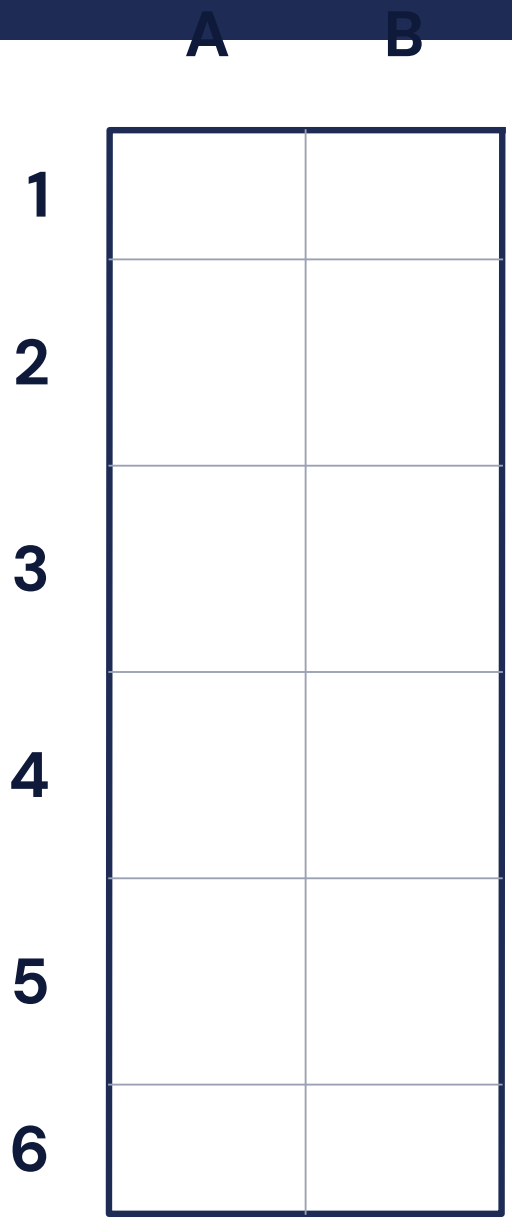
MOISTURE FINDINGS

Floor	**25 REL**
Pin Prick	**31 WME**
Calibration Point	**71 REL**

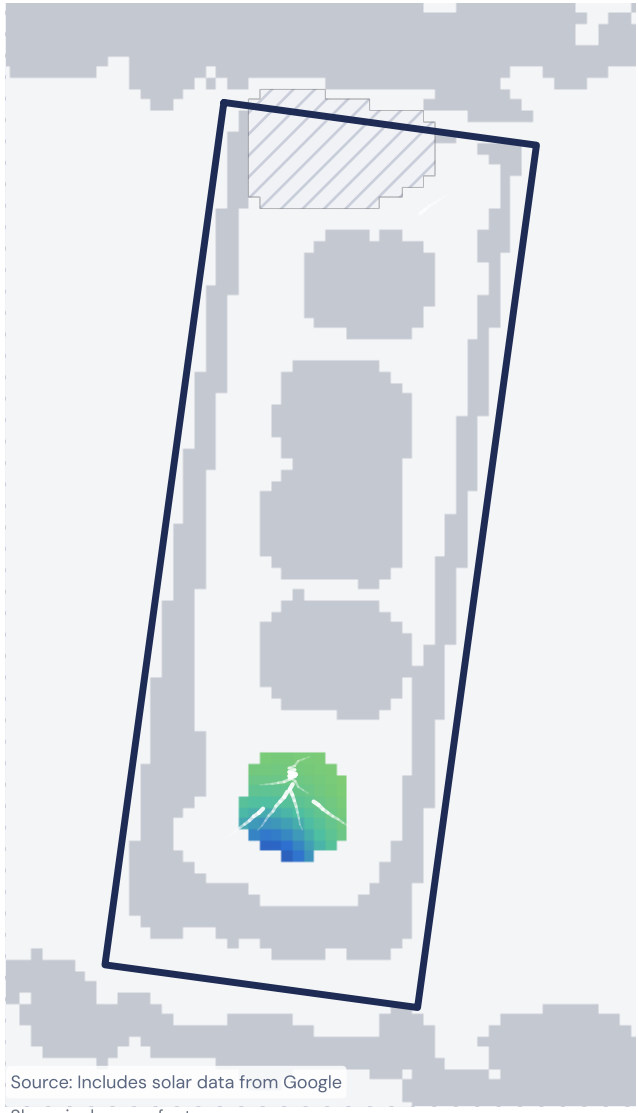
SLOPE DETAIL

Measured slope	**0.16 in/ft SSW**
Flattest tenth	**0.09 in/ft**
Steepest tenth	**0.19 in/ft**

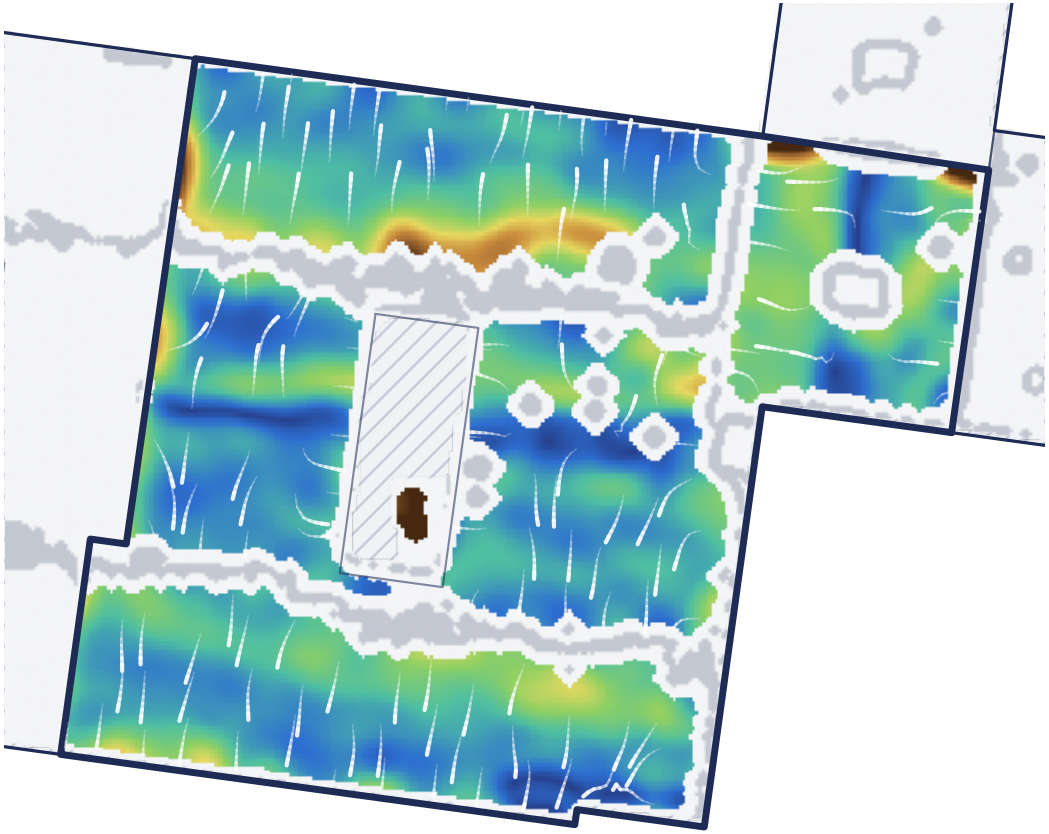
SLOPE DETAIL

Measured slope	**0.13 in/ft SSW**
Flattest tenth	**0.08 in/ft**
Steepest tenth	**0.21 in/ft**

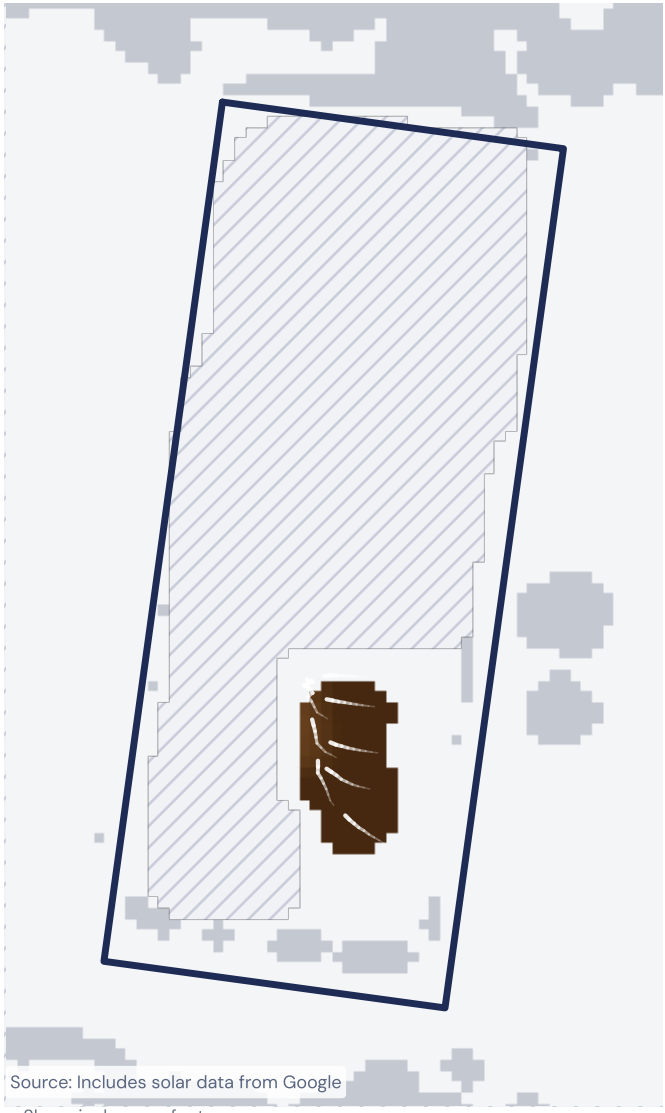
SLOPE DETAIL

Measured slope	**0.53 in/ft NNW**
Flattest tenth	**0.47 in/ft**
Steepest tenth	**0.60 in/ft**

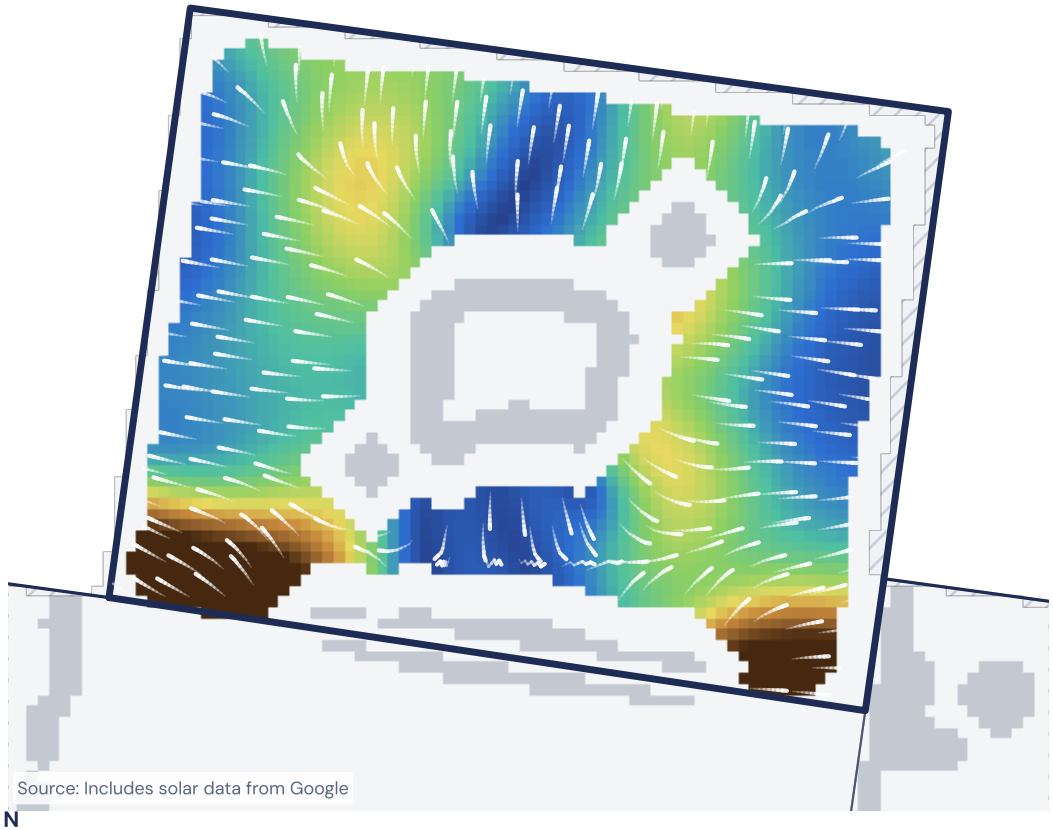
SLOPE DETAIL

Measured slope	**0.15 in/ft N**
Flattest tenth	**0.05 in/ft**
Steepest tenth	**0.28 in/ft**

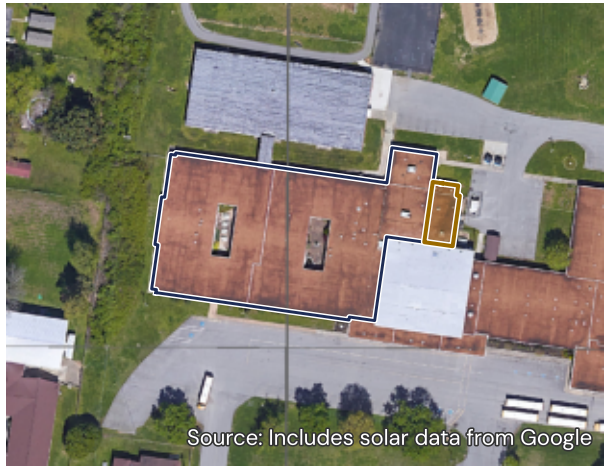
SECTION 6

MOISTURE FINDINGS

A	B	C
1	0	0	0
2	0	0	0
3	0	0	0
4	0	3	0
5	0	3	4
6	0	4	9
7	0	2	9

Cells read	**21 of 21**
Dry | 0 - 3	**17**
Damp | 4 - 6	**2**
Wet | 7 - 10	**2**
Damp share	**9.5% of roof**
Wet share	**9.5% of roof**

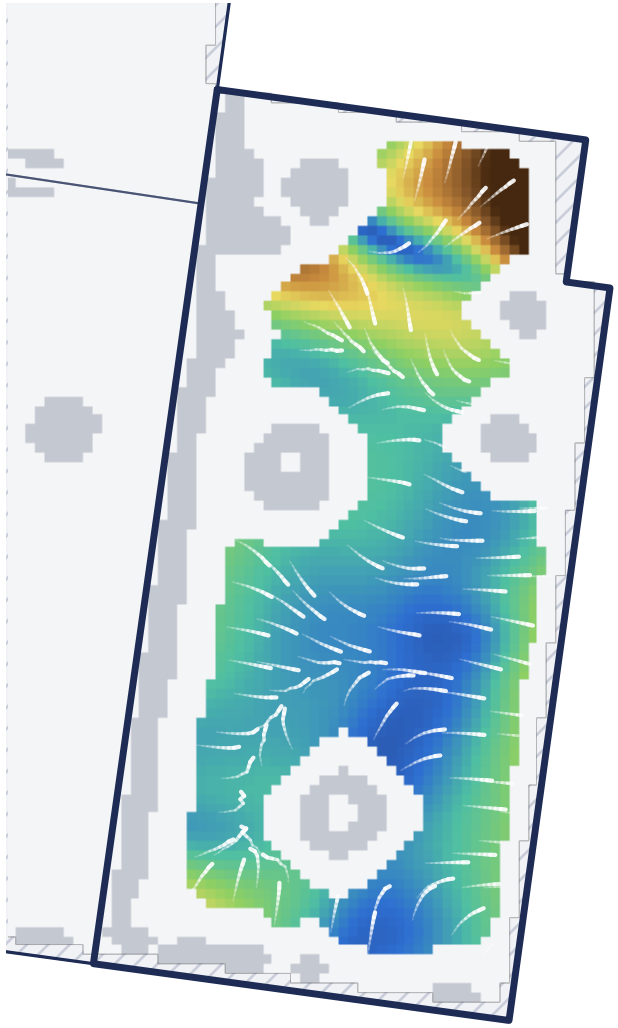
SLOPE DETAIL

Measured slope	**0.13 in/ft E**
Flattest tenth	**0.08 in/ft**
Steepest tenth	**0.27 in/ft**

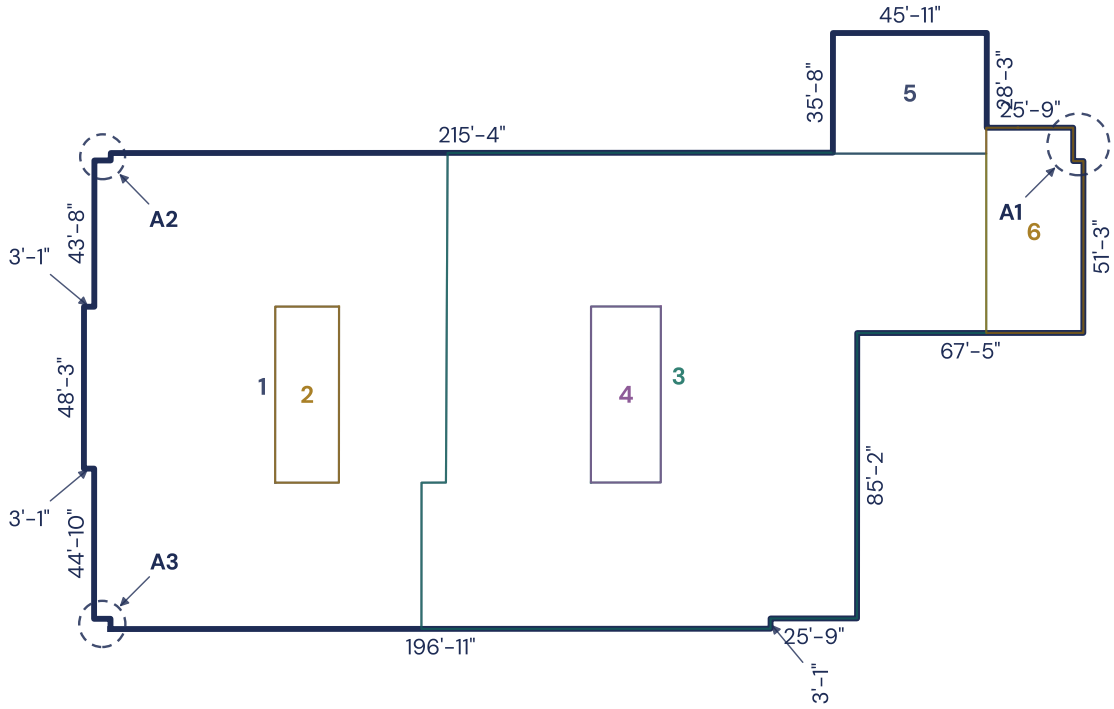
Vent Placement Map

Vents · 3
