WIN®
HOME INSPECTION

August 28, 2026

14211 Serene Way, Lynnwood, WA, 98087

Service: **Full Home Inspection**

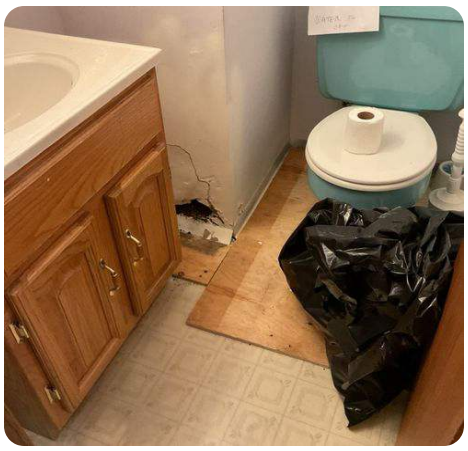
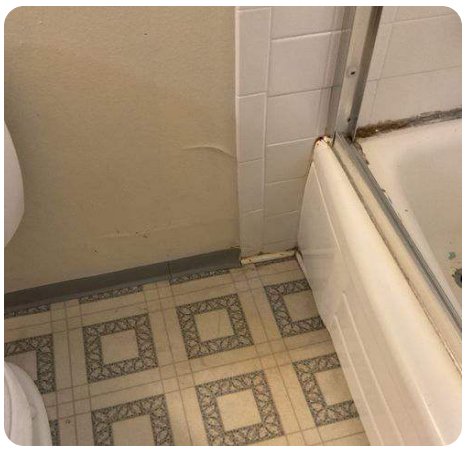
12 Plumbing Leaks

There were 3 plumbing leaks noticed during the inspection. 1) There is a leak in the drain line under the kitchen sink. 2) There is a leak in the drain line under the sink in the 1/2 bathroom. 3) There was water dripping into the crawl space under the bathtub when the crawl space was inspected. The inspector could not determine what leaking due to all of the rodent debris and rodent damaged underfloor insulation that was hanging down. Recommend further evaluation and repairs as necessary by a licensed plumber.

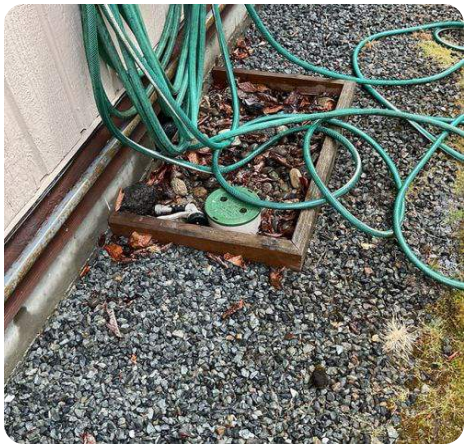
Water Shut-off Location: At Meter, Exterior on west side of house

The water service main shut-off valve was located on the exterior, west side of the house, under the green cover. There is also a water shut off at the water meter at the street. It is important to know the location of the shut-off valve in case of emergencies or when repairs are needed.

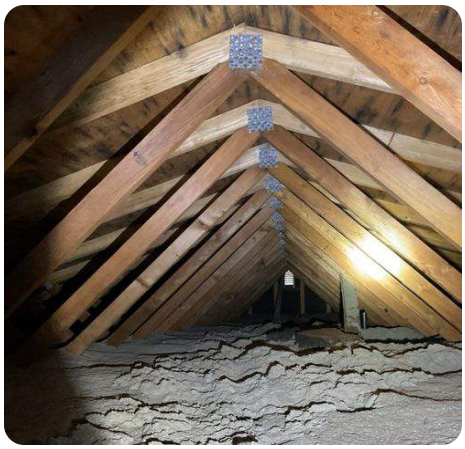
12.3 Structural Components > Roof Structure and Attic Components

The roof structure and sheathing in the attic appeared to be in satisfactory condition at the time of the inspection.

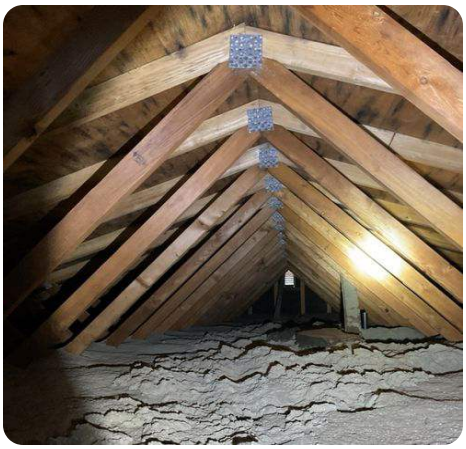
The insulation inside the attic has not been upgraded over the years, there appears to R 19 installed. Recommend upgrading the insulation in the future to R 49 which is the newest insulation standard to help save on the heating costs. Additionally, passive ventilation in the area appears to be functional.

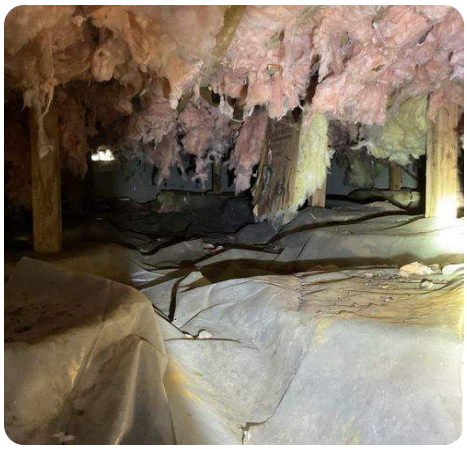
13.2 Insulation and Ventilation > Insulation and Ventilation in Crawl Space

There is extensive rodent activity in the crawl space. All of the underfloor insulation, the plastic vapor barrier, all of the rodent debris needs to be removed, all the openings that the rodents are entering from need to be filled, and new insulation/vapor barrier installed. Also, the crawl space access cover needs to be replaced, it is deteriorated, and has openings under it that rodents can enter thru. And, there appears to be a rodent tunnel under the crawl space access well that needs to be sealed off.
