WO-200-03 — Replace VALVE, GATE, WEDGE, OS&Y 4" P300 (4"-P300-P-1021/A2)

Area	A200 Vessels and column	**Task**	VR Valve replacement in kind
Priority	2 (integrity)	**Issued by**	Facility owner (demonstration)
Equipment	—	**Lines**	4"-P300-P-1021
Isometrics	ISO-4"-P300-P-1021		
Permits	General work permit

DWG ISO-4"-P300-P-1021 REV 0 WO-200-03

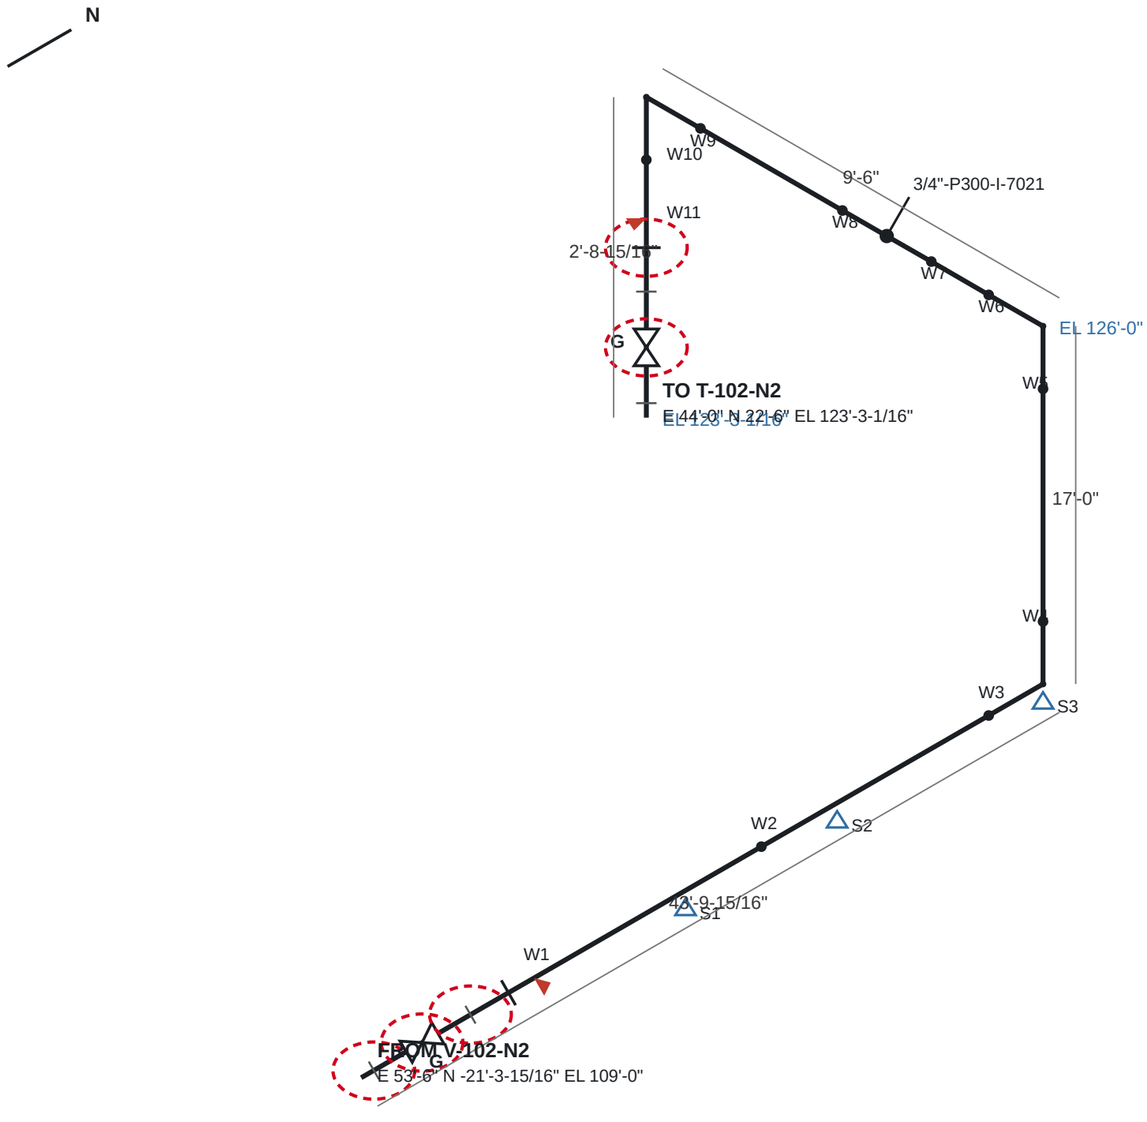
ISOMETRIC — 4"-P300-P-1021 — Replace VALVE, GATE, WEDGE, OS&Y 4" P300 (4"-P300-P-1021/A2)

Outlet isolation valve stem packing leaking and seat passing.

1. Isolate per the isolation list, drain and vent 4"-P300-P-1021 between the isolations.
2. Unbolt and remove VALVE, GATE, WEDGE, OS&Y 4" P300 (4"-P300-P-1021/A2) at E 53'-6" N -20'-8-3/16" EL 109'-0".
3. Inspect both flange faces (SW-NDE-5); dress or report damage.
4. Install a new VALVE, GATE, WEDGE, OS&Y 4" P300 of the same size, class and face-to-face (GATE4-P300), with new gaskets and studs, stem orientation as removed.
5. Tighten the studs to the stated preload in three passes, cross pattern (SW-WO-5).
6. Remove blinds, restore the line-up, leak test the two joints on start-up (SW-TEST-2).
