WO-100-04 — Remake flanged joint 2"-P300-LS-3007/A2 on 2"-P300-LS-3007

Area	A100 Tank farm	**Task**	GJ Flanged joint remake
Priority	1 (safety)	**Issued by**	Facility owner (demonstration)
Primary asset	**T-101** — T-101 tank 12' dia × 22' high — E 25'-0" N 26'-6" EL 100'-6"		
Equipment	T-101	**Lines**	2"-P300-LS-3007
Isometrics	ISO-2"-P300-LS-3007 (generated); owner's drawings ISO-LS-3007		
Permits	General work permit

DWG ISO-2"-P300-LS-3007 REV 0 WO-100-04

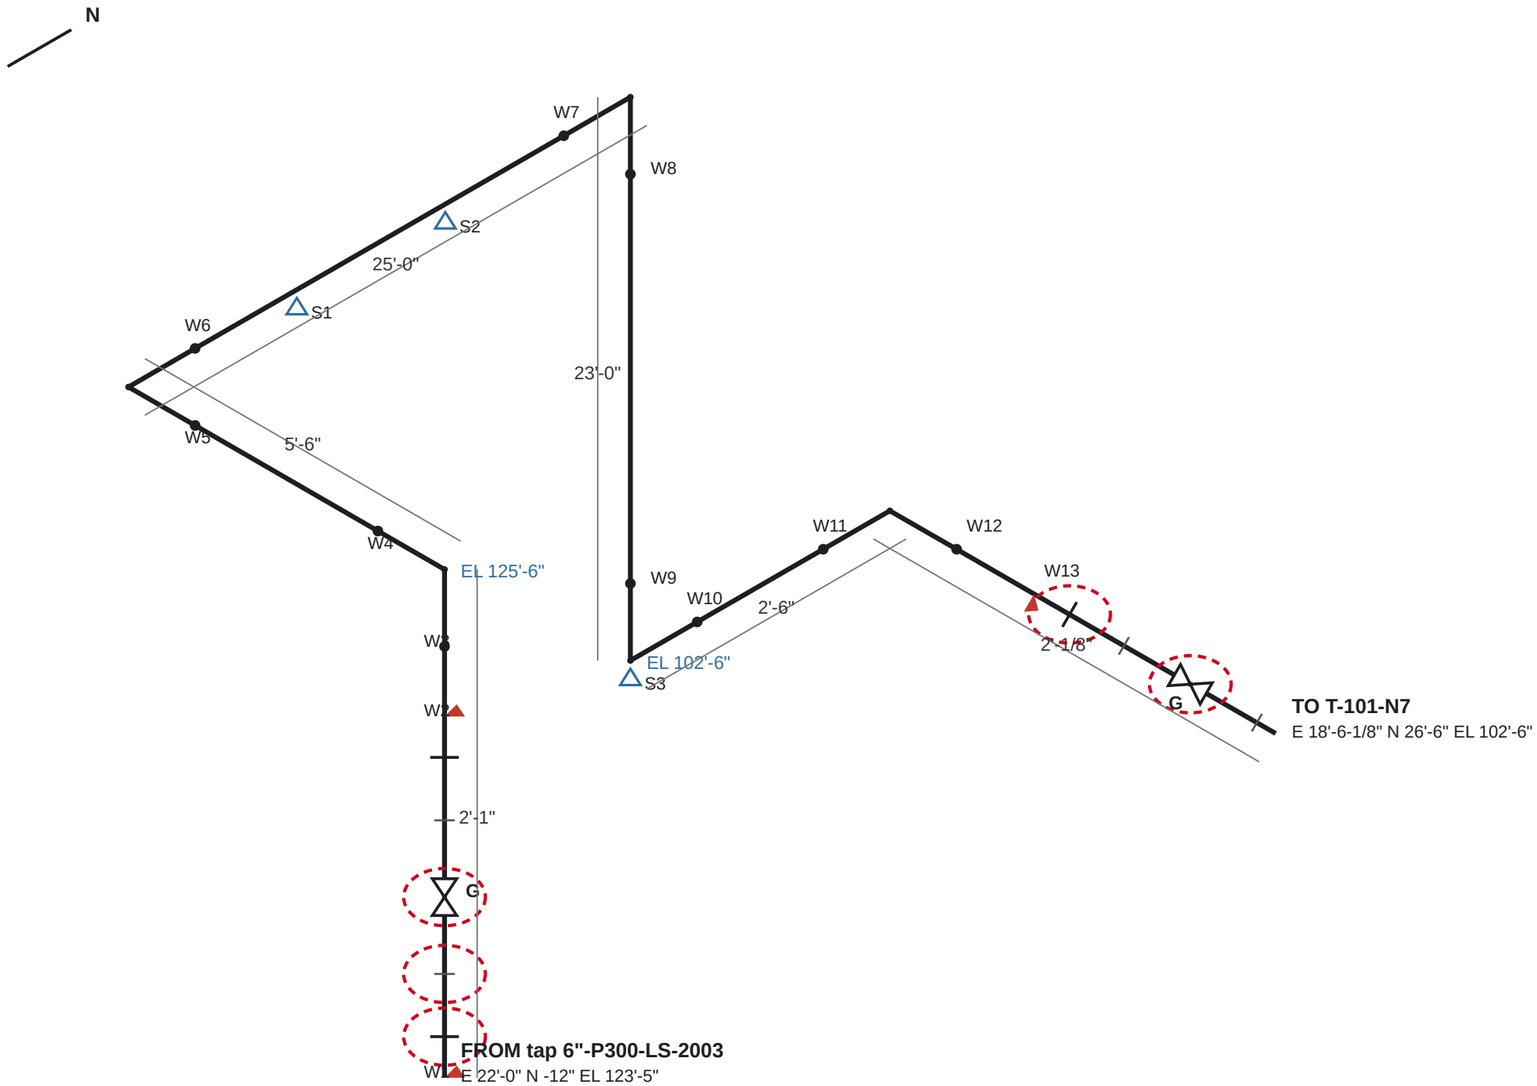
Steam leak at the tank heating-coil inlet flange.

ISOMETRIC — 2"-P300-LS-3007 — Remake flanged joint 2"-P300-LS-3007/A2 on 2"-P300-LS-3007

1. Isolate per the isolation list, drain and vent 2"-P300-LS-3007.
2. Break the joint at E 22'-0" N -12" EL 123'-9-1/4" between FLANGE WELD-NECK 2" P300 RAISED FACE and VALVE, GATE, WEDGE, OS&Y 2" P300.
3. Inspect both flange faces (SW-NDE-5).
4. Fit a new gasket and new studs; tighten to the stated preload in three passes, cross pattern (SW-WO-5).
5. Remove blinds; leak test on start-up (SW-TEST-2).
