WO-400-03 — Replace VALVE, SWING CHECK 3" P300 (4"-P300-P-1008/A2)

Area	A400 Pumps	**Task**	VR Valve replacement in kind
Priority	2 (integrity)	**Issued by**	Facility owner (demonstration)
Primary asset	**P-102A** — P-102A centrifugal pump — E 164'-0" N -18'-6" EL 100'-9"		
Equipment	P-102A	**Lines**	4"-P300-P-1008
Isometrics	ISO-4"-P300-P-1008 (generated); owner's drawings ISO-P-1008		
Permits	General work permit

ISOMETRIC — 4"-P300-P-1008 — Replace VALVE, SWING CHECK 3" P300 (4"-P300-P-1008/A2)

DWG ISO-4"-P300-P-1008 REV 0 WO-400-03

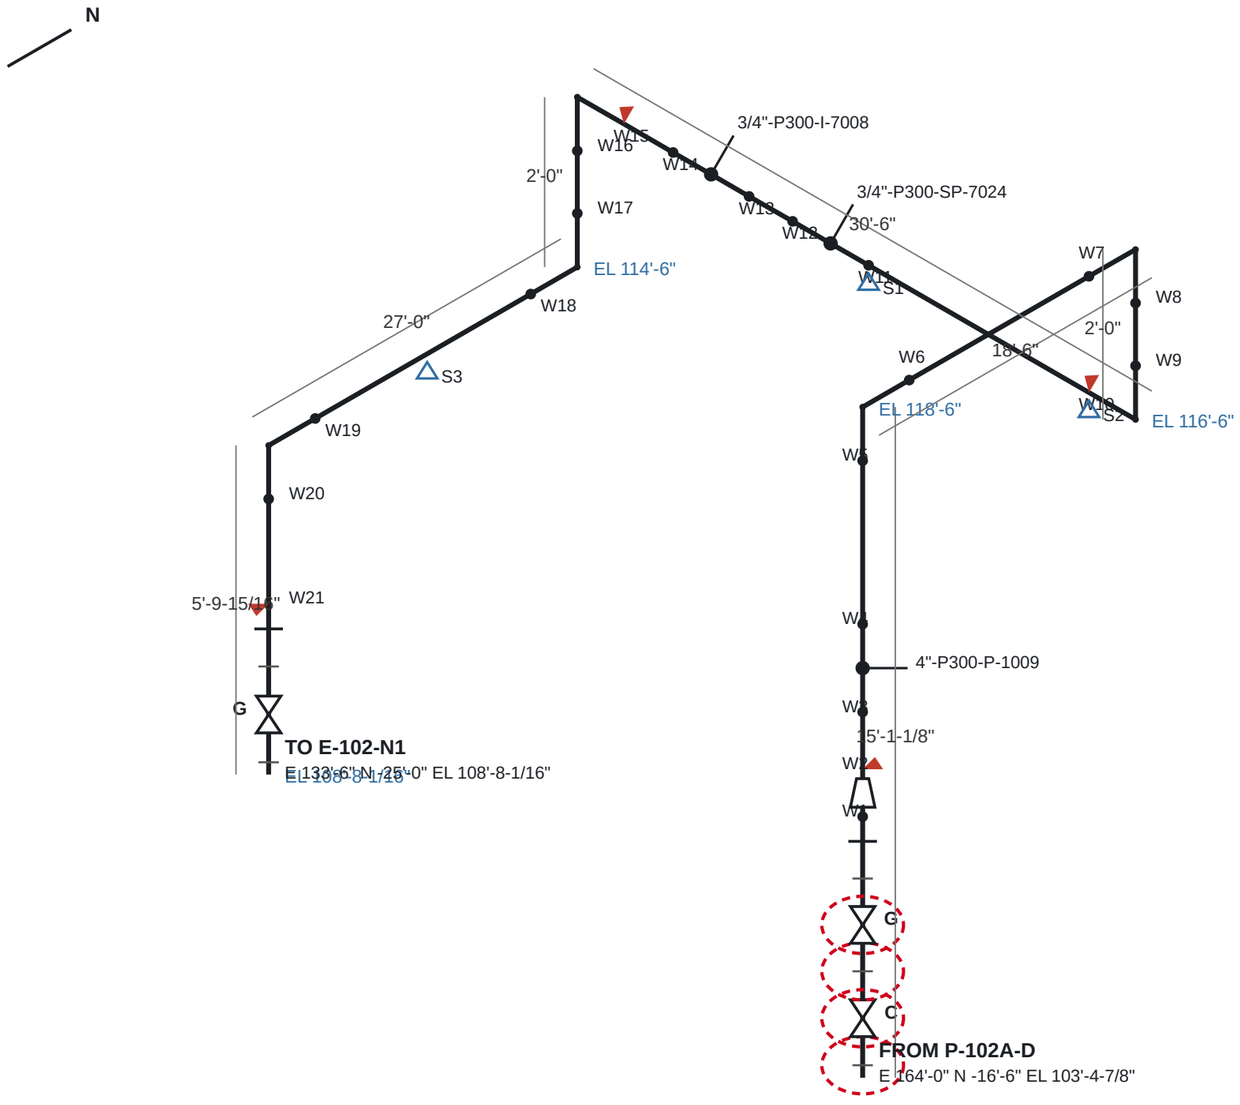
Discharge check valve slamming; replace in kind.

1. Isolate per the isolation list, drain and vent 4"-P300-P-1008 between the isolations.
2. Unbolt and remove VALVE, SWING CHECK 3" P300 (4"-P300-P-1008/A2) at E 164'-0" N -16'-6" EL 104'-1/8".
3. Inspect both flange faces (SW-NDE-5); dress or report damage.
4. Install a new VALVE, SWING CHECK 3" P300 of the same size, class and face-to-face (CHECK3-P300), with new gaskets and studs, stem orientation as removed.
5. Tighten the studs to the stated preload in three passes, cross pattern (SW-WO-5).
6. Remove blinds, restore the line-up, leak test the two joints on start-up (SW-TEST-2).
