WO-200-03 — Replace VALVE, GATE, WEDGE, OS&Y 4" P300 (4"-P300-P-1021/A2)

Area	A200 Vessels and column	**Task**	VR Valve replacement in kind
Priority	2 (integrity)	**Issued by**	Facility owner (demonstration)
Primary asset	**V-102** — V-102 vertical vessel 72" ID × 216" T/T — E 53'-6" N -25'-0" EL 100'-8-1/4"		
Equipment	V-102	**Lines**	4"-P300-P-1021
Isometrics	ISO-4"-P300-P-1021		
Permits	General work permit

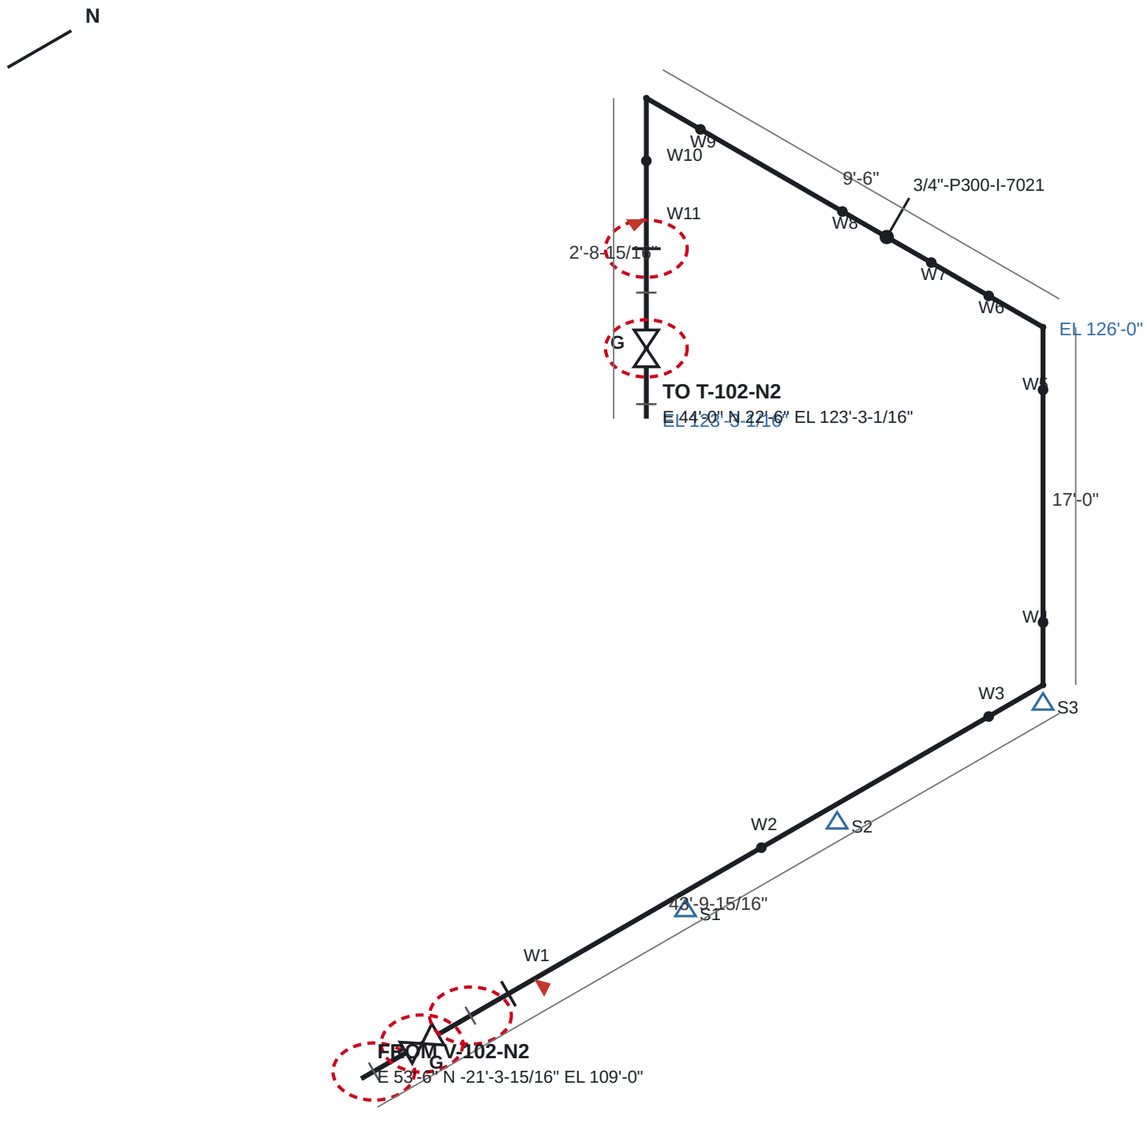
DWG ISO-4"-P300-P-1021 REV 0 WO-200-03

Outlet isolation valve stem packing leaking and seat passing.

1. Isolate per the isolation list, drain and vent 4"-P300-P-1021 between the isolations.
2. Unbolt and remove VALVE, GATE, WEDGE, OS&Y 4" P300 (4"-P300-P-1021/A2) at E 53'-6" N -20'-8-3/16" EL 109'-0".
3. Inspect both flange faces (SW-NDE-5); dress or report damage.
4. Install a new VALVE, GATE, WEDGE, OS&Y 4" P300 of the same size, class and face-to-face (GATE4-P300), with new gaskets and studs, stem orientation as removed.
5. Tighten the studs to the stated preload in three passes, cross pattern (SW-WO-5).
6. Remove blinds, restore the line-up, leak test the two joints on start-up (SW-TEST-2).
