WO-300-05 — Replace VALVE, CONTROL, GLOBE WITH DIAPHRAGM ACTUATOR 4" P300 (4"-P300-P-1005/B13)

Area	A300 Exchangers and drum	**Task**	VR Valve replacement in kind
Priority	3 (reliability)	**Issued by**	Facility owner (demonstration)
Primary asset	**E-101** — E-101 shell-and-tube exchanger 36" ID × 192" — E 111'-6" N -25'-0" EL 106'-6"		
Equipment	E-101	**Lines**	4"-P300-P-1005
Isometrics	ISO-4"-P300-P-1005		
Permits	General work permit

DWG ISO-4"-P300-P-1005 REV 0 WO-300-05

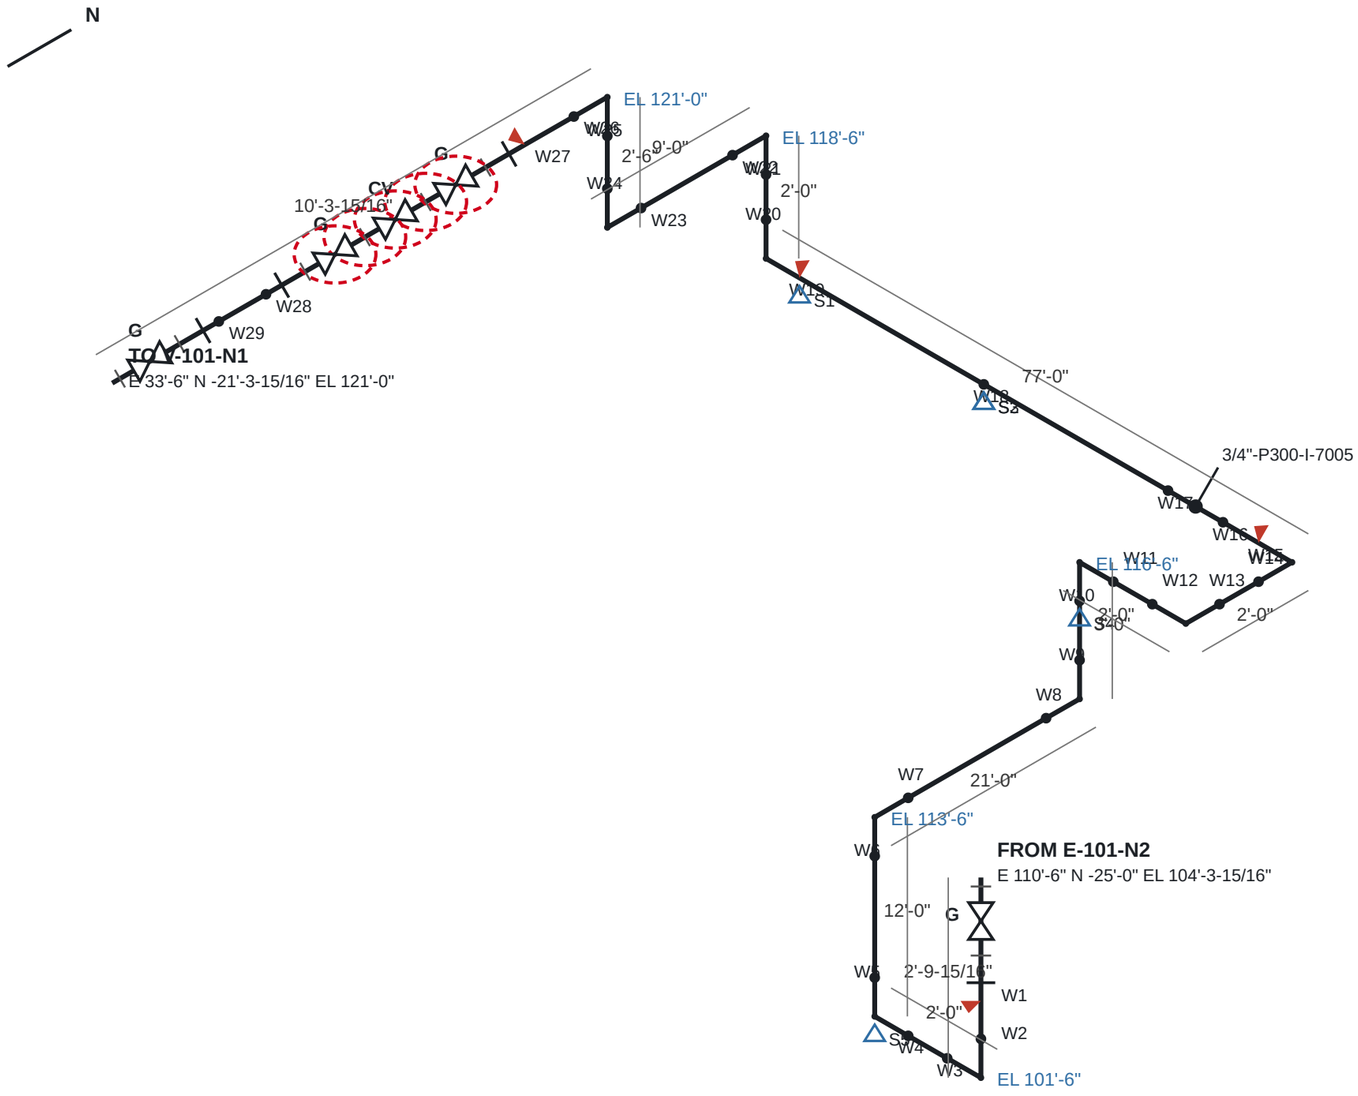
Control valve trim worn; replace the valve in kind.

ISOMETRIC — 4"-P300-P-1005 — Replace VALVE, CONTROL, GLOBE WITH DIAPHRAGM ACTUATOR 4" P300 (4"-P300-P-1005/B13)

1. Isolate per the isolation list, drain and vent 4"-P300-P-1005 between the isolations.
2. Unbolt and remove VALVE, CONTROL, GLOBE WITH DIAPHRAGM ACTUATOR 4" P300 (4"-P300-P-1005/B13) at E 33'-6" N -15'-7-15/16" EL 121'-0".
3. Inspect both flange faces (SW-NDE-5); dress or report damage.
4. Install a new VALVE, CONTROL, GLOBE WITH DIAPHRAGM ACTUATOR 4" P300 of the same size, class and face-to-face (CONTROL4-P300), with new gaskets and studs, stem orientation as removed.
5. Tighten the studs to the stated preload in three passes, cross pattern (SW-WO-5).
6. Remove blinds, restore the line-up, leak test the two joints on start-up (SW-TEST-2).
