WO-400-04 — Remake flanged joint 3"-P300-P-1015/B12 on 3"-P300-P-1015

Area	A400 Pumps	**Task**	GJ Flanged joint remake
Priority	2 (integrity)	**Issued by**	Facility owner (demonstration)
Primary asset	**P-103A** — P-103A centrifugal pump — E 174'-0" N -18'-6" EL 100'-9"		
Equipment	P-103A	**Lines**	3"-P300-P-1015
Isometrics	ISO-3"-P300-P-1015		
Permits	General work permit

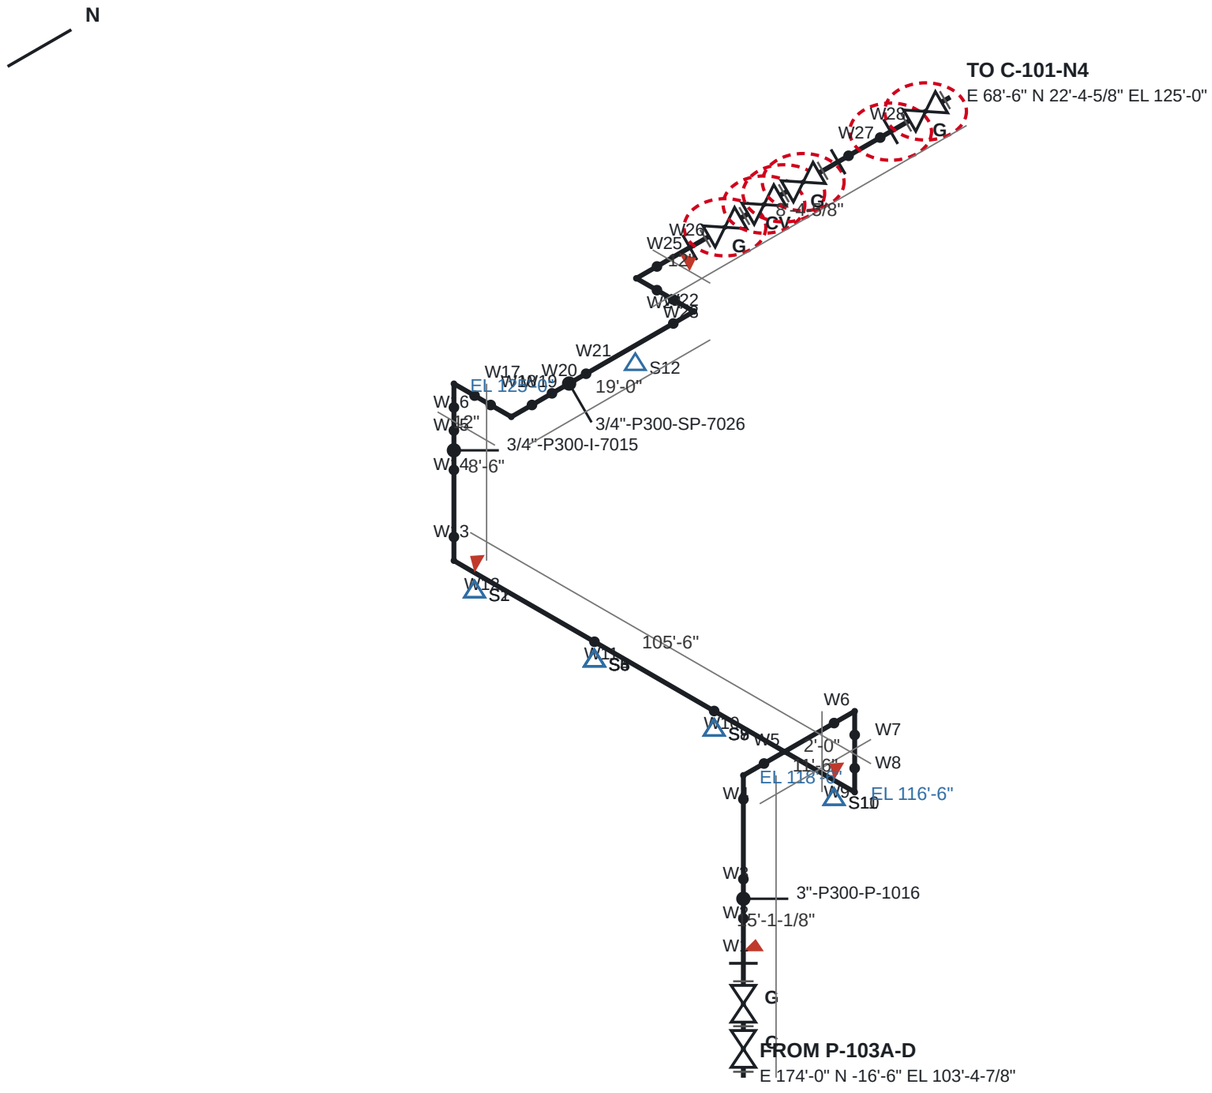
ISOMETRIC — 3"-P300-P-1015 — Remake flanged joint 3"-P300-P-1015/B12 on 3"-P300-P-1015

Weeping joint at the control valve station.

1. Isolate per the isolation list, drain and vent 3"-P300-P-1015.
2. Break the joint at E 68'-6" N 17'-8-13/16" EL 125'-0" between VALVE, CONTROL, GLOBE WITH DIAPHRAGM ACTUATOR 3" P300 and VALVE, GATE, WEDGE, OS&Y 3" P300.
3. Inspect both flange faces (SW-NDE-5).
4. Fit a new gasket and new studs; tighten to the stated preload in three passes, cross pattern (SW-WO-5).
5. Remove blinds; leak test on start-up (SW-TEST-2).
