WO-500-03 — Replace spool SP03 of 1"-P300-HS-5013

Area	A500 Pipe rack	**Task**	SR Spool replacement
Priority	3 (reliability)	**Issued by**	Facility owner (demonstration)
Equipment	—	**Lines**	1"-P300-HS-5013
Isometrics	ISO-1"-P300-HS-5013		
Permits	General work permit, Hot work permit

ISOMETRIC — 1"-P300-HS-5013 — Replace spool SP03 of 1"-P300-HS-5013

DWG ISO-1"-P300-HS-5013 REV 0 WO-500-03

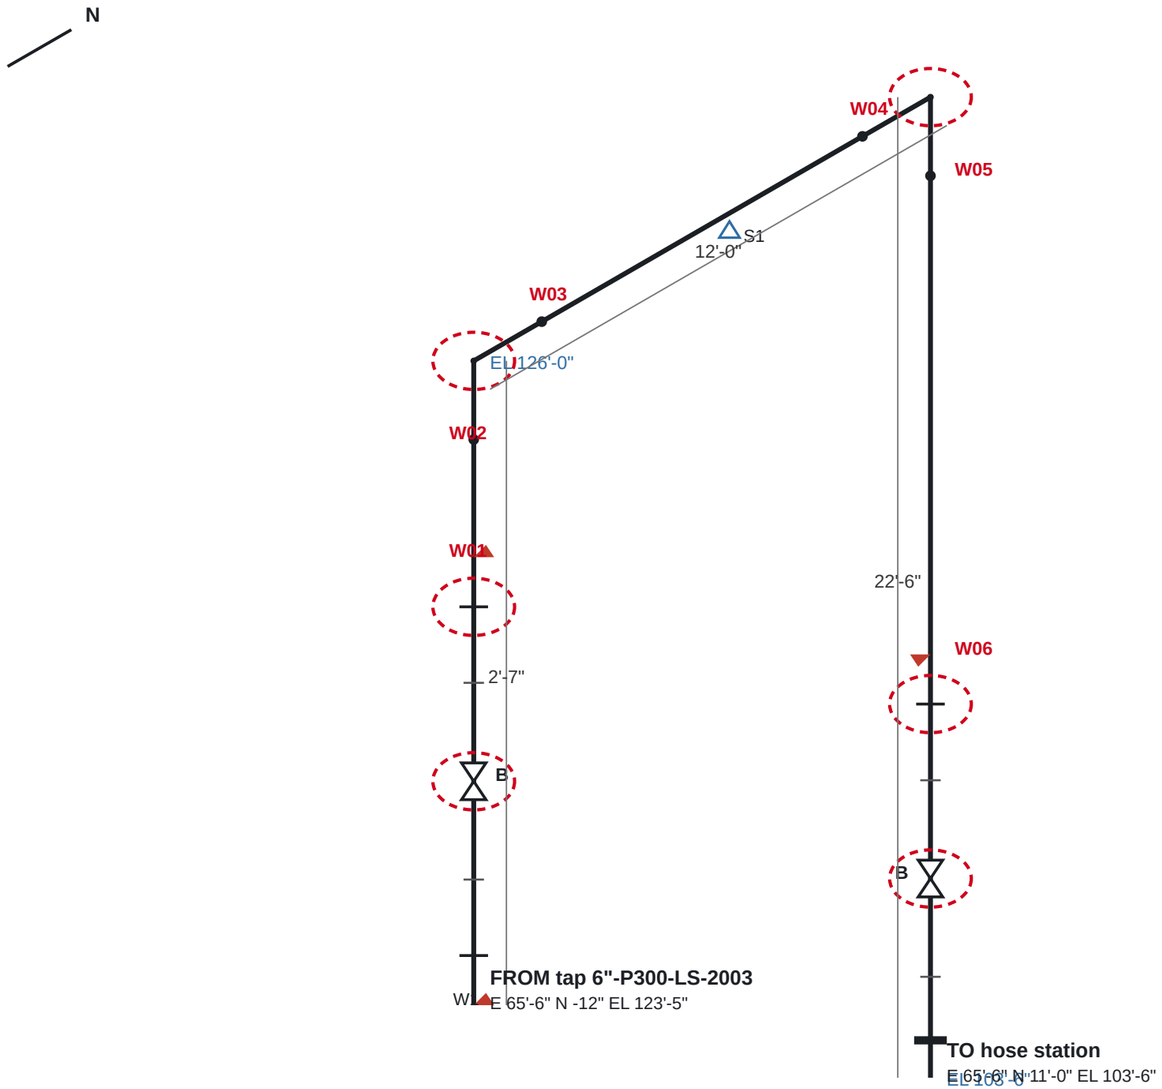
Steam hose-station drop corroded at the elbow.

WO-500-03-W01 replaces W2
WO-500-03-W02 replaces W3
WO-500-03-W03 replaces W4
WO-500-03-W04 replaces W5
WO-500-03-W05 replaces W6
WO-500-03-W06 replaces W7

1. Isolate per the isolation list; drain, vent and purge 1"-P300-HS-5013 between the isolations; confirm gas-free for hot work.
2. Remove spool 1"-P300-HS-5013-SP03 (5 items, 33'-1-3/16" of pipe) — cut at the field welds and break the flanged joints at its ends as listed.
3. Fabricate the replacement spool to ISO-1"-P300-HS-5013 with the same items (parts list), welding to WS-01; 4 shop welds.
4. Install the spool; make 2 field welds; new gaskets and studs at flanged ends, tightened per SW-WO-5.
5. NDE per the NDE table; hydrostatic test at 420 psi for 30 minutes with the relief valves blinded (SW-TEST-1).
6. Remove blinds, restore the line-up, hand back.
