WO-500-04 — Replace VALVE, BALL, FLOATING 1" P150 (1"-P150-HS-5011/A3)

Area	A500 Pipe rack	**Task**	VR Valve replacement in kind
Priority	3 (reliability)	**Issued by**	Facility owner (demonstration)
Equipment	—	**Lines**	1"-P150-HS-5011
Isometrics	ISO-1"-P150-HS-5011		
Permits	General work permit

DWG ISO-1"-P150-HS-5011 REV 0 WO-500-04

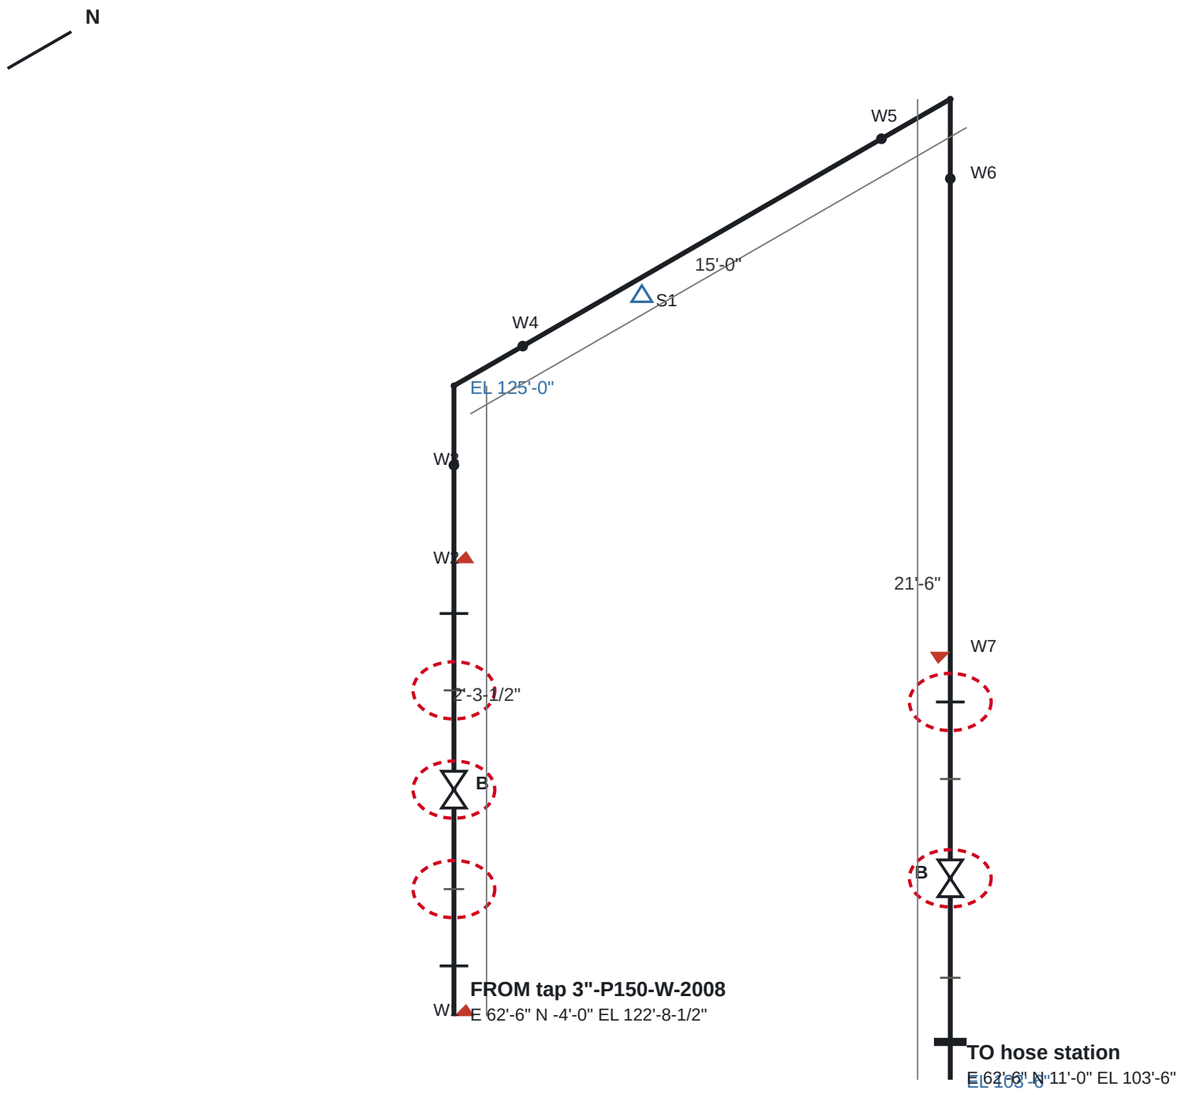
Hose-station take-off valve at the water header seized.

1. Isolate per the isolation list, drain and vent 1"-P150-HS-5011 between the isolations.
2. Unbolt and remove VALVE, BALL, FLOATING 1" P150 (1"-P150-HS-5011/A3) at E 62'-6" N -4'-0" EL 123'-7-1/2".
3. Inspect both flange faces (SW-NDE-5); dress or report damage.
4. Install a new VALVE, BALL, FLOATING 1" P150 of the same size, class and face-to-face (BALL1-P150), with new gaskets and studs, stem orientation as removed.
5. Tighten the studs to the stated preload in three passes, cross pattern (SW-WO-5).
6. Remove blinds, restore the line-up, leak test the two joints on start-up (SW-TEST-2).
