TASK	Roof scan
CLIENT	Jet NSL
PREPARED BY	Ayodele Fajuyigbe
SITE NAME	Saffron Walden Tower
DATE	29th of October 2026

KA ENGINEERING GROUP

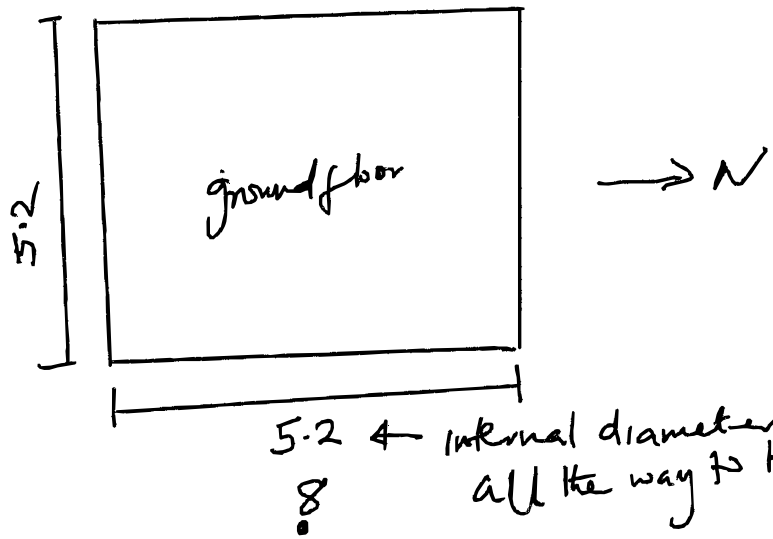
EXISTING SOUTH ELEVATION
(1:125)

① N/S Ramp Roof Support

② E/w Ramp Roof Support

Slab thickness - 175mm

— Concrete slab

— - — Steel floor — Primary beam E/W 510 x 190 x 20mm

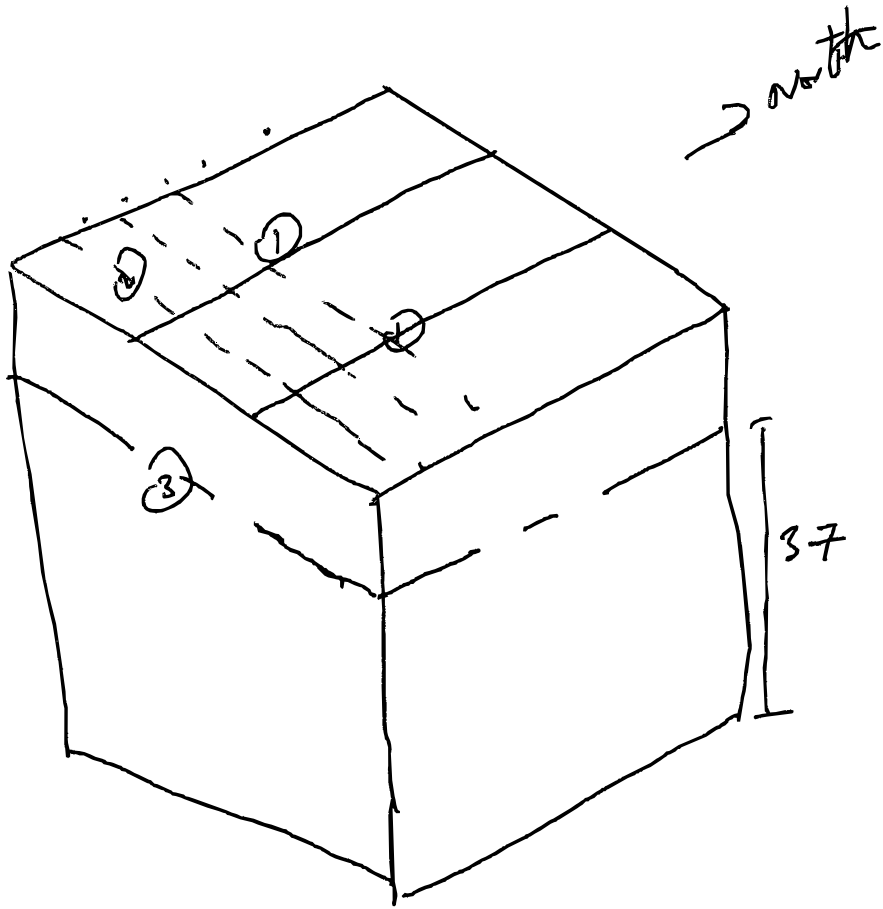
Fourth Floor

ground floor
N
5.2
5.2 ← internal diameter
all the way to the top
150
150
150
300
20 brick
20 brick
20 bricks
2.0m

① 152 x 125 x 9mm

② 8 No bays Embedded beams – 850mm c/c

③ Height of internal steel wall
