Description: **Hydraulic thrust bearing**

Sample ID: 26124405242
Service Level: Enhanced
Bottle ID: b108137312
Tested Lubricant: MOBIL SHC 639

Asset Class: **Circulating System**
 Manufacturer: **FLS**
 Model: **FLS**
 Lubricant: **MOBIL SHC 639**

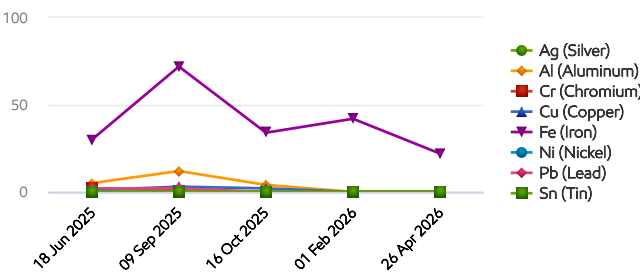
Wear

Al (Aluminum)	5	12	4	0	0
	Cr (Chromium)	2	1	0	0	0
	Cu (Copper)	1	3	2	0	0
	Fe (Iron)	30	72	34	42	22
	Mo (Molybdenum)	2	0	0	0	0
	Ni (Nickel)	0	0	0	0	0
	Pb (Lead)	2	2	0	0	0
	Sn (Tin)	0	0	0	0	0
Contaminant (ppm)	K (Potassium)	1	2	0	0	0
	Na (Sodium)	0	0	0	0	0
	Si (Silicon)	6	0	12	4	0
Additive (ppm)	B (Boron)	2	30	0	9	14
	Ba (Barium)	0	0	0	0	0
	Ca (Calcium)	11	29	14	20	5
	Mg (Magnesium)	1	3	2	2	2
	P (Phosphorus)	532	326	378	539	351
	Zn (Zinc)	590	49	38	71	468
