Description: **Clinker Cooler filter Fan**

Asset Class: **Gear Drive**

Manufacturer: **FLENDER**

Model: H1SH9-3,55-FC

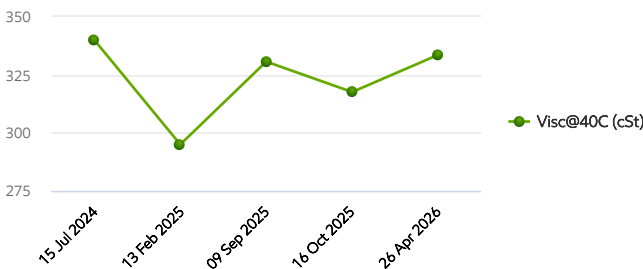
Viscosity

Sample Info	Report Status	Caution	Caution	Caution	Caution	Caution
	Sample ID	24206247250	25049182244	25258159255	25294210244	26124405236
	Service Level	Enhanced	Enhanced	Enhanced	Enhanced	Enhanced
	Bottle ID	b088842834	b094031763	b098270700	b098190203	b108137437
	Tested Lubricant	MOBIL SHC 632	MOBIL SHC 632	MOBIL SHC 632	MOBIL SHC 632	MOBIL SHC 632
	Sampled	15 Jul 2024	13 Feb 2025	09 Sep 2025	16 Oct 2025	26 Apr 2026
	Reported	28 Jul 2024	19 Feb 2025	17 Sep 2025	22 Oct 2025	05 May 2026
	Equipment Age					
	Oil Age					
	Make-up Volume					
	Oil Changed					
Filter Changed						
Lubricant	Contamination Rating	Caution	Caution	Caution	Caution	Caution
	Equipment Rating	Normal	Normal	Normal	Normal	Normal
	Lubricant Rating	Normal	Normal	Normal	Normal	Normal
	ISO Code (4/6/14)		22/21/19			
	Particle Count >4um		23972			
	Particle Count >6um		14322			
	Particle Count>14um		4817			
	PQ Index	11	7	20	10	22
	Visc@40C (cSt)	340.0	295.0	330.7	317.6	333.6

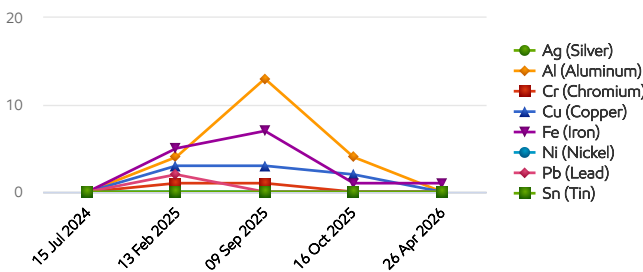
TAN (mg KOH/g)	1.41	1.12	1.20	1.20	1.30
	Water (Vol%)	<0.003	0.050	0.020	<0.003	0.040
Wear (ppm)	Ag (Silver)	0	0	0	0	0
	Al (Aluminum)	0	4	13	4	0
	Cr (Chromium)	0	1	1	0	0
	Cu (Copper)	0	3	3	2	0
	Fe (Iron)	0	5	7	1	1
	Mo (Molybdenum)	0	0	0	0	0
	Ni (Nickel)	0	0	0	0	0
	Pb (Lead)	0	2	0	0	0
	Sn (Tin)	0	0	0	0	0
Contaminant (ppm)	K (Potassium)	0	0	0	0	0
	Na (Sodium)	0	0	0	0	0
	Si (Silicon)	18	21	9	36	15
Additive (ppm)	B (Boron)	16	8	21	0	12
	Ba (Barium)	0	0	0	0	0
	Ca (Calcium)	2	8	35	8	0
	Mg (Magnesium)	0	2	2	0	15
	P (Phosphorus)	367	562	324	482	433
	Zn (Zinc)	13	14	14	3	9
