Caution

Unit ID: 532.MD302

Description: Cement Mill #2 Separator Gearbox

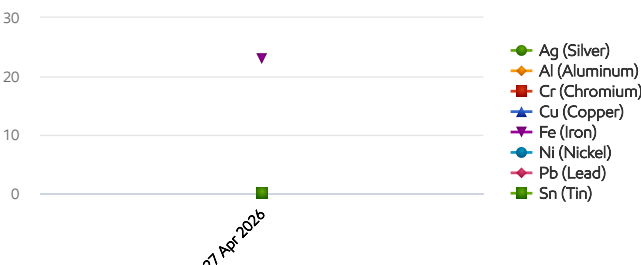
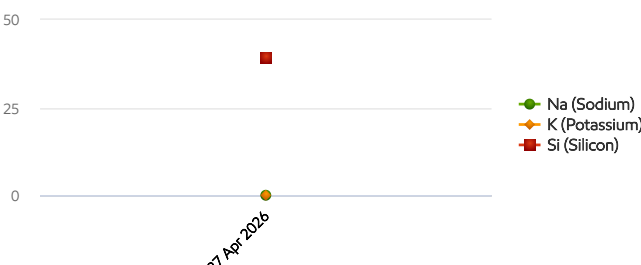
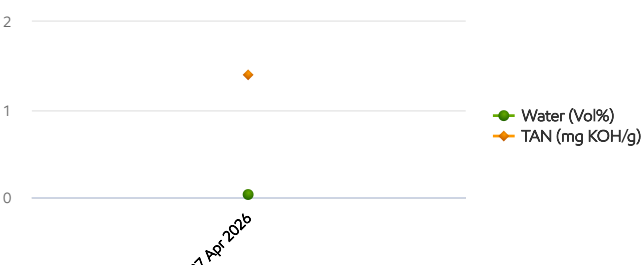
MobilTM			Caution		
			Unit ID: 532.MD302		
			Asset ID: 52305305		
			Description: Cement Mill #2 Separator Gearbox		
Account Information			Sample Information		Equipment Information
ID: 462031			Sample ID: 26124405227		Asset Class: Gear Drive
Name: ASEC - ACC			Service Level: Enhanced		Manufacturer: FLENDER
Address: , , EG			Bottle ID: b098084179		Model: N/A
			Tested Lubricant: MOBIL SHC 632		Lubricant: MOBIL SHC 632
Sample Data & Trends					
Sample Info	Report Status	Caution	Viscosity		
	Sample ID	26124405227			
	Service Level	Enhanced			
	Bottle ID	b098084179			
	Tested Lubricant	MOBIL SHC 632			
	Sampled	27 Apr 2026			
	Reported	05 May 2026			
	Equipment Age				
	Oil Age				
	Make-up Volume				
	Oil Changed				
Filter Changed					
Lubricant	Contamination Rating	Caution	Wear		
	Equipment Rating	Normal			
	Lubricant Rating	Normal			
	ISO Code (4/6/14)				
	Particle Count >4um				
	Particle Count >6um				
	Particle Count>14um

PQ Index	19			
	Visc@40C (cSt)	287.4			
	TAN (mg KOH/g)	1.40			
	Water (Vol%)	0.030			
Wear (ppm)	Ag (Silver)	0	Contaminants		
	Al (Aluminum)	0			
	Cr (Chromium)	0			
	Cu (Copper)	0			
	Fe (Iron)	23			
	Mo (Molybdenum)	0			
	Ni (Nickel)	0			
	Pb (Lead)	0			
	Sn (Tin)	0			
	K (Potassium)	0			
	Na (Sodium)	0			
Si (Silicon)	39				
Additive (ppm)	B (Boron)	12	Physical Properties		
	Ba (Barium)	0			
	Ca (Calcium)	21			
	Mg (Magnesium)	2			
	P (Phosphorus)	433			
	Zn (Zinc)	71
