Unit ID: 533.MD302

Description: **Cement Mill #3 Separator Gearbox**

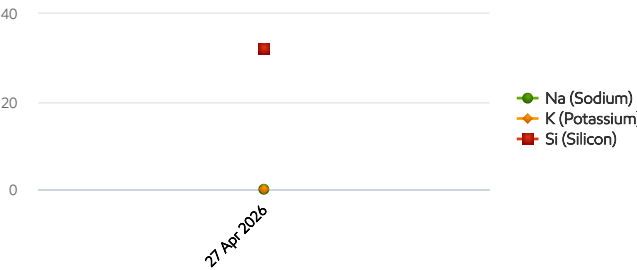
Contaminants

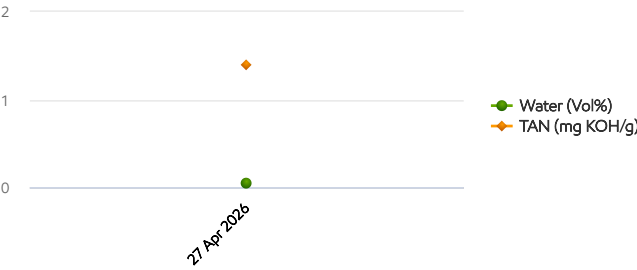
Physical Properties
