Description: **Roller Lubrication Unit (Tank)**

Sample ID: 26124405281
Service Level: Enhanced
Bottle ID: b105154347
Tested Lubricant: MOBIL SHC 639

Asset Class: **Circulating System**
 Manufacturer: **FLS**
 Model: **N/A**
 Lubricant: **MOBIL SHC 639**

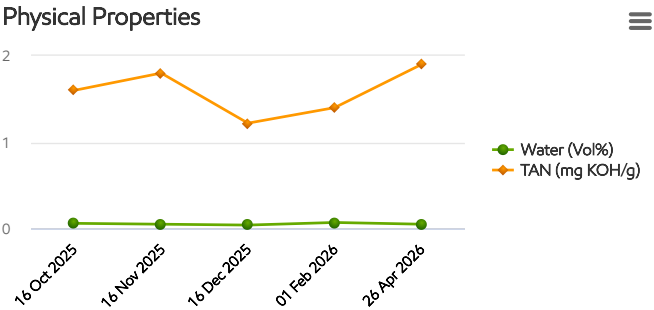
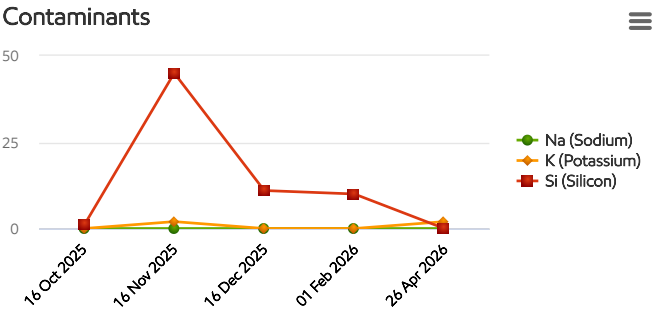
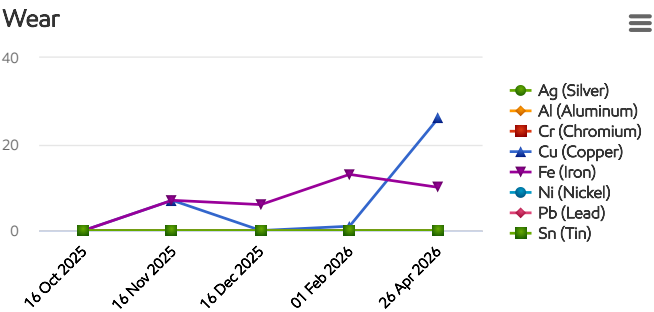
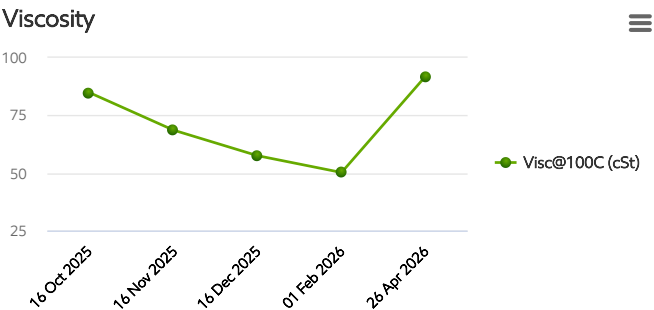
Sample Data & Trends

Caution	
	Unit ID: R2.322.LQ120(T)	Asset ID: 40047887
	Description: Roller Lubrication Unit (Tank)	
Account Information	Sample Information	Equipment Information
ID: 208948 Name: Reliance Heavy Industries Address: Kattameya-Sokhna Road, Suez, 00000 EG	Sample ID: 26124405281 Service Level: Enhanced Bottle ID: b105154347 Tested Lubricant: MOBIL SHC 639	Asset Class: Circulating System Manufacturer: FLS Model: N/A Lubricant: MOBIL SHC 639
Recommendation/Comments		
ACTION REQUIRED - EXCESSIVE WATER CONTAMINATION. Determine source of water and take corrective action. Analyze the oil with an on-site water test if accessible. Potential sources of water include: a. Leaking seals; b. Condensation resulting from low operating temperatures or prolonged shutdowns; c. Compromised oil cooler; d. Direct exposure to atmosphere as a result of compromises to system components (i.e. improperly sealed tank fill access point. Remove water from oil using centrifuges or dehydration units, or drain the oil and recharge the system with new oil. Resample the system after corrective measures have been implemented. Contact your ExxonMobil representative for further assistance if necessary. ACTION REQUIRED - ELEVATED TAN. The Total Acid Number (TAN) of the sampled oil is above the Original Equipment Manufacturer (OEM) limits for this grade. Determine cause of elevated TAN and take corrective action. If the TAN is elevated for the first time with no history of an increasing trend, then resample immediately to confirm condition. Possible causes of an elevated TAN include: a. High oil temperature; b. Localized hot spots; c. Over-extended oil service life; d. Contamination with an oil that has a higher TAN; e. High rates of oxidation and nitration resulting in the formation of organic and inorganic acids. Contact your ExxonMobil representative for further assistance if necessary.
