Unit ID: R2.322.LQ145 (GB) Cancel

Description: Mill2 gear Box

ID: 208948
Name: Reliance Heavy Industries
Address: Kattameya-Sokhna Road, Suez, 00000 EG

Sample ID: 26124405214
Service Level: Enhanced
Bottle ID: b105154805
Tested Lubricant: MOBILGEAR 600 XP 320

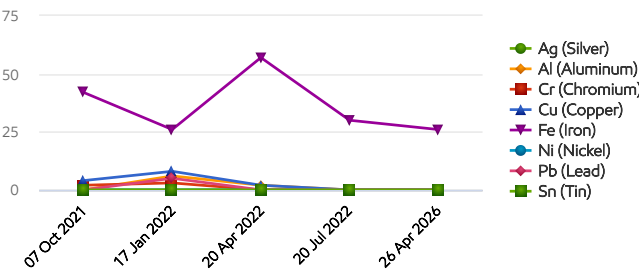
PQ Index	18	18	18	6	36
	Visc@40C (cSt)	328.4	332.2	321.9	297.6	308.6
Wear (ppm)	Oxidation (Ab/cm)	2	6	3	2	1
	Water (Vol%)	0.030	0.040	0.030	0.050	0.040
	Ag (Silver)	0	0	0	0	0
	Al (Aluminum)	0	6	2	0	0
	Cr (Chromium)	2	3	0	0	0
	Cu (Copper)	4	8	2	0	0
	Fe (Iron)	42	26	57	30	26
	Mo (Molybdenum)	0	0	0	0	0
	Ni (Nickel)	0	0	0	0	0
	Pb (Lead)	0	5	0	0	0
Contaminant (ppm)	Sn (Tin)	0	0	0	0	0
	K (Potassium)	0	2	0	0	0
	Na (Sodium)	0	0	0	0	0
	Si (Silicon)	0	14	2	4	0
Additive (ppm)	B (Boron)	14	24	10	0	13
	Ba (Barium)	0	0	0	0	0
	Ca (Calcium)	3	15	1	0	9
	Mg (Magnesium)	0	0	0	2	2
	P (Phosphorus)	309	368	434	304	386
	Zn (Zinc)	22	12	32	26	1

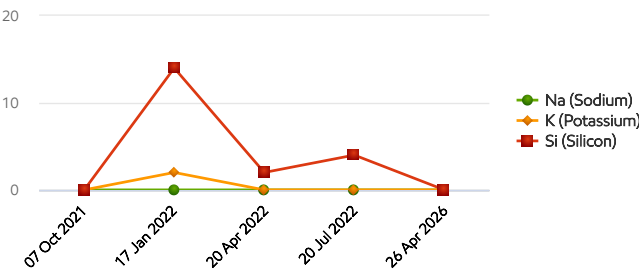
Contaminants

Sample Info	Report Status	Caution	Caution	Alert	Caution	Caution
	Sample ID	21285485216	22022220228	22116260209	22210297228	26124405214
	Service Level	Enhanced	Enhanced	Enhanced	Enhanced	Enhanced
	Bottle ID	b060620988	b060646251	b060744976	b066954897	b105154805
	Tested Lubricant	MOBILGEAR 600 XP 320	MOBILGEAR 600 XP 320	MOBILGEAR 600 XP 320	MOBILGEAR 600 XP 320	MOBILGEAR 600 XP 320
	Sampled	07 Oct 2021	17 Jan 2022	20 Apr 2022	20 Jul 2022	26 Apr 2026
	Reported	13 Oct 2021	23 Jan 2022	27 Apr 2022	31 Jul 2022	05 May 2026
	Equipment Age					
	Oil Age					
	Make-up Volume					
Lubricant	Filter Changed					
	Contamination Rating	Normal	Normal	Caution	Caution	Caution
	Equipment Rating	Caution	Normal	Alert	Normal	Normal
	Lubricant Rating	Normal	Caution	Normal	Normal	Normal
	ISO Code (4/6/14)	22/20/16	23/21/17		23/21/15	
	Particle Count >4um	33058	63852		51134	
	Particle Count >6um	8169	12552		13264	
	Particle Count>14um	397	885		263
