SITE INSPECTION REPORT

Customer Complaint – Surface Dents on Aluminium Composite Panel (ACP) Fascia

Site	Vapi, Gujarat
Date of site visit	22/10/2026]
Evidence reference	Site photographs and site videos
Product	AL32, SH310
Complaint	Dents on the ACP surface
Site Visit By	Mr. Vishal Saroj (CSE WEST)

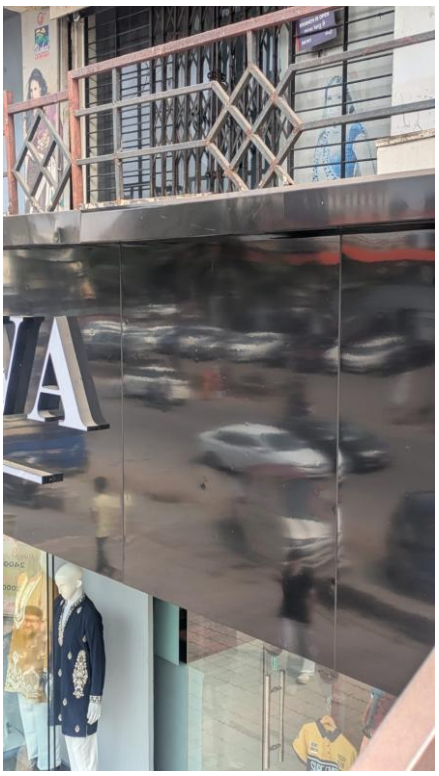
Fig. 1 – Corner / return of the fascia – glossy black ACP, folded edge and panel joints.

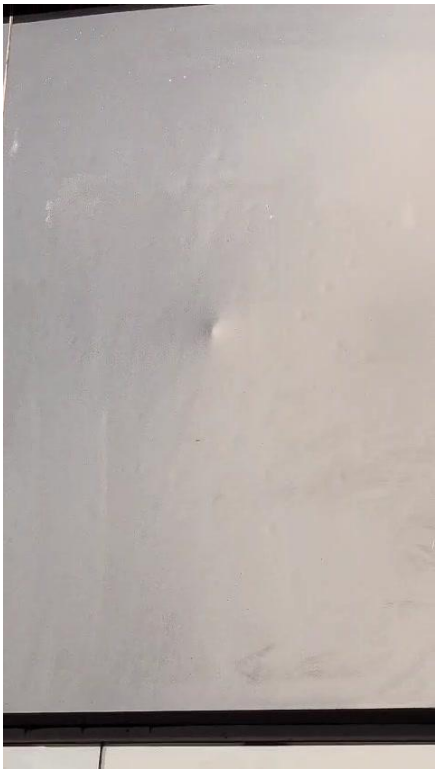
- **Complaint confirmed:** Small, isolated pinpoint dents are present on the panel face at several locations, as seen in Fig. 3 to Fig. 12.
- **Surface finish:** The panels have a high-gloss, mirror-type black finish. This type of finish reflects the surroundings and makes even minor surface imperfections and dents very prominent (see Fig. 1 and 2).
- **Handling damage:** Dents of a larger size were also noted which indicates physical impact or pressure on the surface during the fabrication or installation at site.

Fig. 9 – Close-up: isolated small dent, flat panel area

- **Restricted working space.** The client confirmed that the entire cutting and fabrication work was done in a narrow space. Sheets handled in limited space are easily knocked, rested against hard objects or pressed against the surface.
- **Use of a step ladder for support.** The pattern of the tiny dents resembles the contact points of a step ladder. It is probable that a step ladder was rested against the face of the ACP while the SPF (surface protection film) was being removed.
- **Nature of the dents.** The dents are localised and isolated, with larger impact dents in some places, which is consistent with mechanical contact during fabrication work, rather than a manufacturing defect.

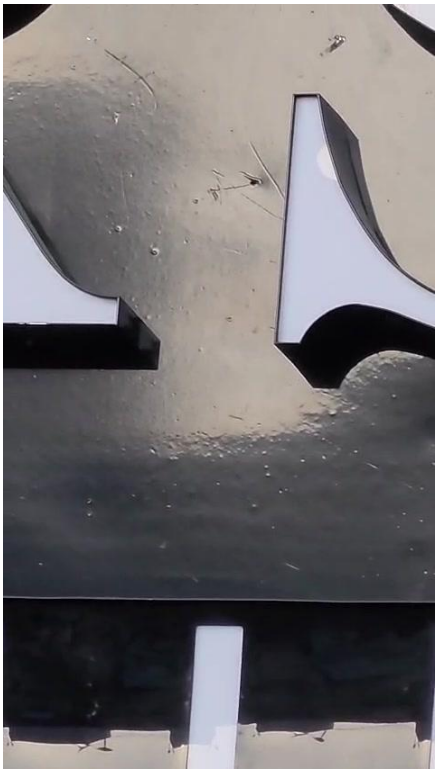
Fig. 11 – Close-up: multiple tiny dents on the upper panel area
