# INY2 M23B HEAVY MANTENANCE

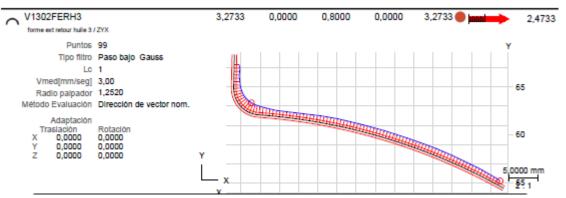
### LIMPIAR PIN

Ø	5039D2 5.9148	6 1300	6.3300	5 9300	-0.0152 -0.2152
Ø	diam 5039 (6,13)		0.5500	3.9300	-0.2132

## Faltas material pieza: Quitar material con piedra fina
