M21B INY7 21/10/22 MAÑANA

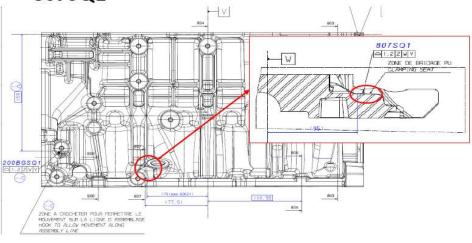
Valor real	Valor nom.	Tol. inf.	Tol. sup.	Desviación		
807SQ1					0.4517		
	1.6517	0.0000	1.2000		1.6517		
X	98.2877	98.2661			0.0216		
Y	-178.5303	-179.3558			0.8256		
Z fo	78.7350 rme section 807 /ZYX	78.7350			0.0000

Valor real Valor nom. Tol. inf. Tol. sup. Desulation 807SQ1 1.908 0.000 1.908 0.025 1.78.610 1.79.564 0.953 7.977 0.000

Exceso material pieza:

valor real (absoluto) menor que 179.564 (nominal)

Faltas material pieza:

valor real (absoluto) mayor que 179.564 (nominal)

Aportar material con Spark Depo Ej: 178.610 (valor absoluto)

Quitar material con piedra fina Ej: 180.015 (valor absoluto)

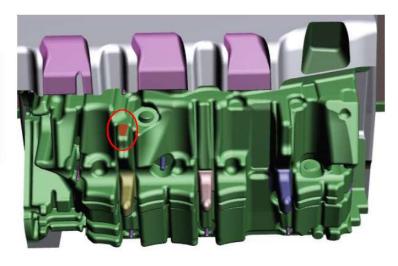
Name	Measured valueN	ominal value	+Tol	-Tol	Desviación +/-	
AV2L1Z	198,3944	199,0000	0,6000	-0,6000	-0,6056	-0,0056
AV2L1	1,2553	0,0000	1,2000	0,0000	1,2553	0,0553

NO SE PUEDE TOCAR
