Paper Calendar - ESP32-S3 e-paper board (PhotoPainter drop-in)

1. Cover

Customer	alsoft (own board)
Board	Paper Calendar - ESP32-S3 e-paper board (PhotoPainter drop-in)
Revision	0.1
Date	2026-11-01
Reviewer	alsoft

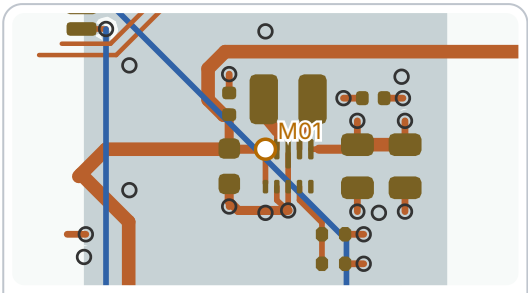
M01 decoupling_order

medium · U3.10, C7, C6

U3 pin 10 (VSYS): the small 100 nF capacitor C7 is 2.2 mm away while the larger 10 µF C6 is closer at 1.6 mm, so the small one is not nearest the pin. Fix: swap them.

Recommendation: swap the capacitors' places, or move the small one next to the pin

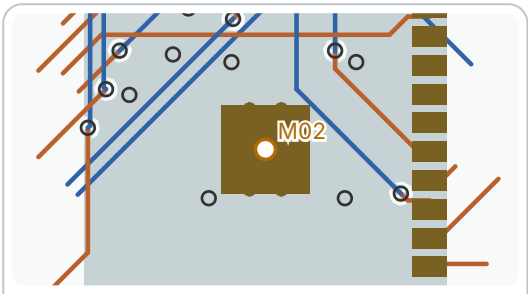
M02 exposed_pad_vias

medium · U5.41

U5: the 3.9 x 3.9 mm exposed pad has 10 vias where 11 are recommended for heat and ground. Fix: add a via grid inside the pad.

Why: U5 exposed pad 3.9 x 3.9 mm (15.21 mm^2) has 10 vias, 11 recommended

Recommendation: a via grid in the pad (fanout_planes exposed_in_pad=True; JLC_VIA_SMALL fits a 2x2 grid in small pads)

M02: a via grid in the pad (fanout_planes exposed_in_pad=True; JLC_VIA_SMALL fits a 2x2 grid in small pads)

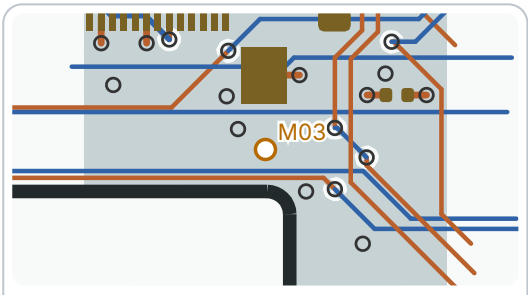
M03 edge_clearance

medium · J2

J2: the part sits 1.85 mm from the board edge but assembly needs 2.5 mm. Fix: move it inward, or order with edge rails at extra cost.

Recommendation: move the part in, or order with edge rails (>= 5 mm; JLC adds them by default and charges for the panel)

M03: move the part in, or order with edge rails (>= 5 mm; JLC adds them by default and charges for the panel)

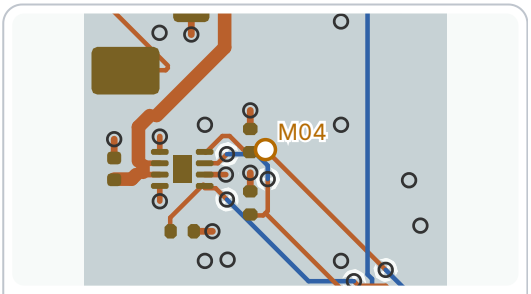
M04 acute_angles

medium · I2C_SDA

I2C_SDA: a track corner on F.Cu is sharper than recommended (tracks meet at 45 degrees), which can cause etching defects. Fix: re-route with gentler turns.

Recommendation: re-route the corner with 45 degree turns, or open it up so the tracks meet at 90 degrees or more

M04: re-route the corner with 45 degree turns, or open it up so the tracks meet at 90 degrees or more

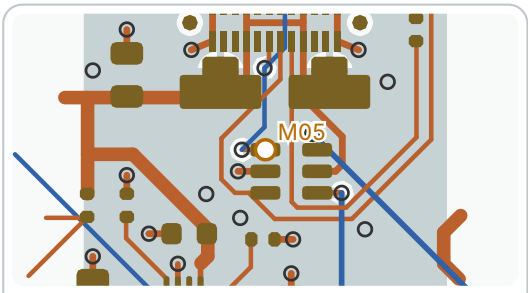
M05 esd_order

medium · J1.A7, J1.B7, U1.1, USB_C_DN

USB_C_DN: the protection part U1 sits 2 via(s) away from connector pin J1 pin A7, so surges can reach the chip first. Fix: place it right behind the connector pad on the same layer. The same issue appears at 1 more place.

Recommendation: put the protection part on the signal path right behind the connector pad, connected on one layer, and route on from it to the IC

M05: put the protection part on the signal path right behind the connector pad, connected on one layer, and route on from it to the IC

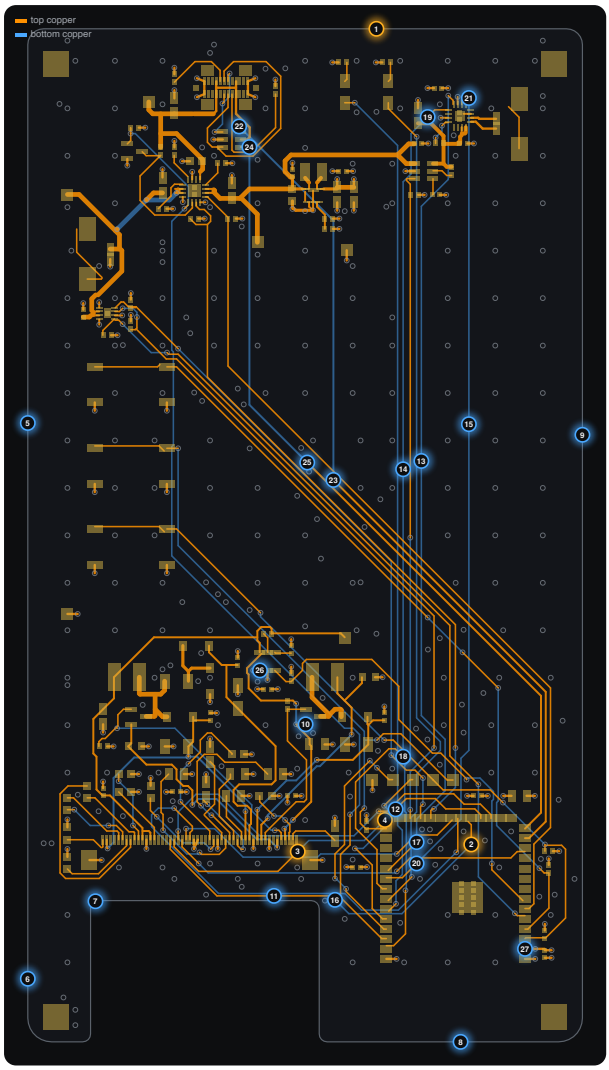
EMC overview

M23 edge_stitching

A 42 mm stretch of the board edge has no ground via (limit 20 mm), so the plane pair can radiate there. Fix: add a ground via fence along that edge.

M24 layer_change

EPD_MOSI: the signal changes layers (F.Cu to B.Cu) 6.2 mm from its nearest return-current path, which can radiate. Fix: add a ground via next to the layer change.
