PAGE 1 — EXECUTIVE SUMMARY & KEY FINDINGS

Ameritech | Ameritech Consulting Group conducted an independent analysis of the City of Austin's Sidewalk Infrastructure. *This is not a final audit.* This report evaluates **175,609 active sidewalk segments** across all 10 council districts against Americans with Disabilities Act (ADA) 2010 Standards, Public Right-of-Way Accessibility Guidelines (PROWAG), and City of Austin Transportation Design Standards. Data was sourced from the Austin Open Data Portal (sidewalk inventory, 311 service requests, traffic signals), Capital Metro transit data, Austin ISD school locations, and U.S. Census ACS 2022 demographics.

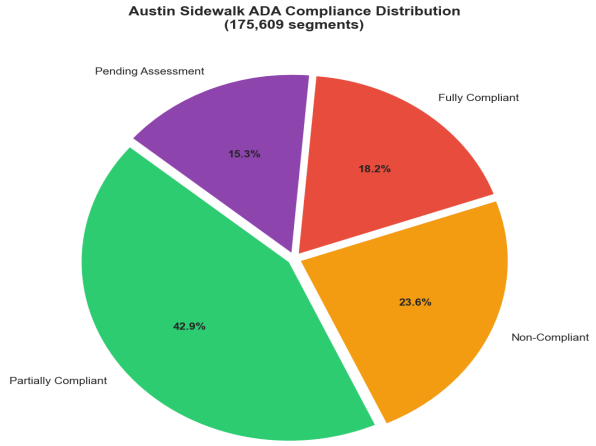
Of the **175,609 active sidewalk segments** assessed citywide, only **21.5%** fully satisfy ADA requirements. An additional **50.6%** are partially compliant with minor deficiencies, while **27.9%** exhibit significant violations requiring remediation. 26,784 segments remain pending assessment under the current inspection cycle.

Figure 1 (left): ADA compliance distribution across all assessed segments. Figure 2 (right): Top infrastructure deficiency categories by segment count.

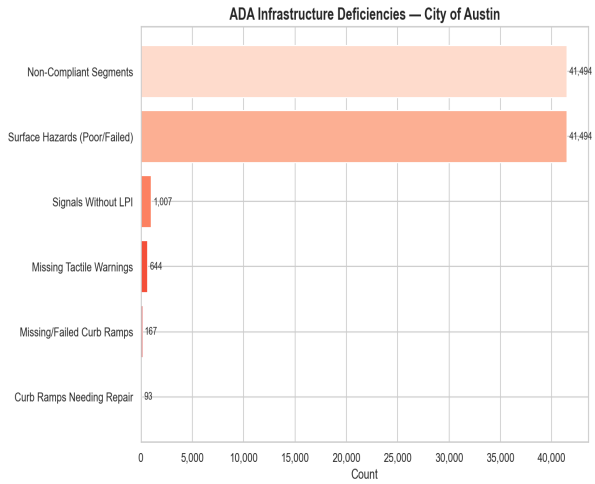
Missing / Failed Curb Ramps	167	16.7%	PROWAG R304 — 1:12 max slope, 36" min width	CRITICAL
Curb Ramps Requiring Repair	93	—	Surface defects >¼", settlement, displacement	HIGH
Missing Tactile Dome Warnings	644	64.4%	ADA §406.13 — truncated yellow domes required	HIGH
Signals Without Ped. Interval	1,007	75.7%	MUTCD §4E — leading pedestrian interval	HIGH
Hazardous Surface Conditions	41,494	23.1%	ADA §402 — firm, stable, slip-resistant surface	HIGH
Improper Cross-slope / Grade	40,899	23.3%	ADA — max 2% cross-slope, 8.33% running slope	MEDIUM

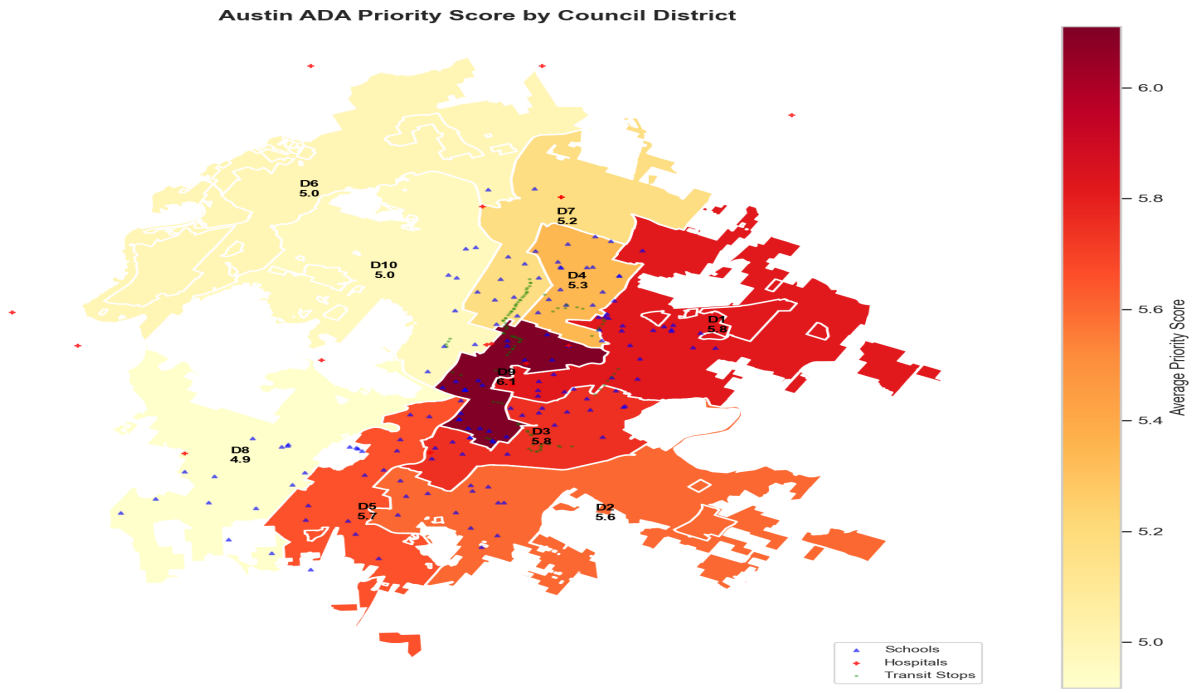
ADA compliance rates vary significantly across Austin's 10 council districts, revealing a **17.6-percentage-point gap** between the highest- and lowest-performing districts. This disparity is not random: districts with higher concentrations of lower-income residents and communities of color consistently show lower compliance rates — a pattern that reflects decades of unequal infrastructure investment and maintenance.

Figure 3: Austin council district map shaded by average ADA priority score. Higher scores (darker) indicate greater remediation urgency. School (▲), hospital (+), and transit stop (●) overlays show proximity to critical facilities.

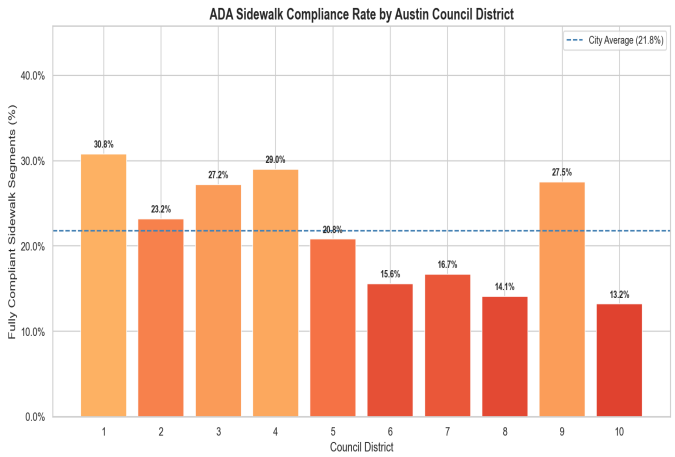
Figure 4 (left): Compliance rate by district (city average dashed). Figure 5 (right): Equity need vs. compliance rate — districts with greater need show lower compliance.
