TASK GROUP INSTRUCTION
 AIM REV 20.11.4.0 (OCTOBER 2020)

TGI NO.:	COMPONENT NAME: FWD UPTAKE RPR	TYPE: AY	PHASE: A	REPEAT: 0	CHANGE: 0
SHIP/HULL NO.: DDG-115	SHIP/HULL NAME: USS RAFAEL PERALTA	SYSTEM:		PROJ/WO NO: K61	CASREP CAT:
CU PHASE TITLE: *F/O – REPAIR FWD UPTAKE SPACE					
PREPARING ACTIVITY:					
PREPARED BY: REIYA KIMURA		CODE 234.	PHONE 070-7603-8983	DATE 28-NOV-2025	
APPROVED BY: HIDEO HARADA		CODE 234.	PHONE 315-243-5176	DATE 28-NOV-2025	
CONCURRED BY:		CODE	PHONE	DATE	
CONCURRED BY:		CODE	PHONE	DATE	
CONCURRED BY:		CODE	PHONE	DATE	
CONCURRED BY:		CODE	PHONE	DATE	
REASON FOR WORK/NEED FOR CHANGE:					
CHANGE INSTRUCTIONS:					
SPECIAL REQUIREMENTS: HOT WORK IN MAGAZINE AND ADJACENT SPACES IAW S6740-AA-SAF-010 AND NAVSEA OP 4

1.1 Title: FWD Uptake Space; repair

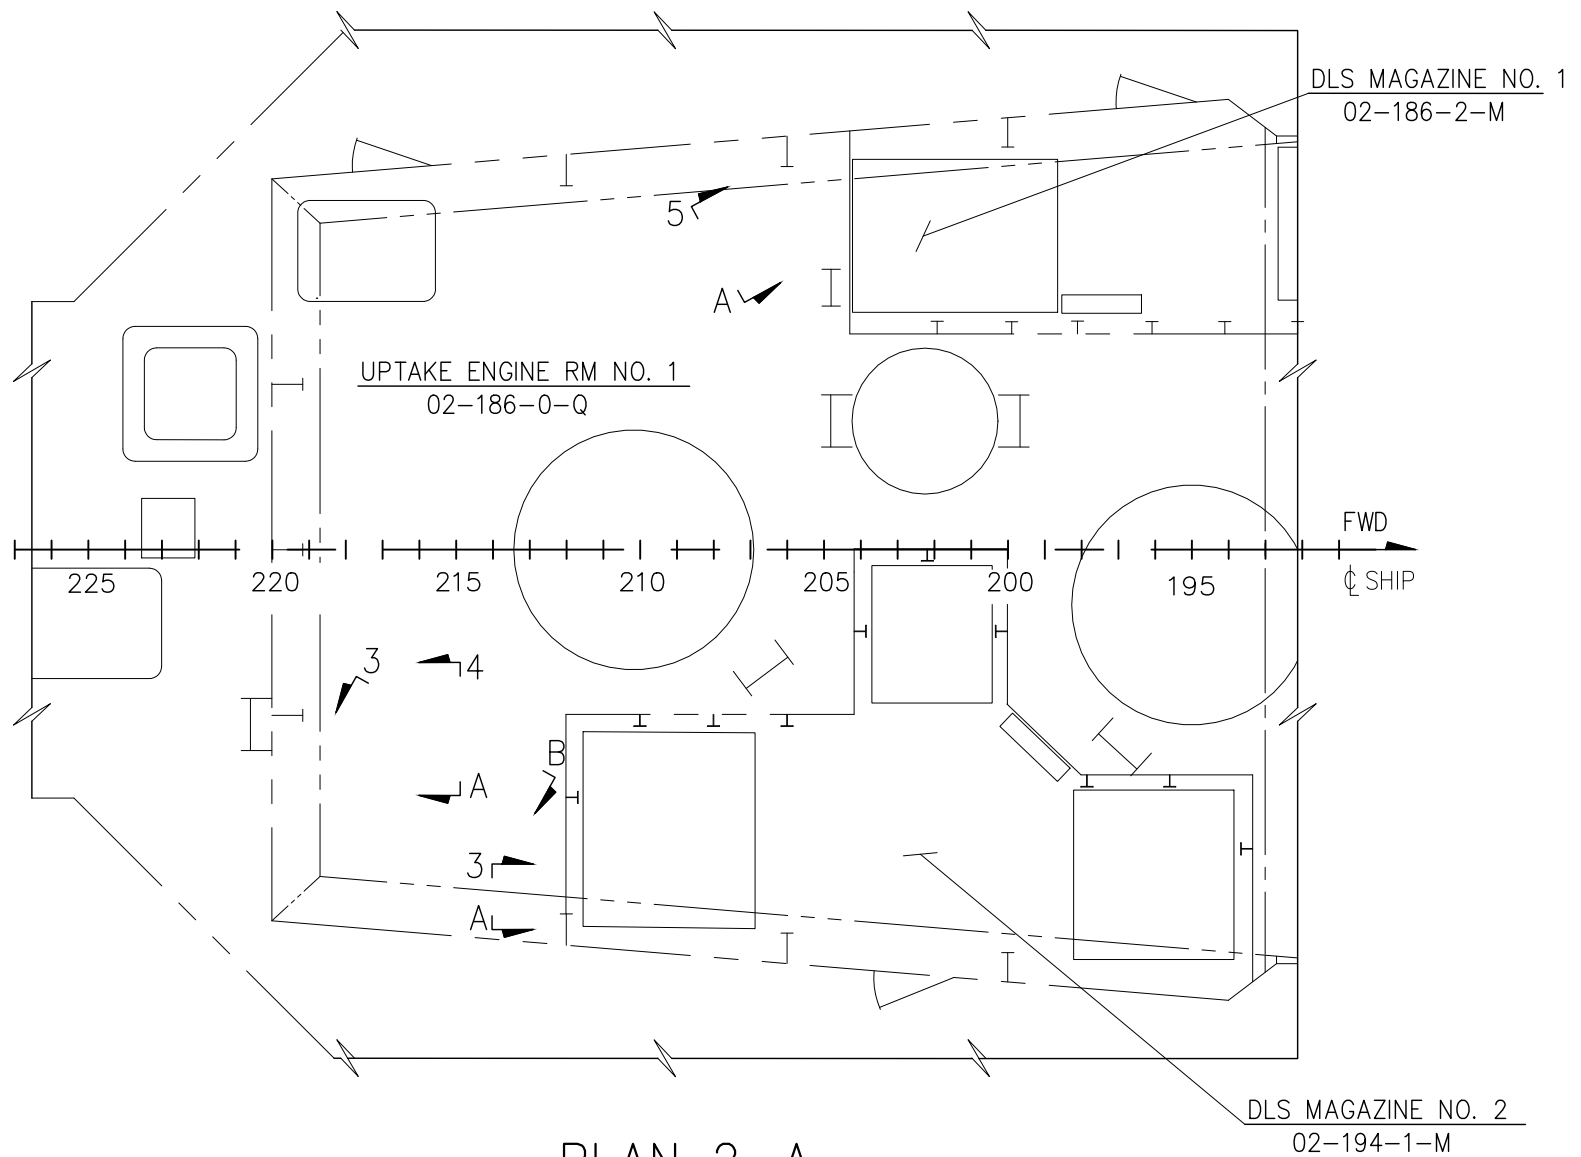
REPLT
 02 LVL UPTAKE ENGINE RM NO. 1
 LKG OUTBOARD
 - SCALE : NONE -

CABLE HANGER (9 EA)
 CKT R-RA96(R4)
 (REPLT)
 SEE DET 5-B FOR REPLT

THERMOSTAT, CKT LC24-1L-D12(3)
 (REPLT)
 SEE NOTE 4

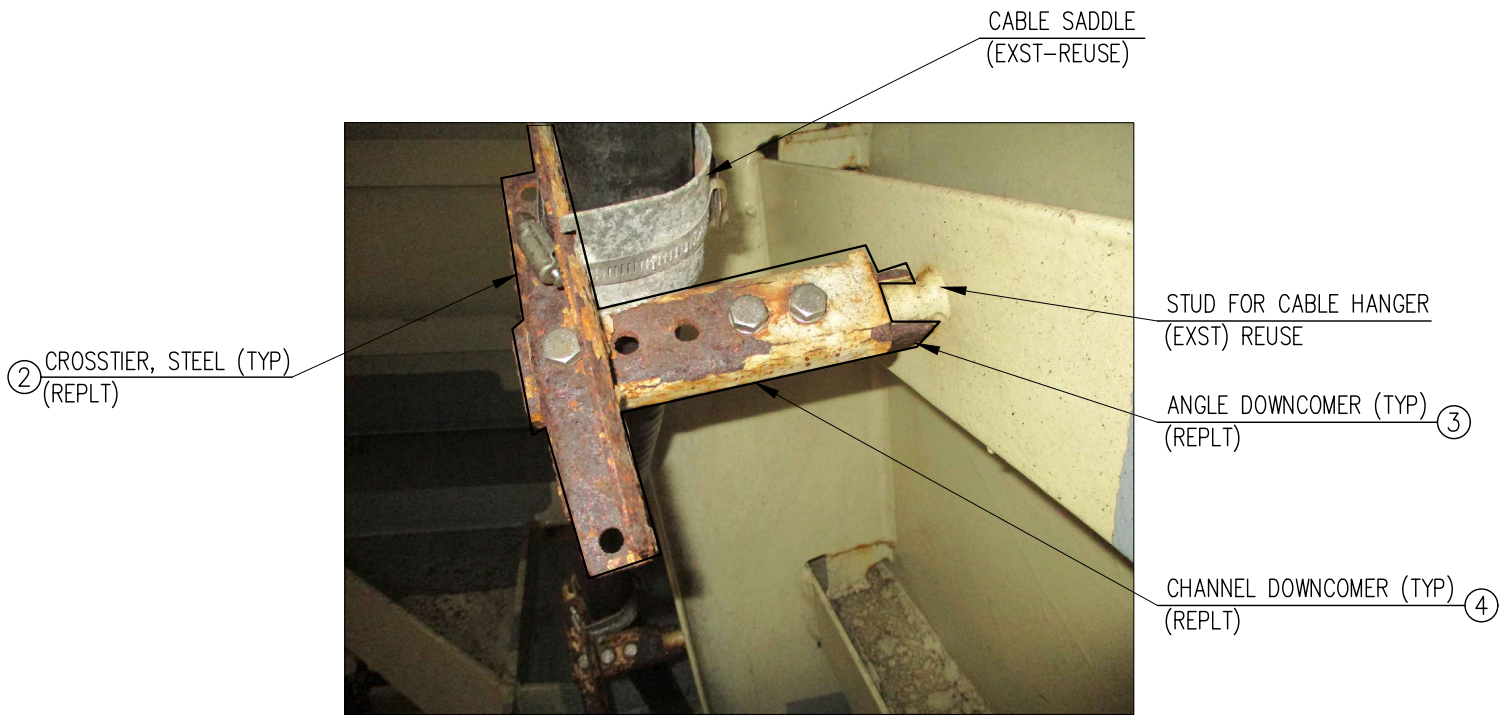
REPLT
03 LVL UPTAKE ENGINE RM NO. 1
LKG AFT
- SCALE : NONE -

④③② CABLE HANGER (5 EA)
CKT R-RA96(R4)
(REPLT)
SEE DET 5-B FOR REPLT

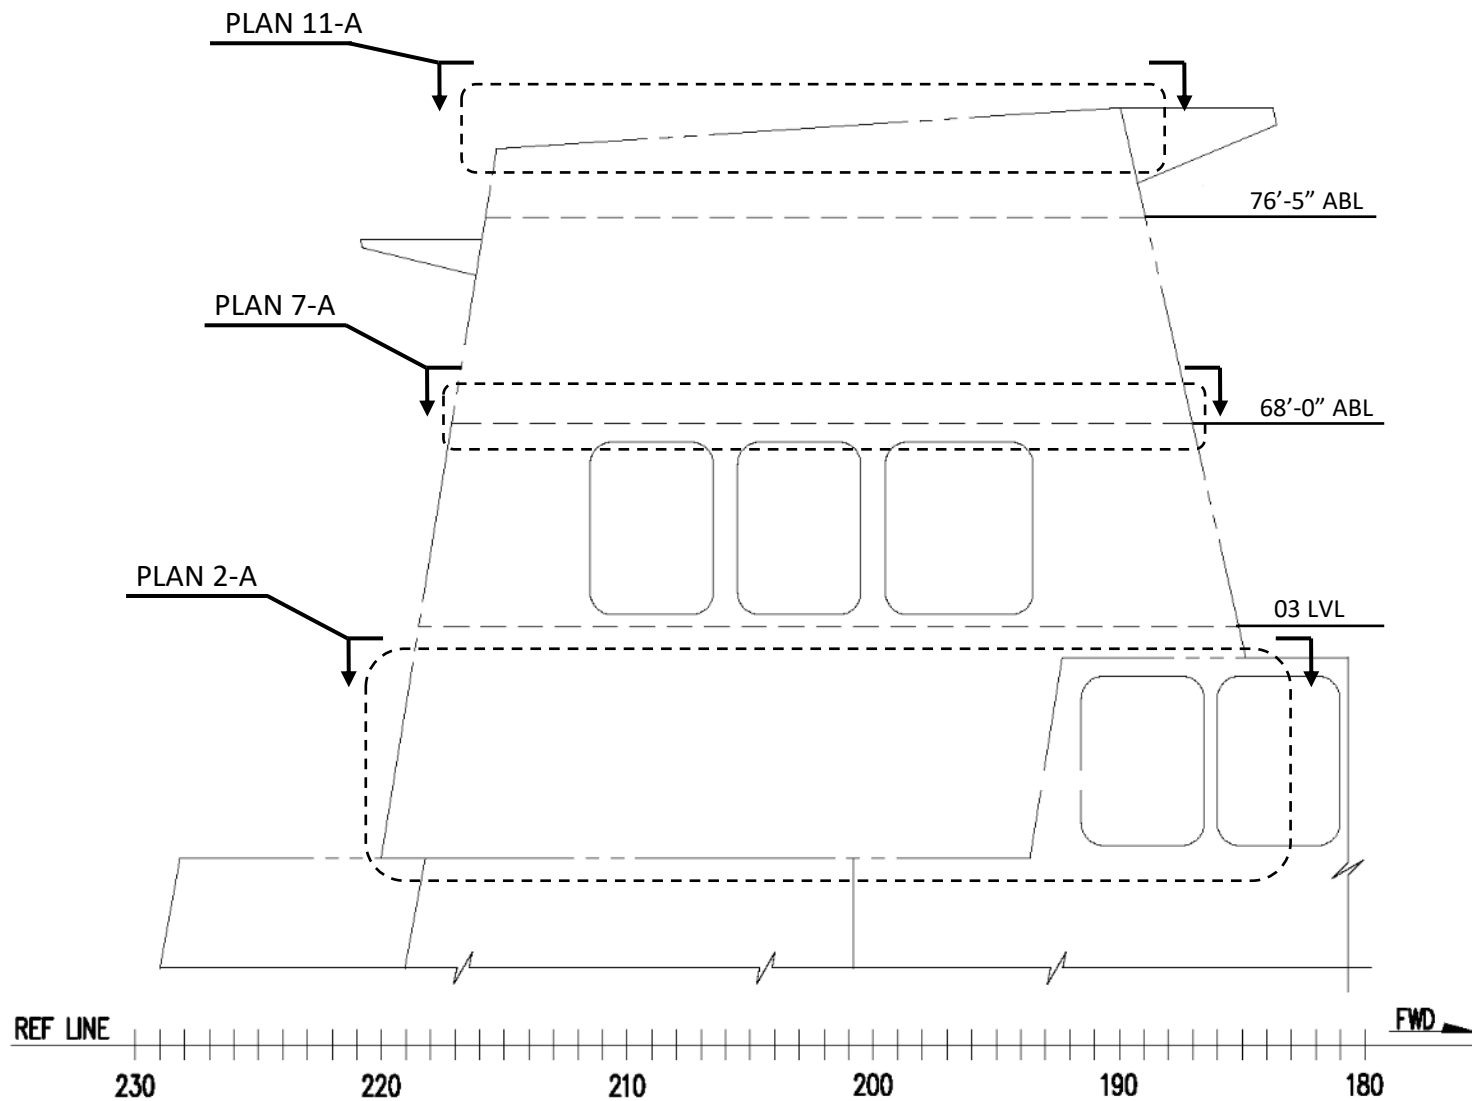
1.3.3 Quantity (32 SF), Insulation and Lagging, Exhaust Duct, No. One Ship Service Gas Turbine Generator (SSGTG)

1.3.3 Quantity (32 SF), Insulation and Lagging, Exhaust Duct, No. One Ship Service Gas Turbine Generator (SSGTG), Frame 202, Located in 1.2.1

5.1 Remove each existing insulation and lagging listed in 1.3.1 through 1.3.3 from each exhaust duct, using 2.3 for guidance.

5.2 Accomplish the requirements of 009-011 of 2.1 for installation of each new insulation and lagging listed in 1.3.1 through 1.3.3 to each exhaust duct, using 2.4 and 2.5 for guidance.

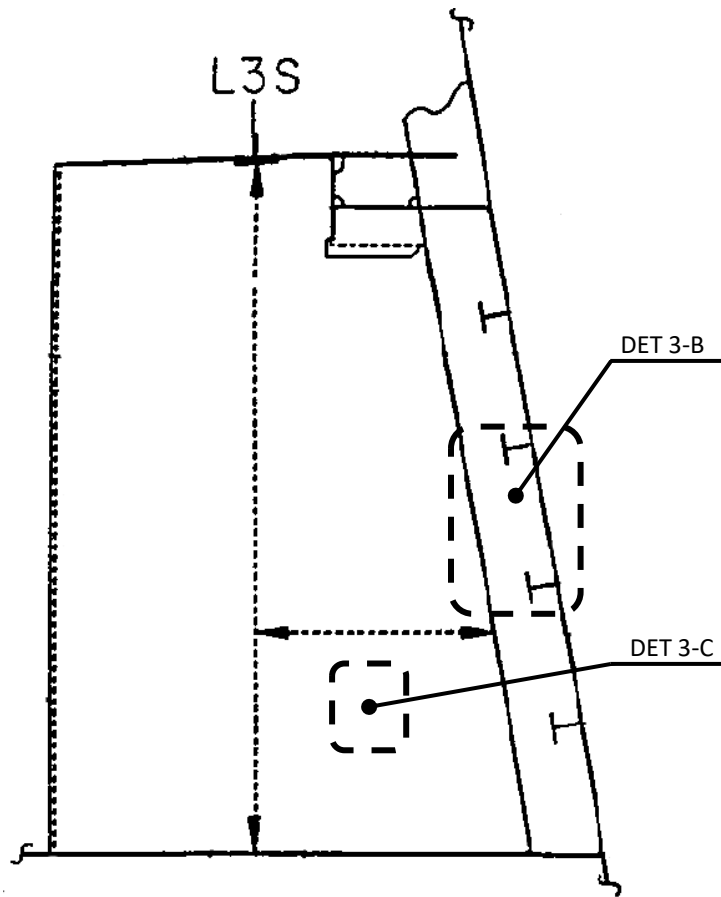
SECT 3-A
TRNSV BHD FR 212, STBD
LKG AFT

1.3.4.1 Quantity (2 EA), Stud on Web Frame 212, Stbd

1.3.4.2 Quantity (One EA), Stud on Transverse Bulkhead, Frame 212, Stbd

LOCATION OF UNUSED STUD LISTED IN 1.3.4.1 & 1.3.4.2

5.3 Remove unused each existing stud, padeye, cable stud, cable clamp, and stuffing tube listed in 1.3.4 through 1.3.8 in accordance with Enclosure-01, using 2.6 for guidance.

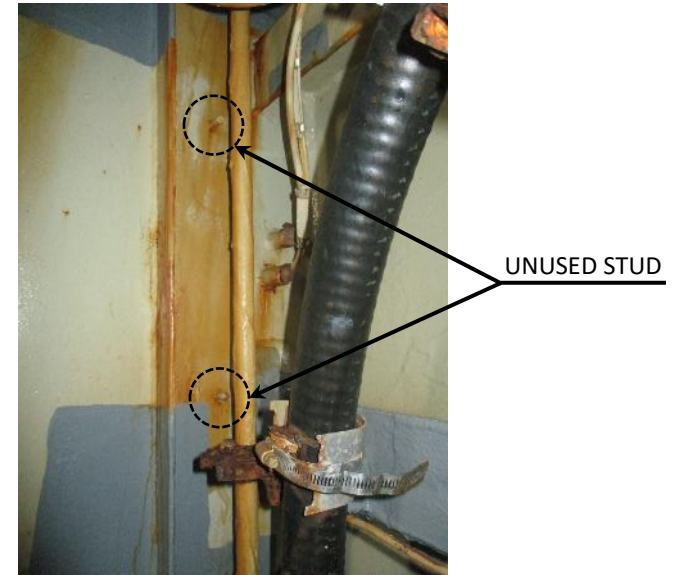
DET 3-B
UNUSED STUD LISTED IN 1.3.4.1

DET 3-C
UNUSED STUD LISTED IN 1.3.4.2

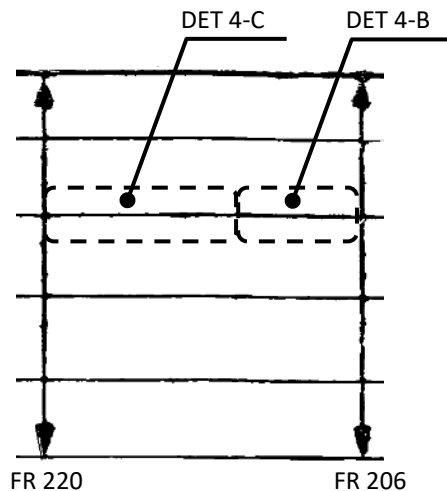
EL 4-A
LONG BHD, STACK SIDE
FR 206-212, PORT
LKG OUTBD

1.3.4.3 Quantity (7 EA), Stud on Horizontal Stiffener on Longitudinal Bulkhead of Forward Stack, Frames between 206 and 212, Port

1.3.4.4 Quantity (One EA), Stud on Lateral Stiffener on Sloping Transverse Bulkhead, Frame 220, Port

LOCATION OF UNUSED STUD LISTED IN 1.3.4.3 & 1.3.4.4

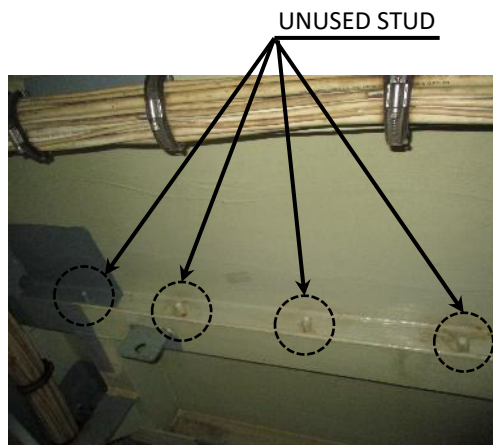
DET 4-C
UNUSED STUD LISTED IN 1.3.4.3

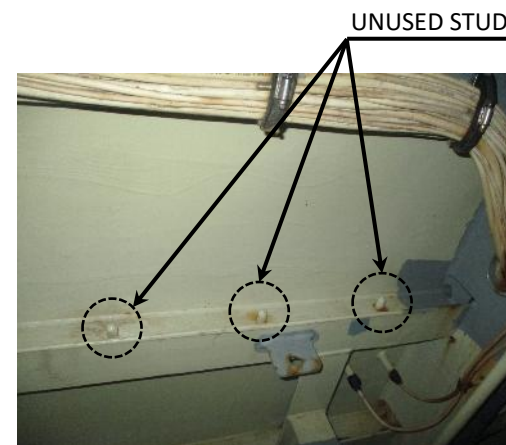
DET 4-B
UNUSED STUD LISTED IN 1.3.4.3

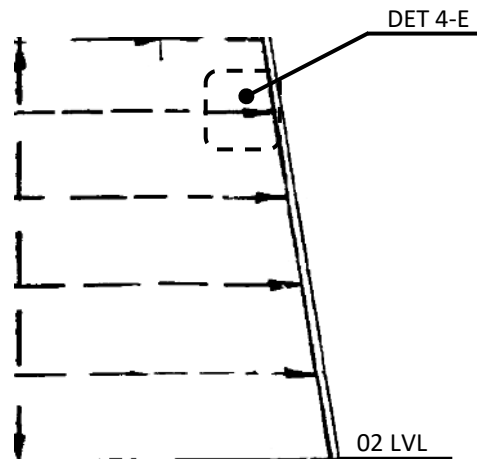
SECT 4-D
SLOPING TRANSV BHD
FR 220, PORT
LKG AFT

DET 4-E
UNUSED STUD LISTED IN 1.3.4.4

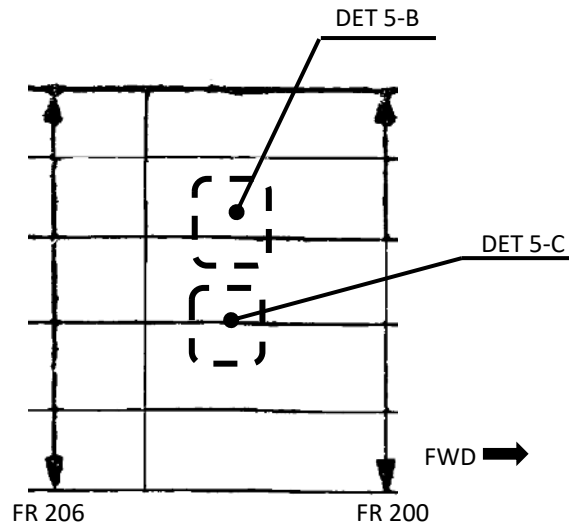
EL 5-A
LONG BHD, STACK SIDE
FR 200-206, PORT
LKG OUTBD

1.3.4.5 Quantity (3 EA), Stud on Horizontal Stiffener on Longitudinal Bulkhead of Forward Stack, Frames between 204 and 206, Port

LOCATION OF UNUSED STUD LISTED IN 1.3.4.5

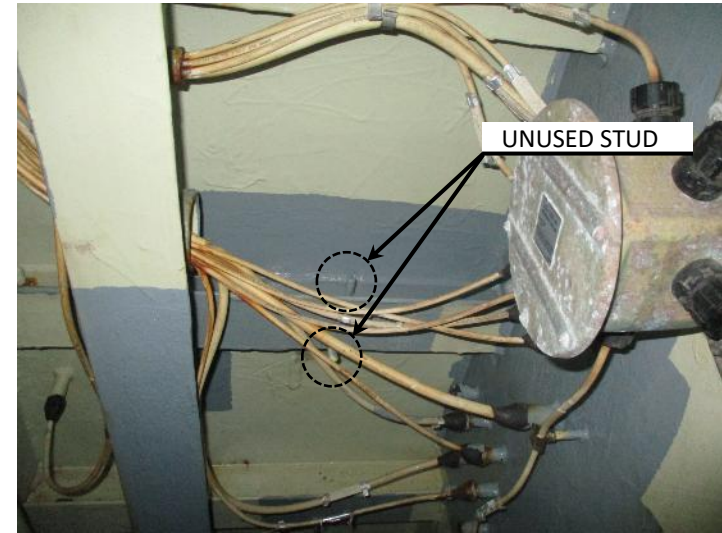
DET 5-B
UNUSED STUD LISTED IN 1.3.4.5

DET 5-C
UNUSED STUD LISTED IN 1.3.4.5

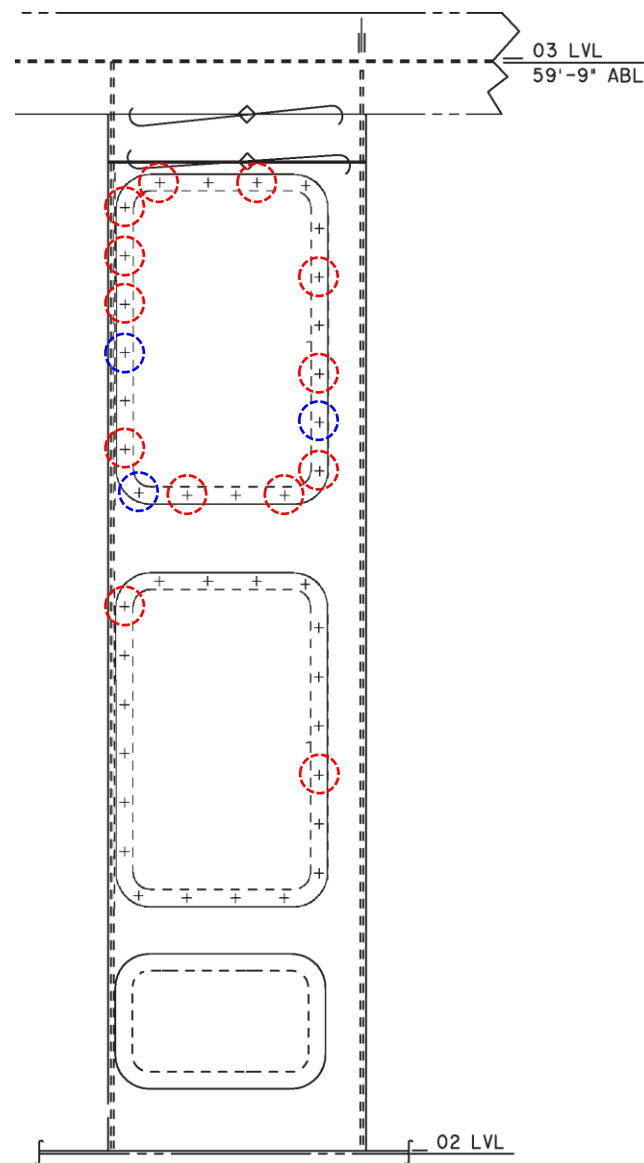
SECT 6-A
CABLE TRK ON SLOPING TRANSV BHD
FR 186, LKG FWD
SKETCH
ENCLOSURE-03

1.3.10.1 Quantity (13 EA), Stud for Access Cover Plate

CABLE TRUNK LISTED IN 1.3.11

5.4 Remove 2 each of access cover plate of each existing cable trunk listed in 1.3.10, using 2.7 for guidance.

5.4.1 Remove remaining portion of each existing stud listed in 1.3.10.1.

5.5 Accomplish build up weld of remaining bolt holes on each existing cable trunk listed in 1.3.10, using 2.7 for guidance.

5.6 Install each new stud listed in 1.3.10.2 in accordance with 2.7 and 2.8.

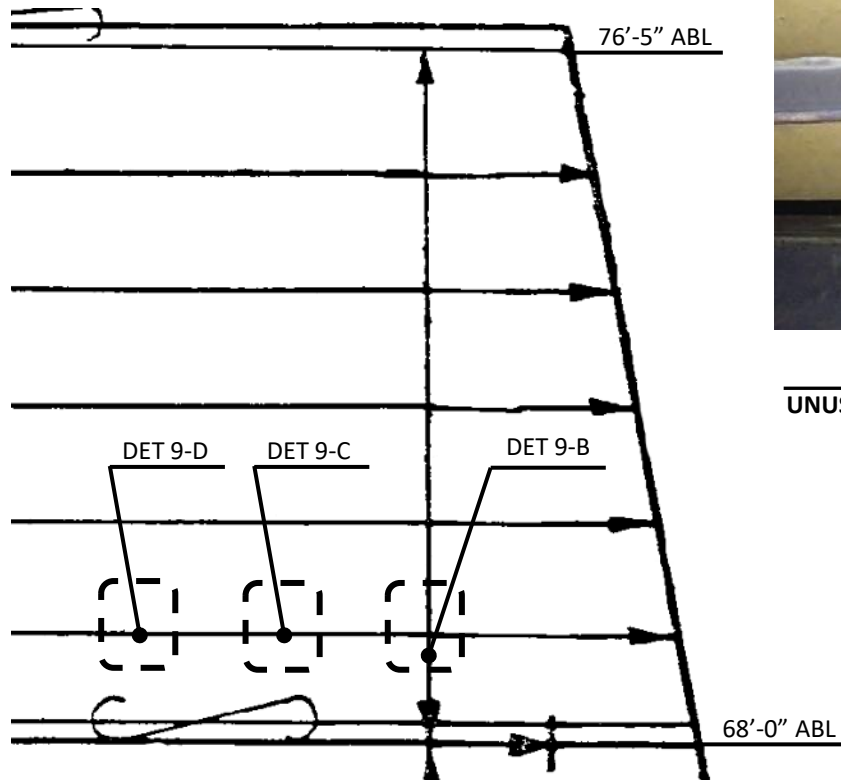
SECT 9-A
SLOPING TRANSV BHD
FR 186, STBD
LKG FWD

LOCATION OF UNUSED CABLE STUD LISTED IN 1.3.6.2 & 1.3.6.3, AND CABLE CLAMP LISTED IN 1.3.7

DET 9-C
UNUSED CABLE STUD LISTED IN 1.3.6.3

DET 9-B
UNUSED CABLE STUD LISTED IN 1.3.6.2

DET 9-D
UNUSED CABLE CLAMP LISTED IN 1.3.7

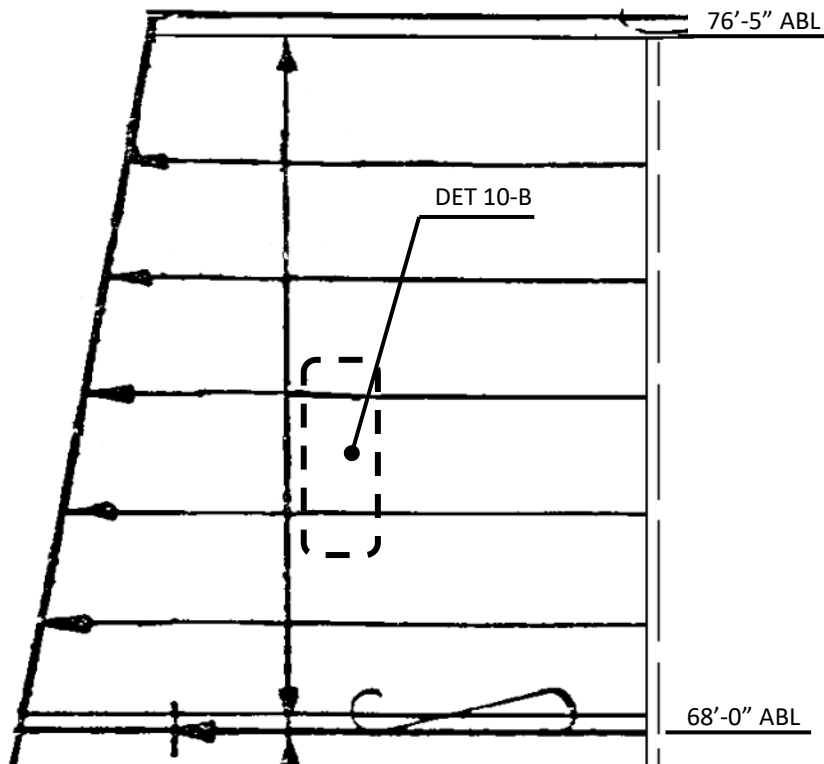
SECT 10-A
SLOPING TRANSV BHD
FR 220, PORT
LKG AFT

1.3.6.1 Quantity (2 EA), Cable Stud on Horizontal Stiffener on Sloping Transverse Bulkhead, Frame 220, Stbd

LOCATION OF UNUSED CABLE STUD LISTED IN 1.3.6.1

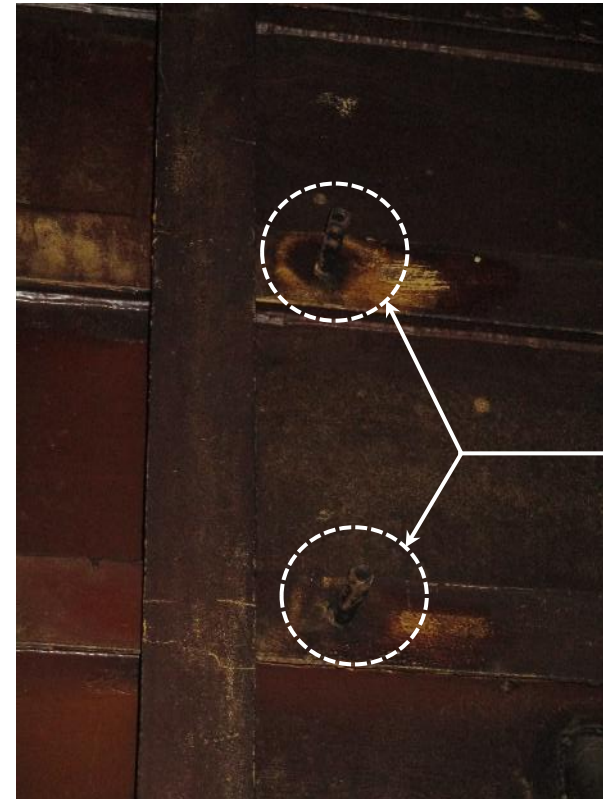
DET 10-B
UNUSED CABLE STUD LISTED IN 1.3.6.1

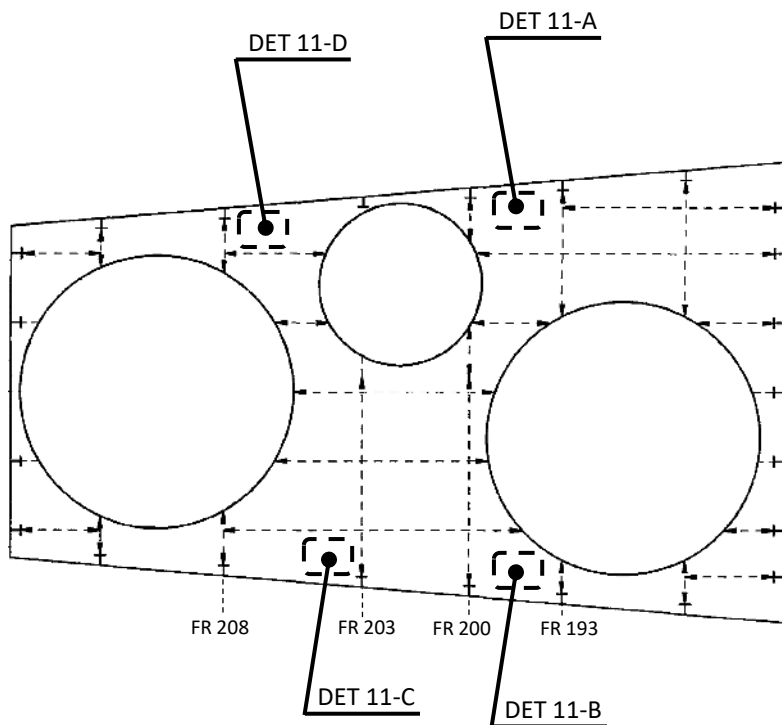
PLAN 11-A
STACK TOP 81'-3" ABL, 02-186-0-Q

LOCATION OF UNUSED PADEYE LISTED IN 1.3.5.1

DET 11-B
UNUSED PADEYE
FR 197-200, STBD

DET 11-A
UNUSED PADEYE
FR 197-200, PORT

DET 11-D
UNUSED PADEYE
FR 205-208, PORT

DET 11-C
UNUSED PADEYE
FR 203-205, STBD
