HAZARDOUS BUILDING MATERIALS SURVEY REPORT

B300 Roof and HVAC Repair Mod 1
Pre-Renovation Services

B300, Portsmouth Naval Shipyard
Kittery, ME 03904

September 10, 2024

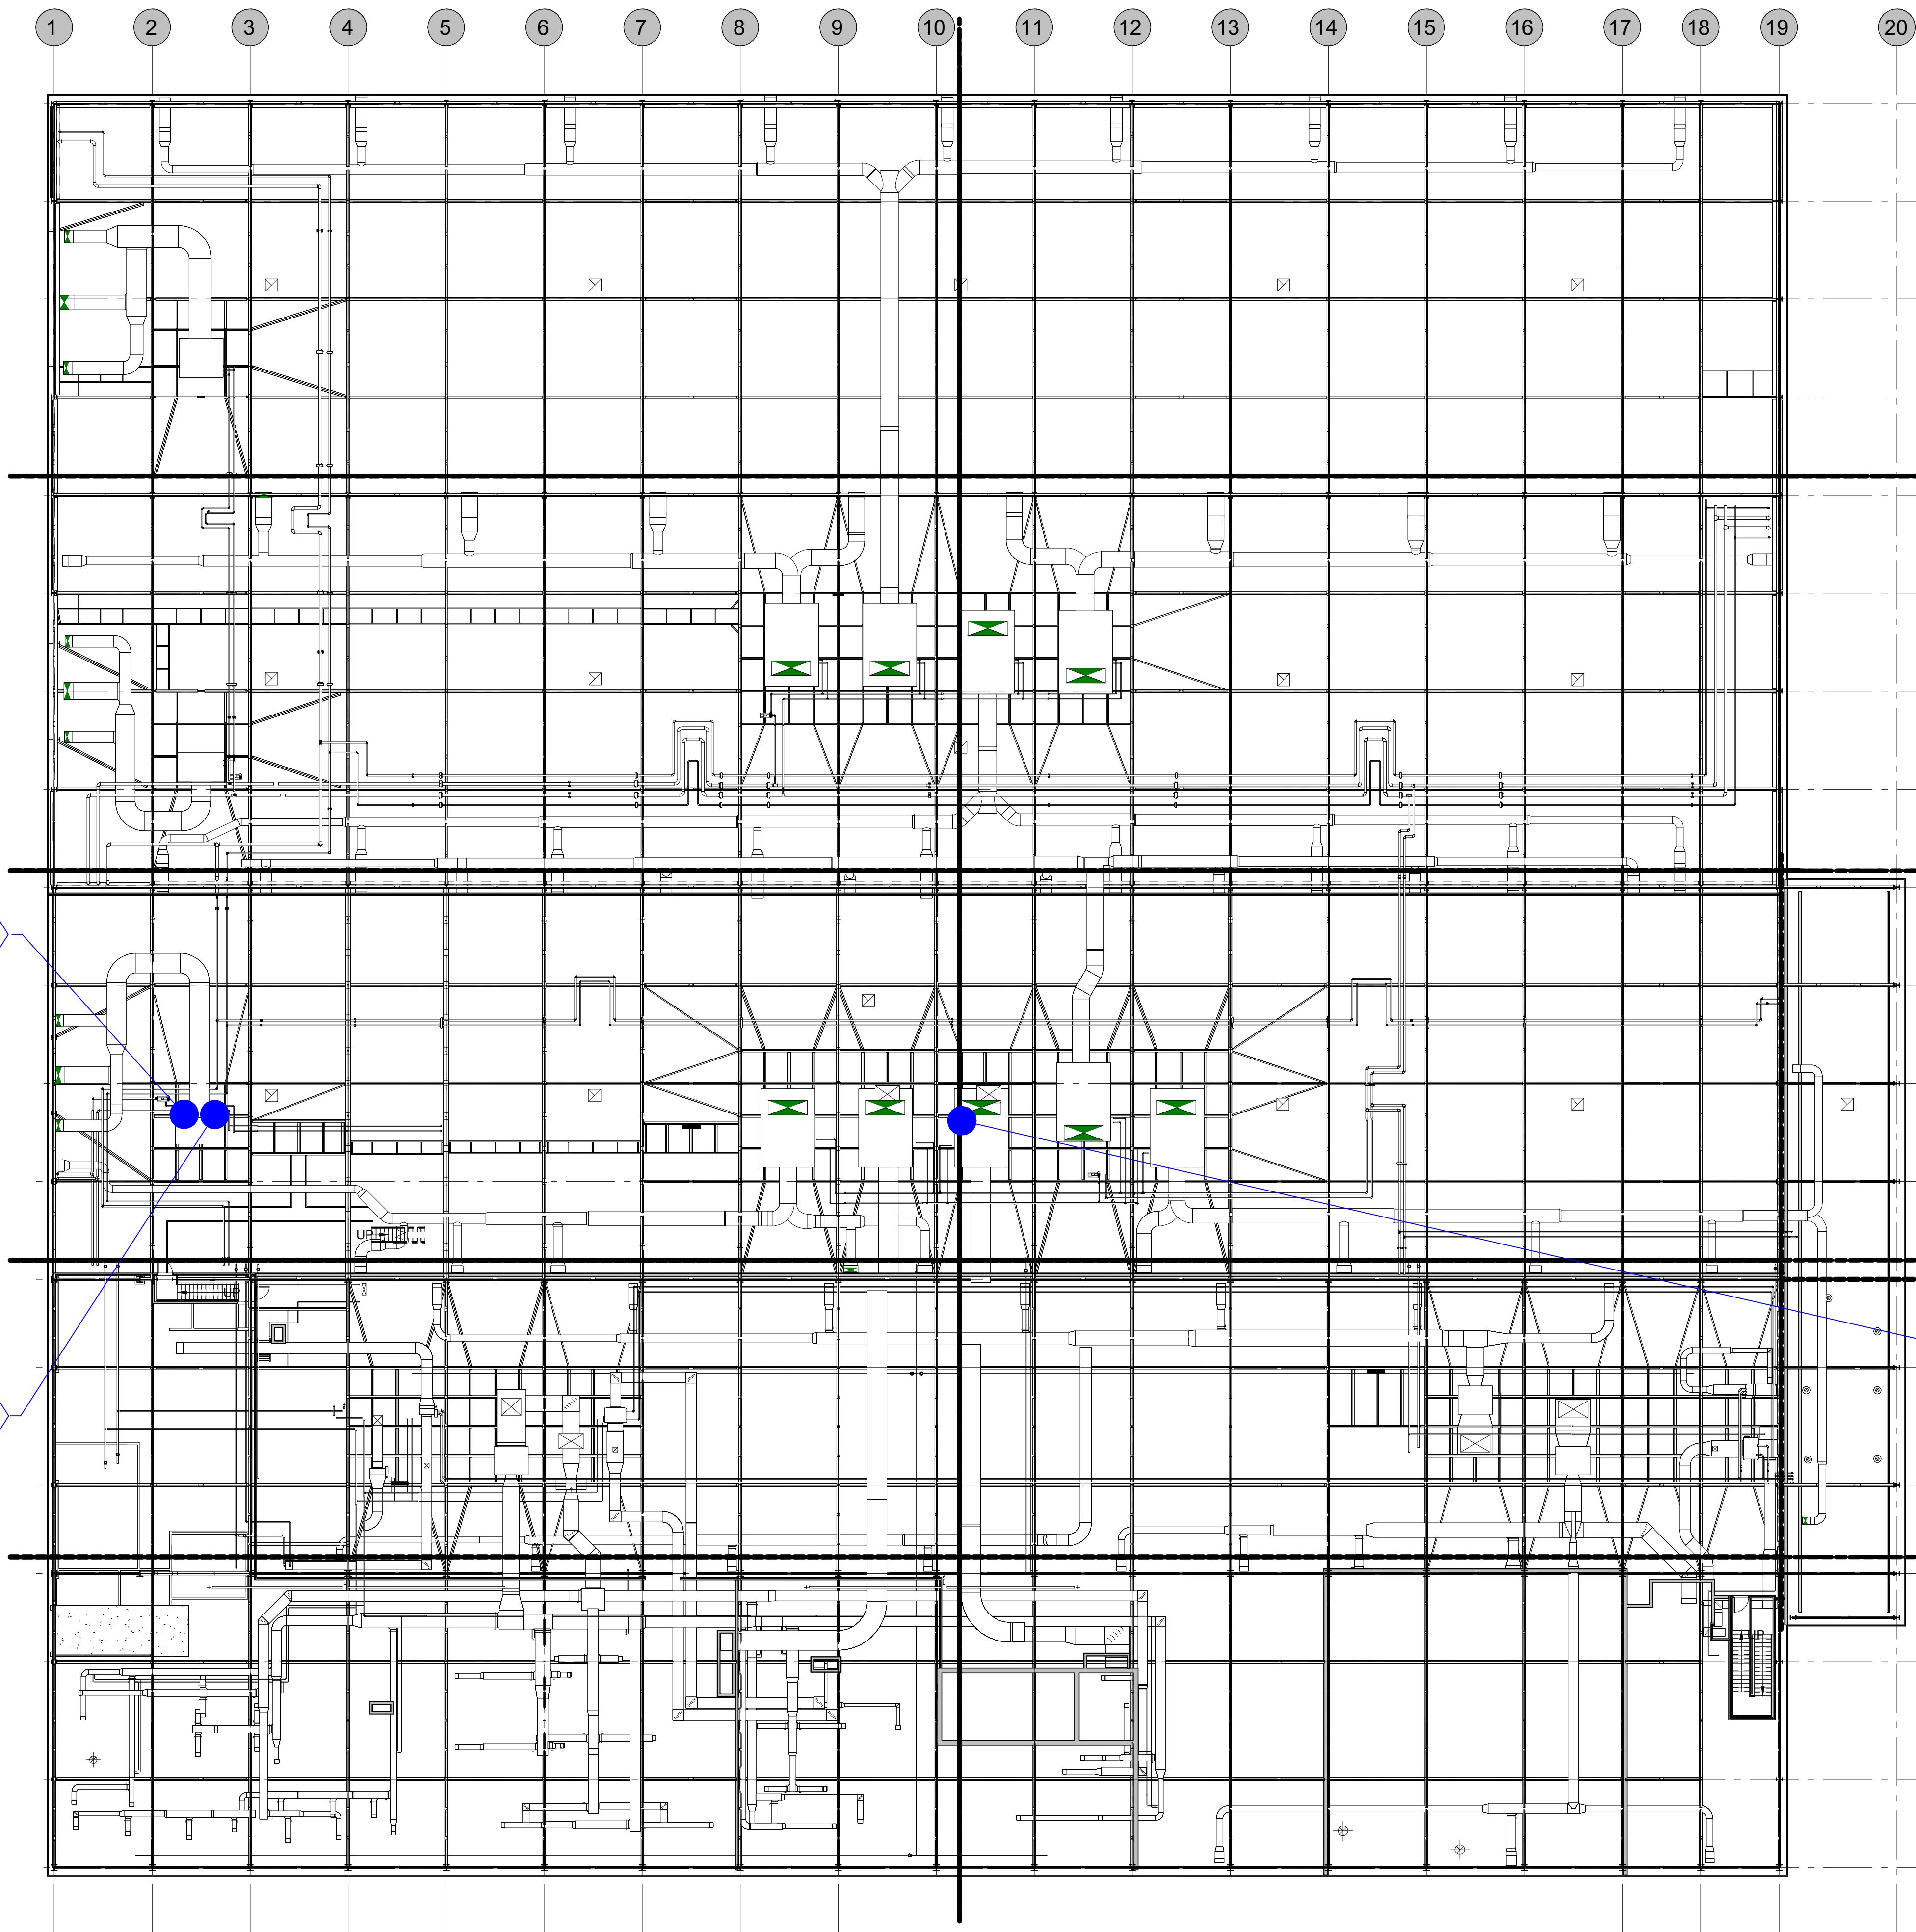
Revisions: Date:	CONSULTANT	ARCHITECT/ENGINEER OF RECORD	STAMP	Drawing Title ASBESTOS AND PCB SAMPLING LOCATIONS 2ND FLOOR PLAN	Phase	Project Title PORTSMOUTH PNSY, B300 MOD 1		Project Number R2023006.000	
	Environmental Consultants: Mabbett[®] Scientists Engineers Program Managers Mabbett & Associates, Inc. 105 Central Street Stoneham, MA 02180 T. 781-275-6050 www.mabbett.com					Building Number 300		Drawing Number RBM-2	
						Location B300, Portsmouth Naval Shipyard, Kittery, ME 03904			
						Issue Date 09/04/2024	Checked MFD	Drawn PEH
