HLB-C2 · F · age not recorded · position C2 · tether arm A

allego_2__uid0802-01-46-57

post-surgery day not recorded · day 3 post-tether · body weight not recorded · duration unknown · ZT span unknown · criterion HUM · QC epoch 10 s

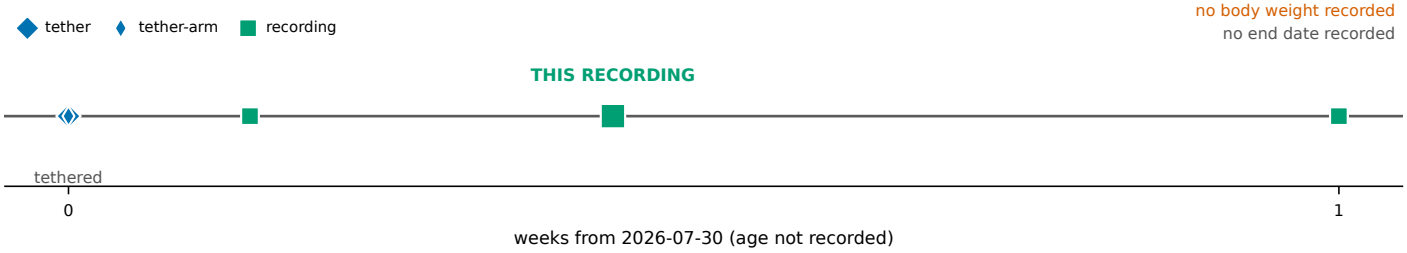
LIFE TIMELINE

✗ 2 CONNECTION — FAIL

0.2% usable, longest unbroken block 0.5 min

vs 60 Hz < 139.6 uV (p1 of 112 wire-free inputs in this file), rms 10-150 uV, zero railed samples

INTERMITTENT: 0.2% of epochs usable but the longest unbroken run is only 0.5 min, under the 15 min a recording needs to be an outcome ...

Second scoreable animal of 31 July, 4.02 h gated with r@1min +0.532. Later a CONFIRMED CHEWED TETHER, read off the data before it was seen: both channels sit at intermediate hum, 1076 and 1331 uV, which is QUIETER than the 2276 uV bare-wire floor, with near-zero railing and no signal. A partially conducting damaged cable, not an open one.

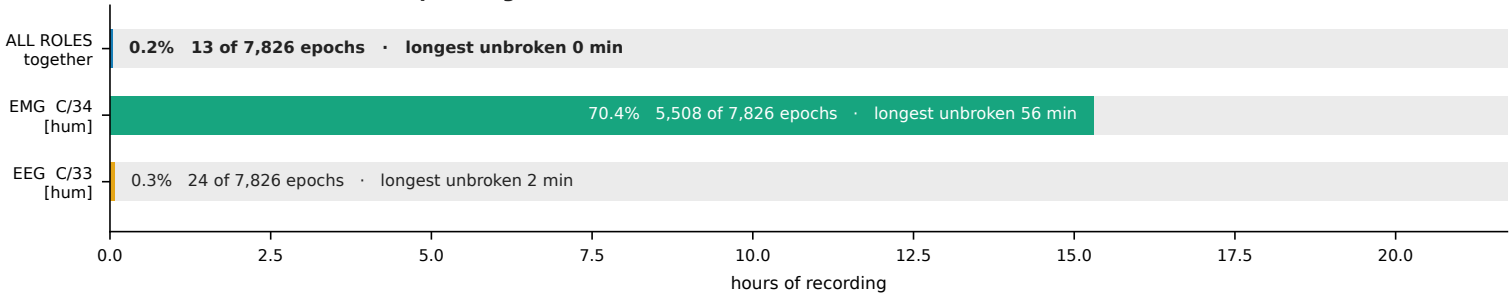
RUNG 2 evidence — usable epochs against the in-file wire-free floor

falsification: the same criterion scores the 112 wire-free inputs in this file at 0.88% usable, and must be near zero · floor 60 Hz p1 140 uV, 1-40 Hz slope p1 -3.33
