Glow Worm cxi, hxi & sxi PCB - Components

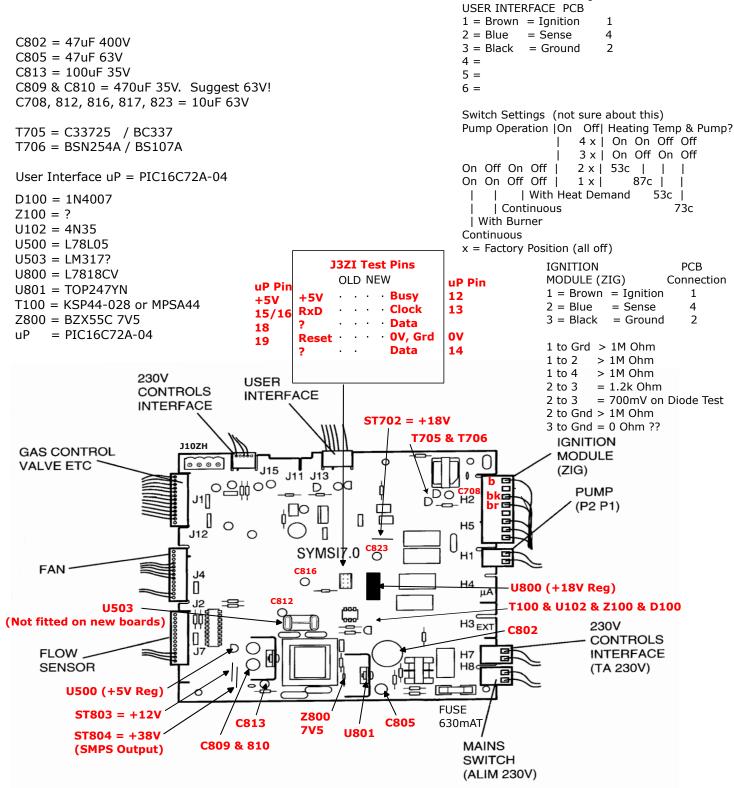
The main DC voltage from the SMPS is around 40V. Interesting that the smoothing capacitors C809 & C810 are 35V working!! Perhaps use 50V or 63V replacement caps here.

The 12V and 38V supplies are from separate secondary windings. +5V is derived from the 12V rail. They all share the common Gnd.

As C809 & C810 capacitors work the hardest they should be replaced as a matter of course (with 50V or 63V working 105deg). C802 is an HV capacitor and should be replaced. C813 is for the 12V rail and again should be replaced as it is next to the heatsink. As should C805. All with 105deg spec parts.
