Streetwork compliance report (Video ID: test_video_1)

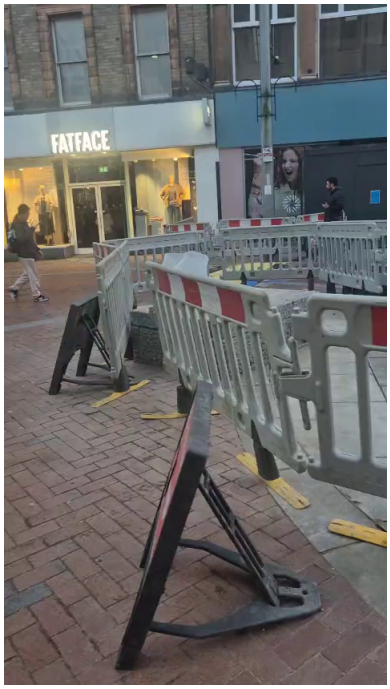
Timestamp: 0s

- [00:00 - 00:07] (high) There is a noticeable gap between the first and second barricade units, compromising the continuity of the barrier system.

- Verify that each unit is locked and properly aligned.
- Inspect signage compliance and enforce penalties for violations.
- Ensure all pedestrians comply with high-vis vest and hard hat requirements.
- Inspect the connection points between units to guarantee integrity.
- Verify that the signage complies with UK standards regarding size, color, and placement.
- Ensure the signage is clearly visible and legible by improving lighting or positioning.
- Provide training on mandatory PPE regulations.
- Ensure all barricade units are securely connected without any gaps.

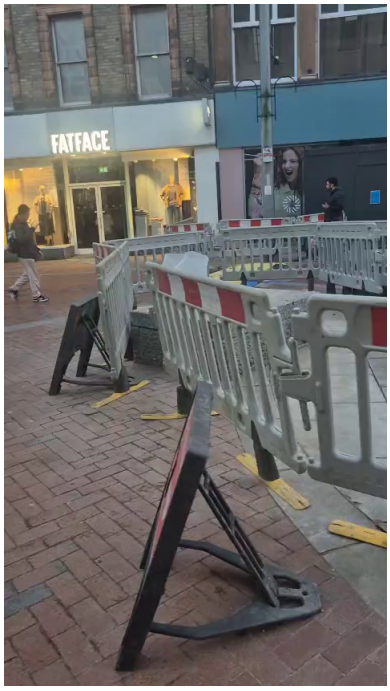
Timestamp: 0s

- [00:00 - 00:07] (low) The signage is present but lacks clarity due to poor visibility.
