Technical BulletinModel 6 Cyl.Group 6SubjectPart Identifier Care of Targa Roof Cover StripsPart Identifier 6636Number 9604

Models Affected: Model Year 1996 911 Targa

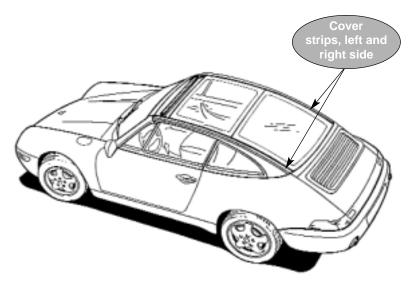
clean them only with a soap and water solution. Petroleum cleaning products used on the cover strips or any other plastic parts can cause

them to become brittle and crack.

Concern: When cleaning the cover strips on the Targa roof, it is very important to
