RAPID DISASTER SITUATION REPORT (SITREP)

Educational Prototype

Event Date: **2024-07-02** | Satellite: **2024-07-04 to 2024-07-11** | AOI: **[92.85, 26.55, 93.10, 26.75]**

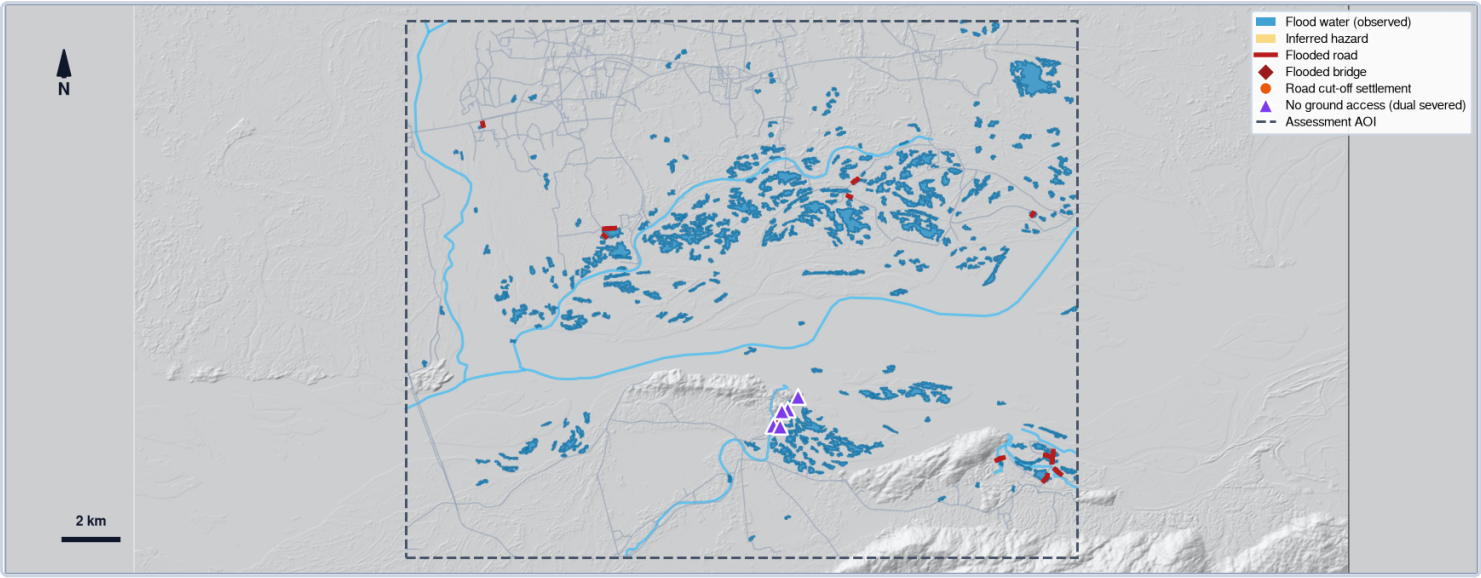
17.36 km²	9	0	5
OBSERVED FLOOD WATER	FLOODED BUILDINGS	FLOODED BRIDGES	CUT-OFF SETTLEMENTS

Satellite analysis identifies **17.36 km²** of directly observed hazard extent and **0.0 km²** inferred along tributaries. Affected stretch extends along **Brahmaputra** from near **Chutia** to near **Kuwarital** (Sensors: Pre 2024-06-21 to 2024-07-01 / Post 2024-07-04 to 2024-07-11).
