RAPID DISASTER SITUATION REPORT (SITREP)

Educational Prototype

Event Date: **2023-10-04** | Satellite: **2023-10-06 to 2023-10-11** | AOI: **[88.58, 27.53, 88.72, 27.67]**

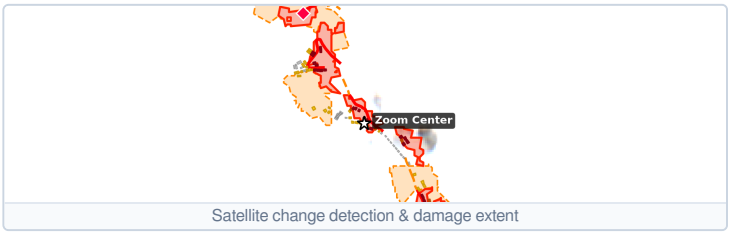
1. WHERE DID THE FLOOD HIT?

Satellite change detection & damage extent

Satellite analysis identifies **0.42 km²** of directly observed hazard extent and **0.98 km²** inferred along tributaries. Affected stretch extends along **Teesta (LachenChu)** from near **Nanga** to near **Nanga** (Sensors: Pre 2023-09-26 to 2023-10-01 / Post 2023-10-06 to 2023-10-11).
