RAPID DISASTER SITUATION REPORT (SITREP)

Educational Prototype

Event Date: **2026-08-26** | Satellite: **2026-08-27 to 2026-09-01** | AOI: **[85.30, 28.10, 85.42, 28.25]**

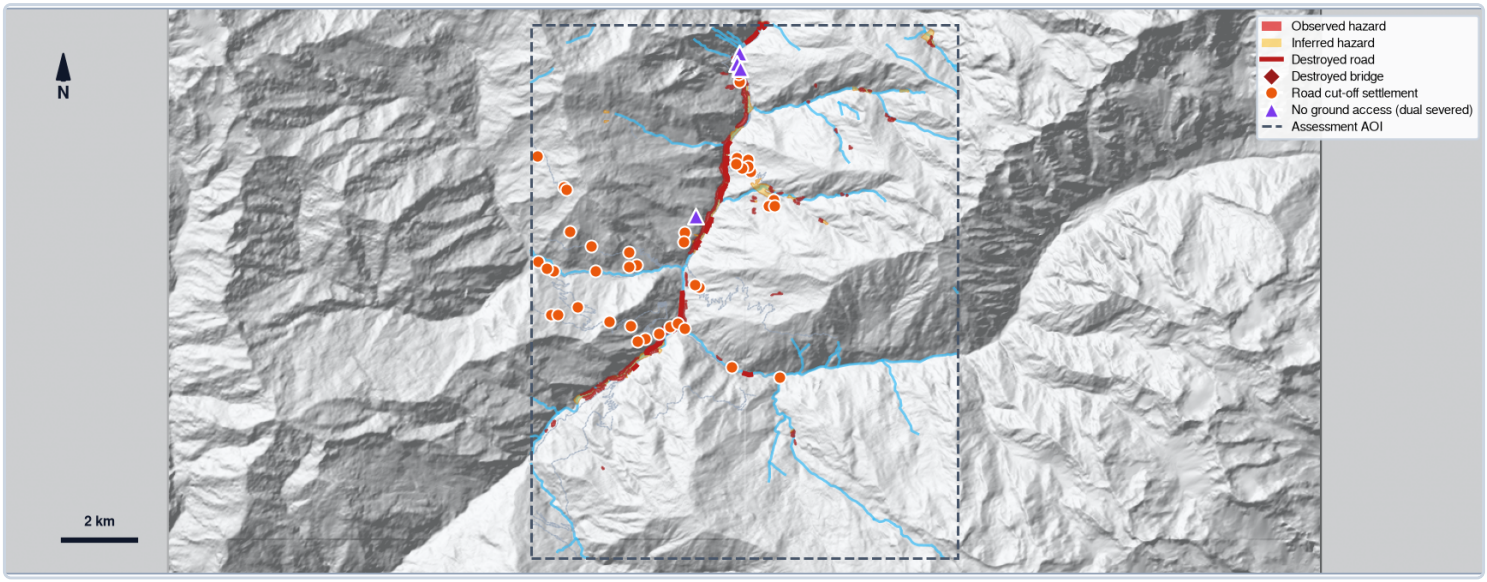
Satellite analysis identifies **1.08 km²** of directly observed hazard extent and **1.07 km²** inferred along tributaries. Affected stretch extends along **Bhote Koshi** from near **Dalphedi** to near **Sano Bharkhu** (Sensors: Pre 2026-08-12 to 2026-08-24 / Post 2026-08-27 to 2026-09-01).
