RAPID DISASTER SITUATION REPORT (SITREP)

Educational Prototype

Event Date: **2021-06-15** | Satellite: **2021-06-16 to 2021-06-24** | AOI: **[85.53, 27.80, 85.62, 27.95]**

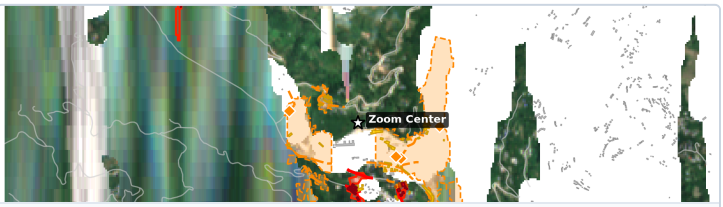
Satellite change detection & damage extent

Satellite analysis identifies **0.9 km²** of directly observed hazard extent and **0.99 km²** inferred along tributaries. Affected stretch extends along **Indrawati river** from near **Dongdhing** to near **Sikharpur** (Sensors: Pre 2021-06-04 to 2021-06-14 / Post 2021-06-16 to 2021-06-24).
