Report Sheet

Appusbwall2 and appusbwal21

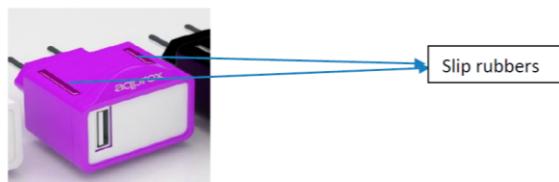
1. Please, improve this mark injection in the curve frontal it is not beautiful this mark in the frontal of product. Please improve this aspect because the slick printing logo is in this place.
