HOUSE PRE-PURCHASE INSPECTIONS

Property Inspection Report

DEFECTS IMAGES

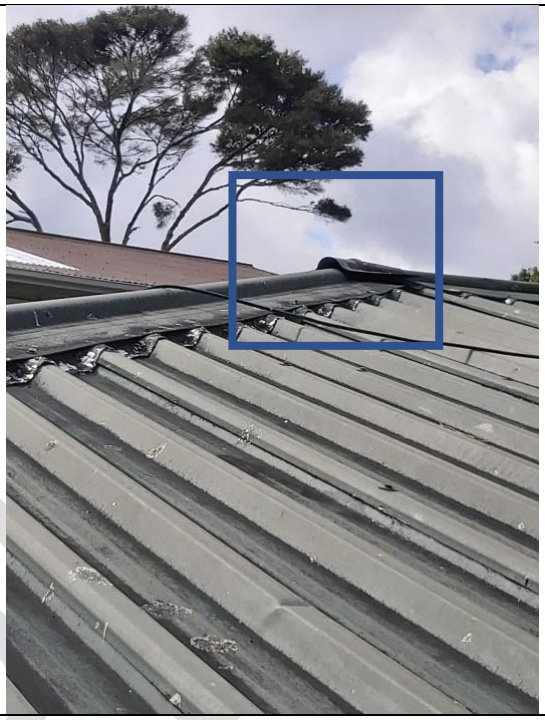
Material: Metal

Defect: The end of the Ridge flashing on the roof requires fixing as it appears to be lifted. Recommend contacting a licensed building practitioner for further advice.

Next action: Contact/seek advice from a licenced building practitioner
