ABACUS
BUILDING
CONSULTING

SAFE AND SANITARY REPORT

1/1 OPUA STREET, BELMONT

Client:	Lucy Mckenzie
At:	1/1 Opua Street, Belmont 0622
Job no:	250011
Date:	10/10/2025

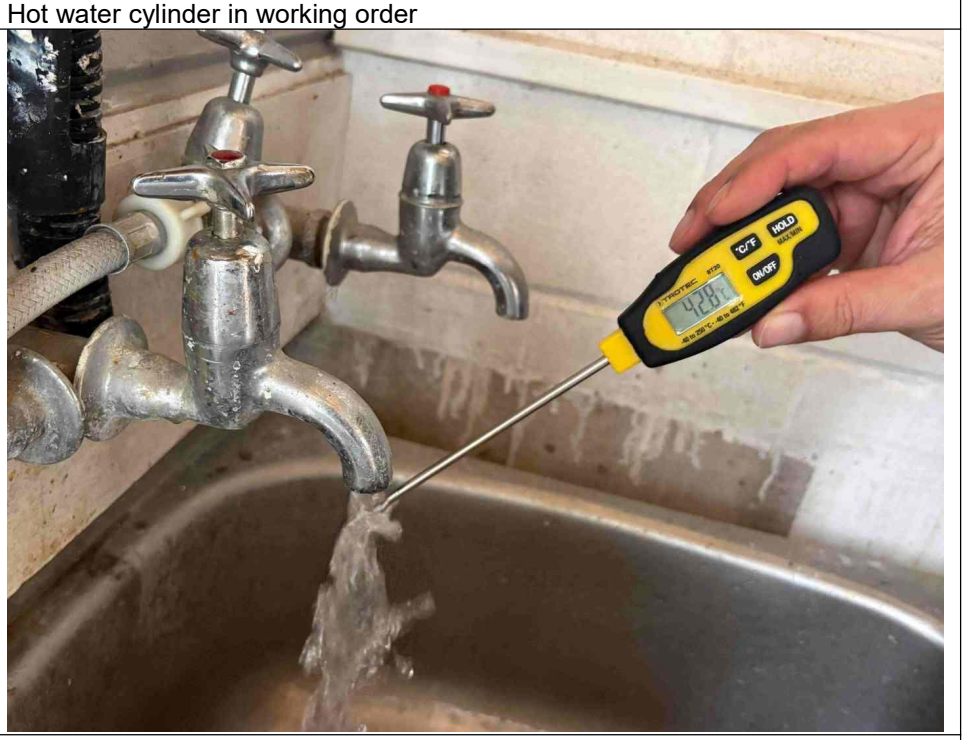
Photograph 15	Normal moisture reading from interior
	Shower photo
Photograph 16	Shower

Photograph 17	Vanity and bath
	Toilet photo
Photograph 18	Toilet
Photograph 19	Kitchen sink

Photograph 20	Hot water cylinder in working order
