Substation	BERTAM VALLEY			Date: 02/06/2026
	Equipment	RMU SF6	Manufacturer	INDKOM	Time: 9:20 AM
	Model	INS24	Rating	12kV	Humidity: 79%
	Area	OVERVIEW		Panel No.	-
Panel Name	-

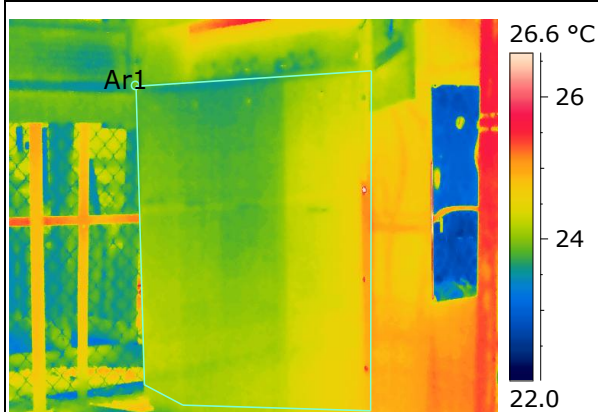
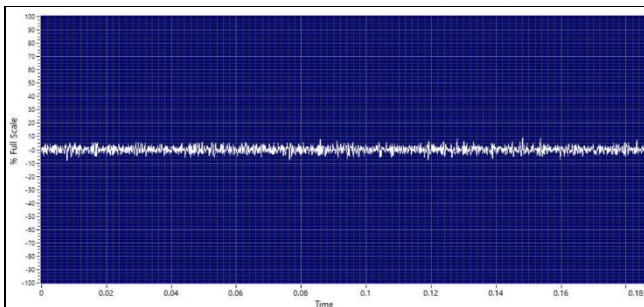
PARAMETER	VALUE
Spot Temp.1 (Sp1)	-
Spot Temp. 2 (Sp2)	-
Average Temp. (Ar1)	24.1 °C
Ambient Temp.	21.0 °C
Delta T (ΔT)	-
Load (A)	-
Defect	-

Analysis: No Anomaly.

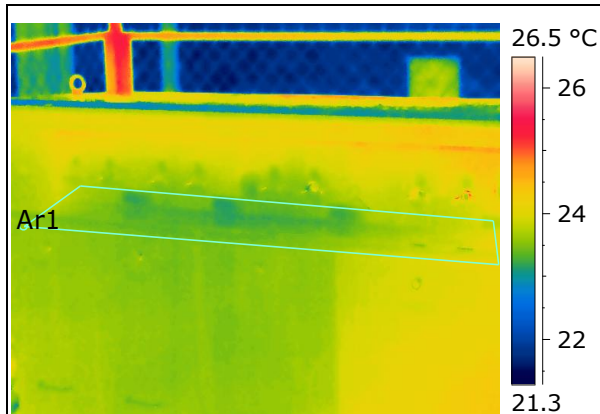
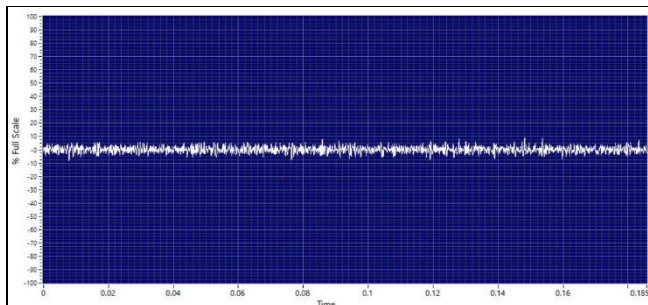
PARAMETER	VALUE
Spot Temp.1 (Sp1)	-
Spot Temp. 2 (Sp2)	-
Average Temp. (Ar1)	23.5 °C
Ambient Temp.	21.0 °C
Delta T (ΔT)	-
Load (A)	-
Defect	-

Analysis: No Anomaly.

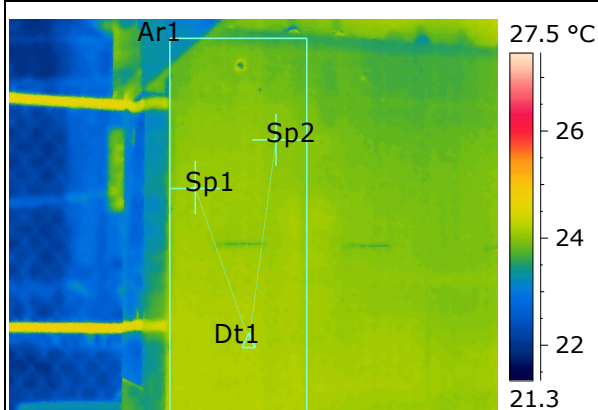
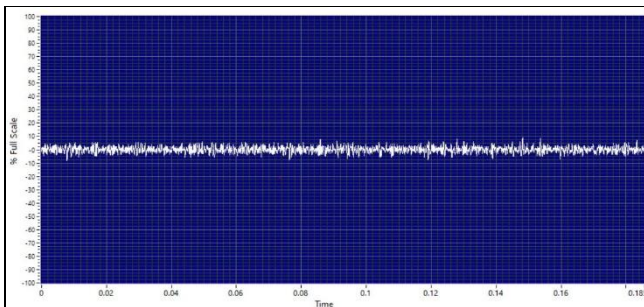
PARAMETER	VALUE
Spot Temp.1 (Sp1)	24.1 °C
Spot Temp. 2 (Sp2)	24.0 °C
Average Temp. (Ar1)	24.1 °C
Ambient Temp.	21.0 °C
Delta T (Δ T)	0.1 °C
Load (A)	-
Defect

Decibel (dB)	0dB
Sound characteristic	Normal
Severity	
Sound clip

Analysis: No Anomaly.

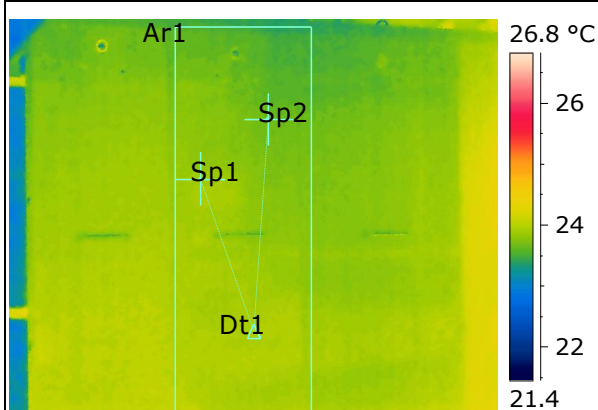
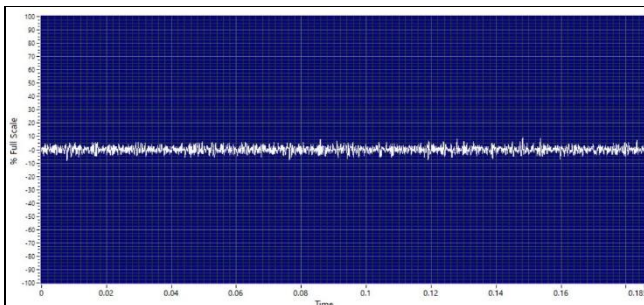
PARAMETER	VALUE
Spot Temp.1 (Sp1)	23.9 °C
Spot Temp. 2 (Sp2)	23.6 °C
Average Temp. (Ar1)	23.8 °C
Ambient Temp.	21.0 °C
Delta T (Δ T)	0.3 °C
Load (A)	-
Defect

Decibel (dB)	0dB
Sound characteristic	Normal
Severity	
Sound clip

Analysis: No Anomaly.

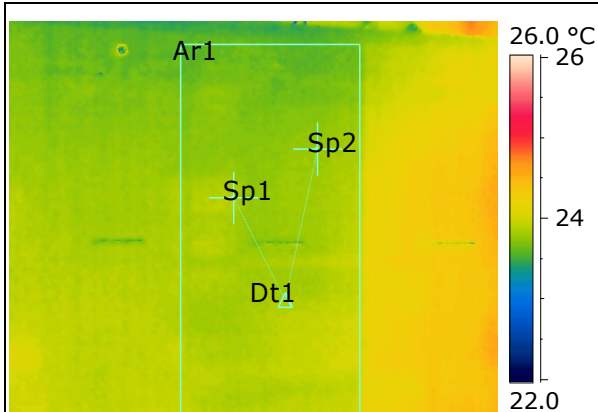
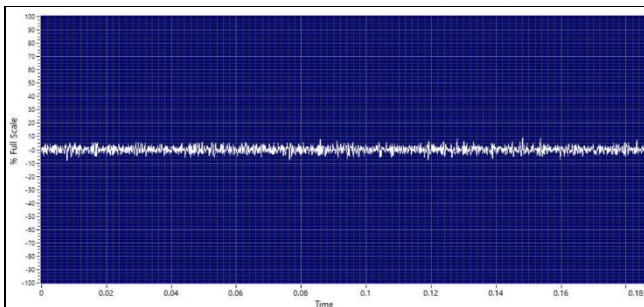
PARAMETER	VALUE
Spot Temp.1 (Sp1)	23.9 °C
Spot Temp. 2 (Sp2)	23.8 °C
Average Temp. (Ar1)	23.8 °C
Ambient Temp.	21.0 °C
Delta T (Δ T)	0.1 °C
Load (A)	-
Defect

Decibel (dB)	0dB
Sound characteristic	Normal
Severity	
Sound clip

Analysis: No Anomaly.

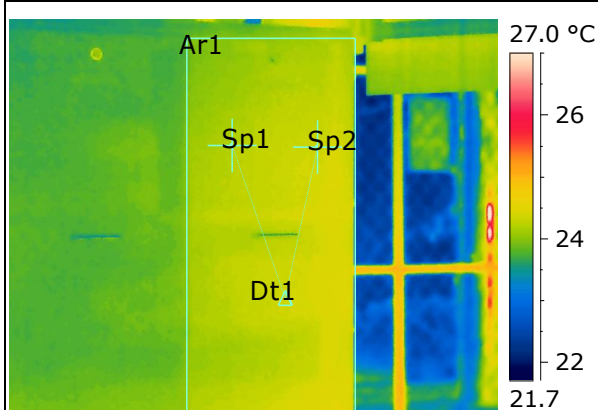
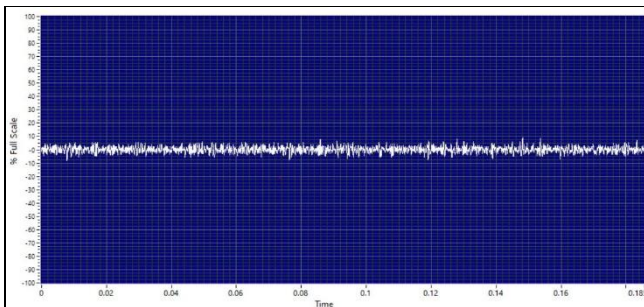
PARAMETER	VALUE
Spot Temp.1 (Sp1)	24.2 °C
Spot Temp. 2 (Sp2)	24.3 °C
Average Temp. (Ar1)	24.3 °C
Ambient Temp.	21.0 °C
Delta T (Δ T)	0.1 °C
Load (A)	-
Defect

Decibel (dB)	0dB
Sound characteristic	Normal
Severity	
Sound clip

Analysis: No Anomaly.

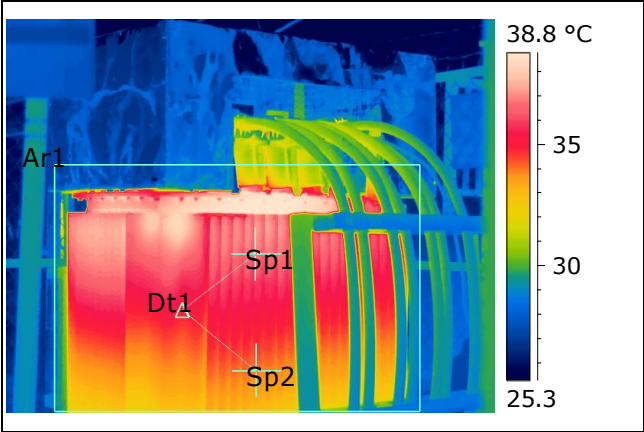
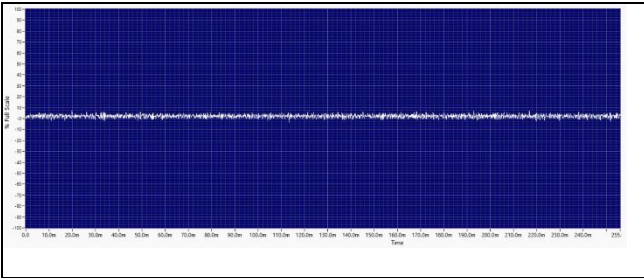
PARAMETER	VALUE	PARAMETER	VALUE
Spot Temp.1 (Sp1)	36.6 °C	Serial No.	EWT55674
Spot Temp. 2 (Sp2)	33.9 °C	Heater (A)	-
Average Temp. (Ar1)	33.2 °C	CB Position	-
Ambient Temp.	21.0 °C	Busbar Position	-
Delta T (Δ T)	2.7 °C	Cable Type	-
Load (A)	-		
Defect	-

Analysis: No Anomaly.

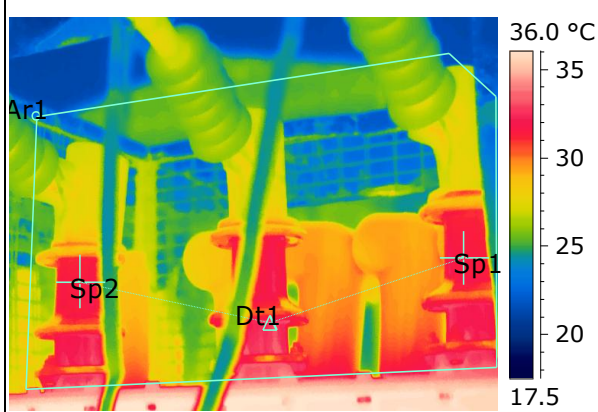
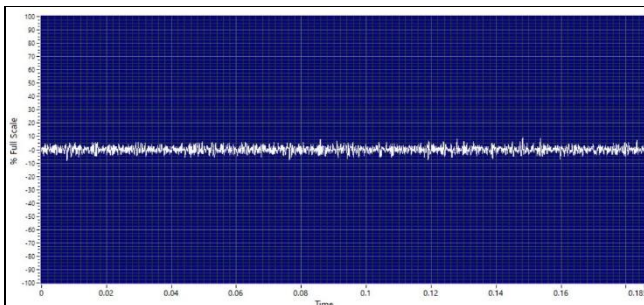
PARAMETER	VALUE
Spot Temp.1 (Sp1)	31.5 °C
Spot Temp. 2 (Sp2)	31.4 °C
Average Temp. (Ar1)	27.3 °C
Ambient Temp.	21.0 °C
Delta T (ΔT)	0.1 °C
Load (A)	-
Defect

Decibel (dB)	0dB
Sound characteristic	Normal
Severity	
Sound clip

Analysis: No Anomaly.

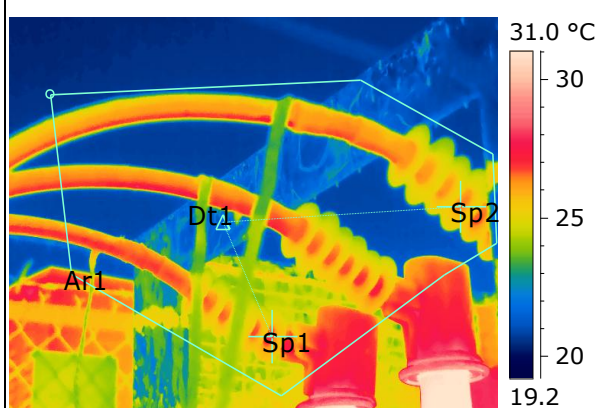
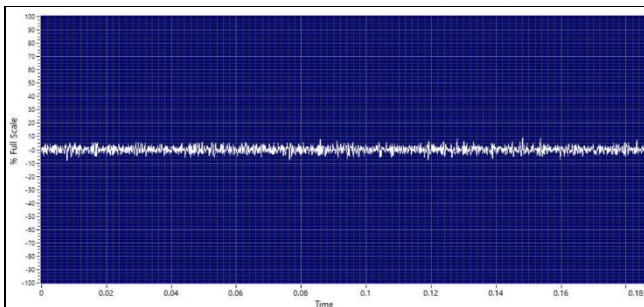
PARAMETER	VALUE
Spot Temp.1 (Sp1)	26.5 °C
Spot Temp. 2 (Sp2)	26.4 °C
Average Temp. (Ar1)	23.7 °C
Ambient Temp.	21.0 °C
Delta T (ΔT)	0.1 °C
Load (A)	-
Defect

Decibel (dB)	0dB
Sound characteristic	Normal
Severity	
Sound clip

Analysis: No Anomaly.

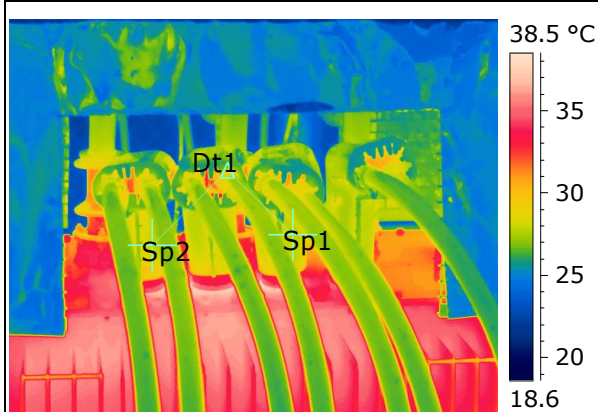
PARAMETER	VALUE
Spot Temp.1 (Sp1)	27.5 °C
Spot Temp. 2 (Sp2)	27.7 °C
Average Temp. (Ar1)	-
Ambient Temp.	21.0 °C
Delta T (ΔT)	0.2 °C
Load (A)	-
Defect

Analysis: No Anomaly.

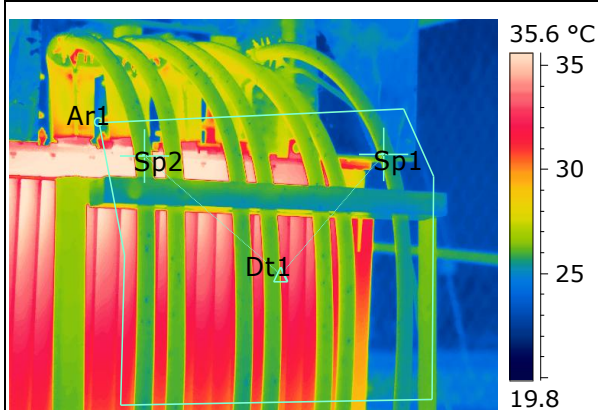
PARAMETER	VALUE
Spot Temp.1 (Sp1)	25.7 °C
Spot Temp. 2 (Sp2)	26.0 °C
Average Temp. (Ar1)	28.1 °C
Ambient Temp.	21.0 °C
Delta T (ΔT)	0.3 °C
Load (A)	-
Defect

Analysis: No Anomaly.

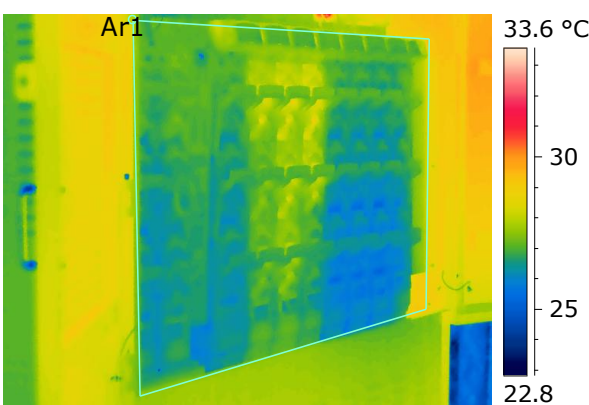
PARAMETER	VALUE	PARAMETER	VALUE
Spot Temp.1 (Sp1)	-	Serial No.	RTLRL 642-045
Spot Temp. 2 (Sp2)	-	Heater (A)	-
Average Temp. (Ar1)	26.8 °C	CB Position	-
Ambient Temp.	21.0 °C	Busbar Position	-
Delta T (Δ T)	-	Cable Type	-
Load (A)	-		
Defect	-

Analysis: No Anomaly.
