**CONDITION BASED ASSESSMENT  
FULL SCANNING REPORT  
SBUM DIAGNOSTIC PAHANG  
TNB BAHAGIAN PEMBAHAGIAN PAHANG**

| SUBSTATION NAME (ERMS) | : | SS KG BENGALI |
| DATE | : | 06 MAR 2026 |

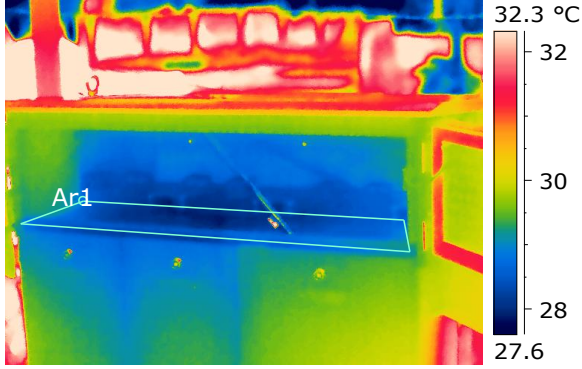
| | Area | OVERVIEW | | | Panel No. |

**Analysis:** Please refer the following page for details defect.

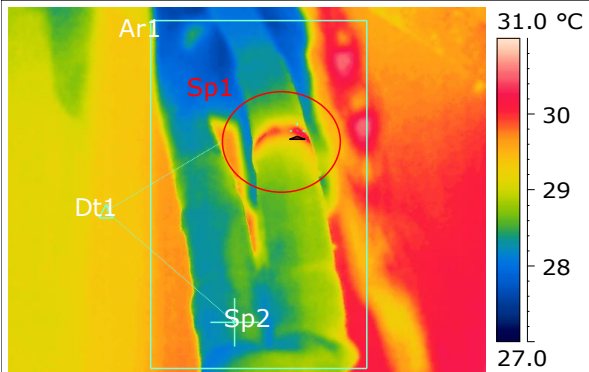
| | Area | OVERVIEW TOP | | Panel No. | - |

**Analysis:** Please refer the following page for details defect.

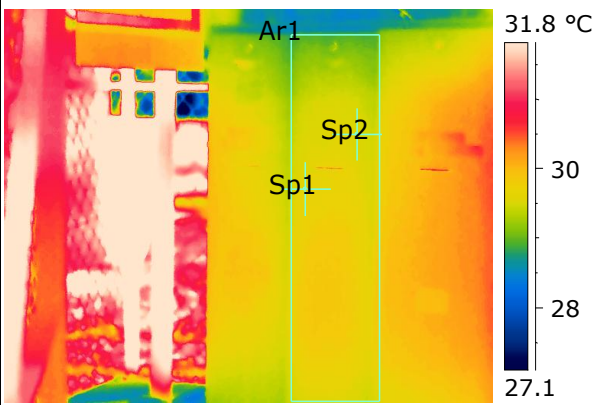
| | Area | CABLE COMPARTMENT | | Panel No. | CRB00770 |

| IR IMAGE | | VISUAL IMAGE | |
|---|---|---|---|
| Delta T ( Δ T) | 2.0 °C | Cable Type | XLPE |

**Analysis:** Thermal image above indicates hotspot detected at **CABLE XLPE – CABLE TERMINATION**.

**Recommendation:** To inspect and make a new termination or replace defective parts if necessary.

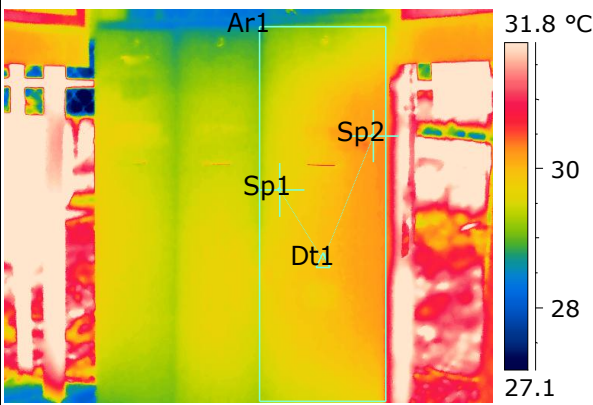
| | Area | CABLE COMPARTMENT | | Panel No. | CRB00771 |

**Analysis:** No Anomaly.
