CHHATTISGARH STATE INDUSTRIAL
DEVELOPMENT CORPORATION

Drishti — Automated Land Monitoring Report

Project Name	Detection - RIKHI
Industrial Area	RIKHI
Report Date	13 February 2026, 12:20 UTC
Total Features Detected	8
Plot Features	8
Total Area Covered	37,855 sq.m (407,470 sq.ft)

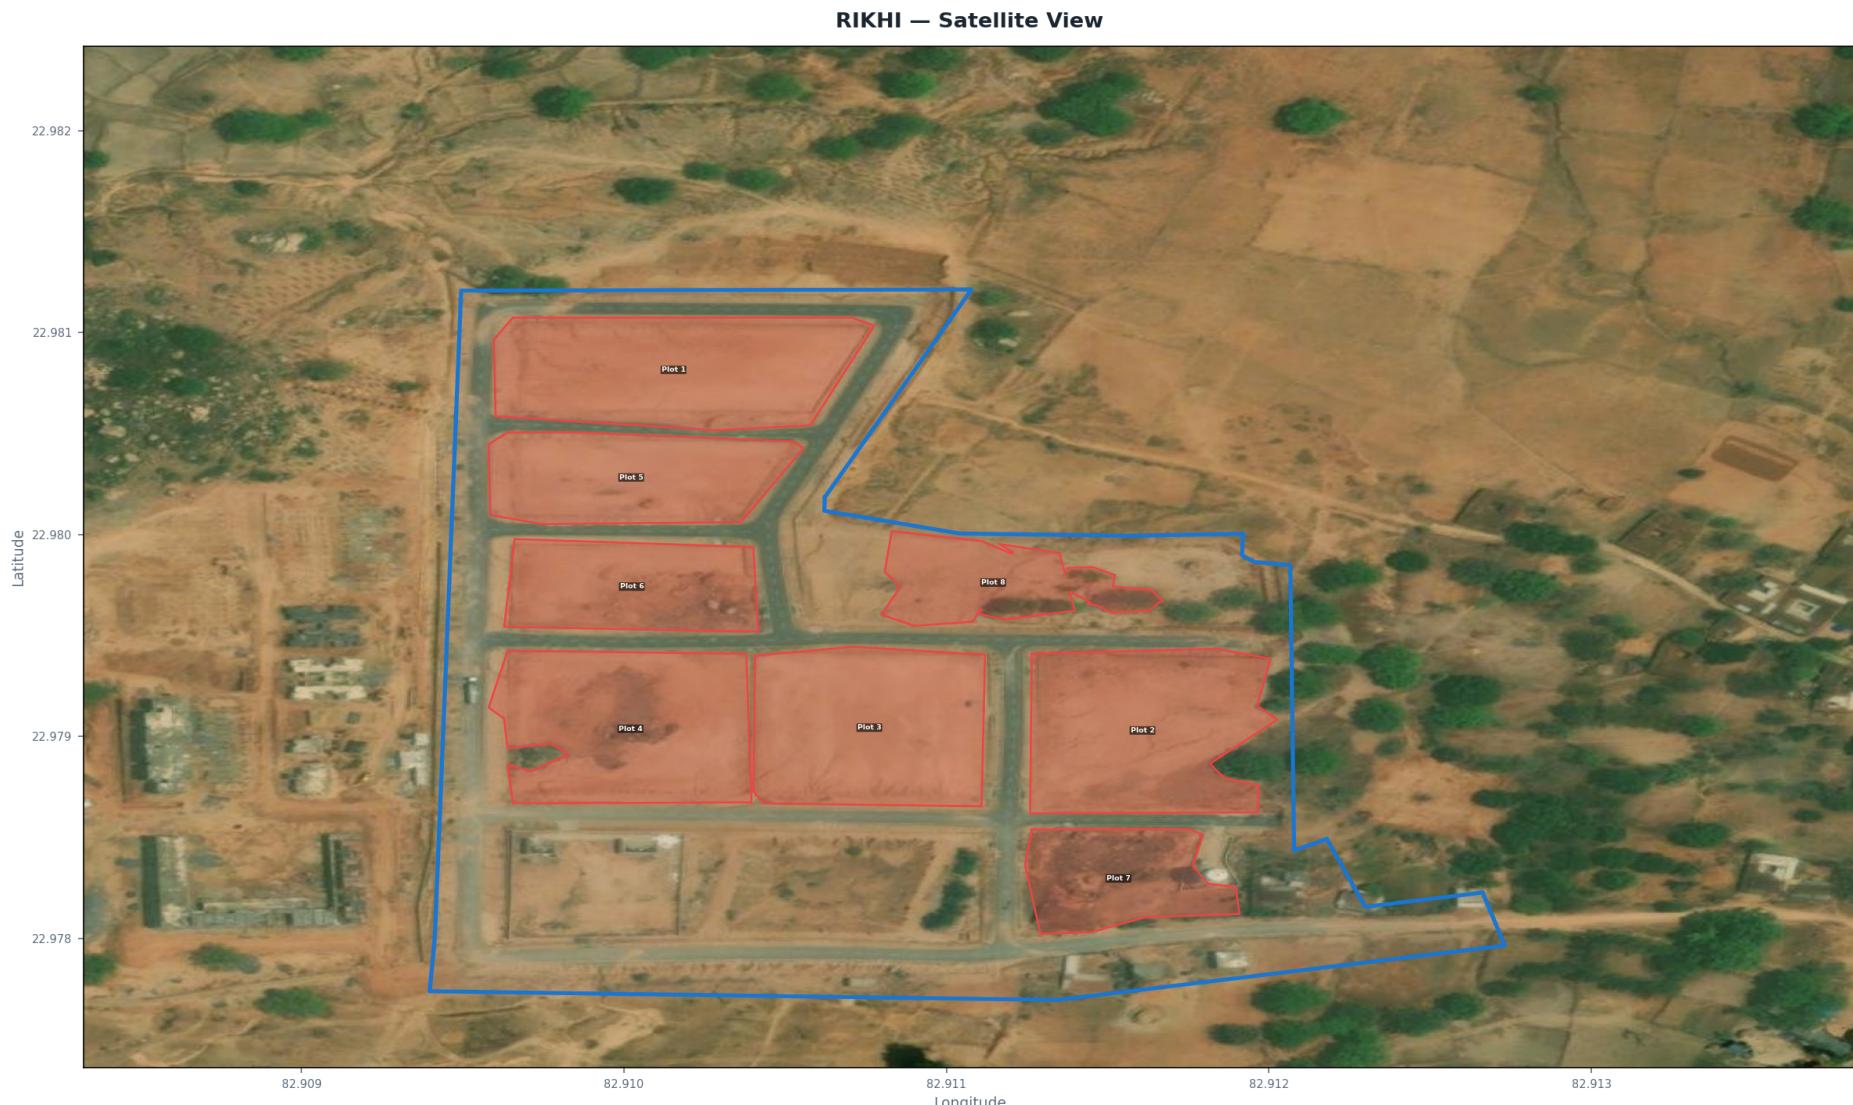
Satellite Imagery — Detected Boundaries

High-resolution satellite imagery with detected plot boundaries overlaid. Source: ESRI World Imagery.

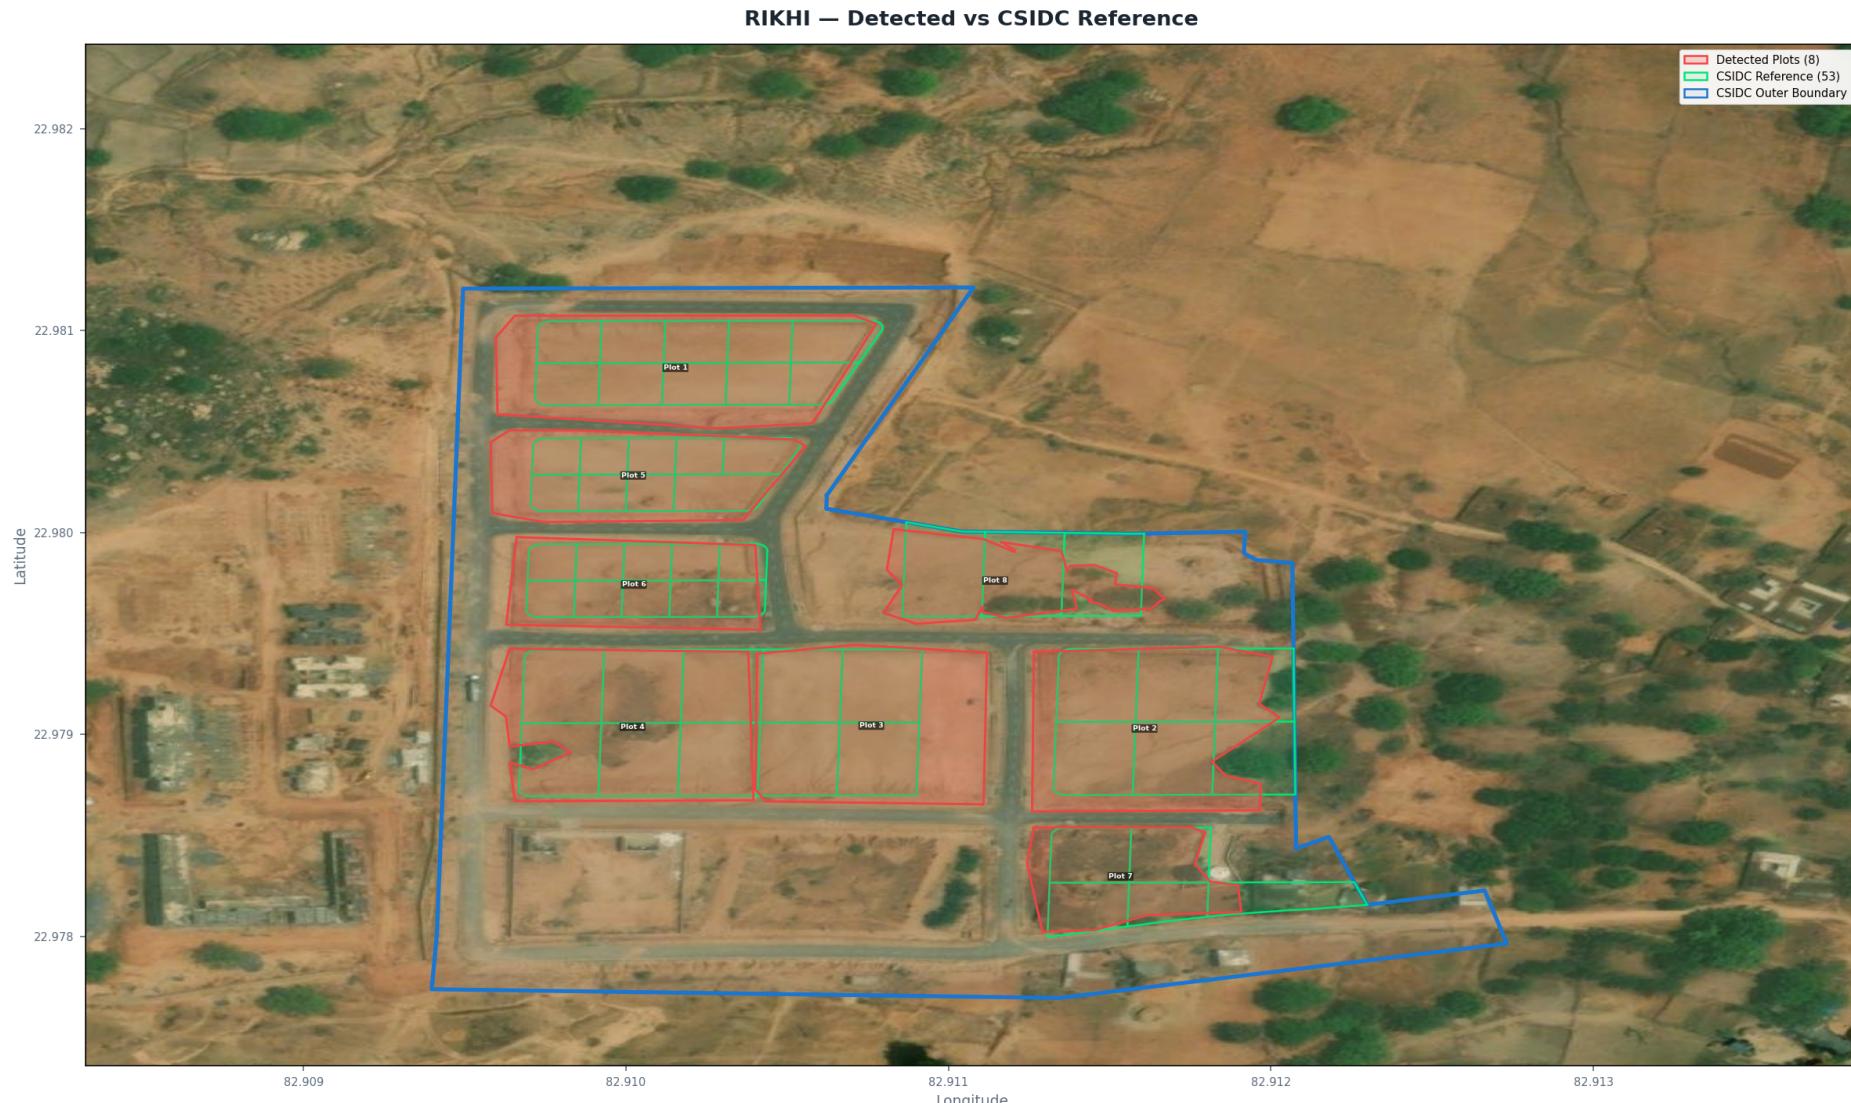
CSIDC Reference Plots — Satellite Overlay

Official CSIDC reference plot boundaries (53 plots) overlaid on satellite imagery. These represent the allotted plot layout as recorded in the CSIDC GeoServer database.

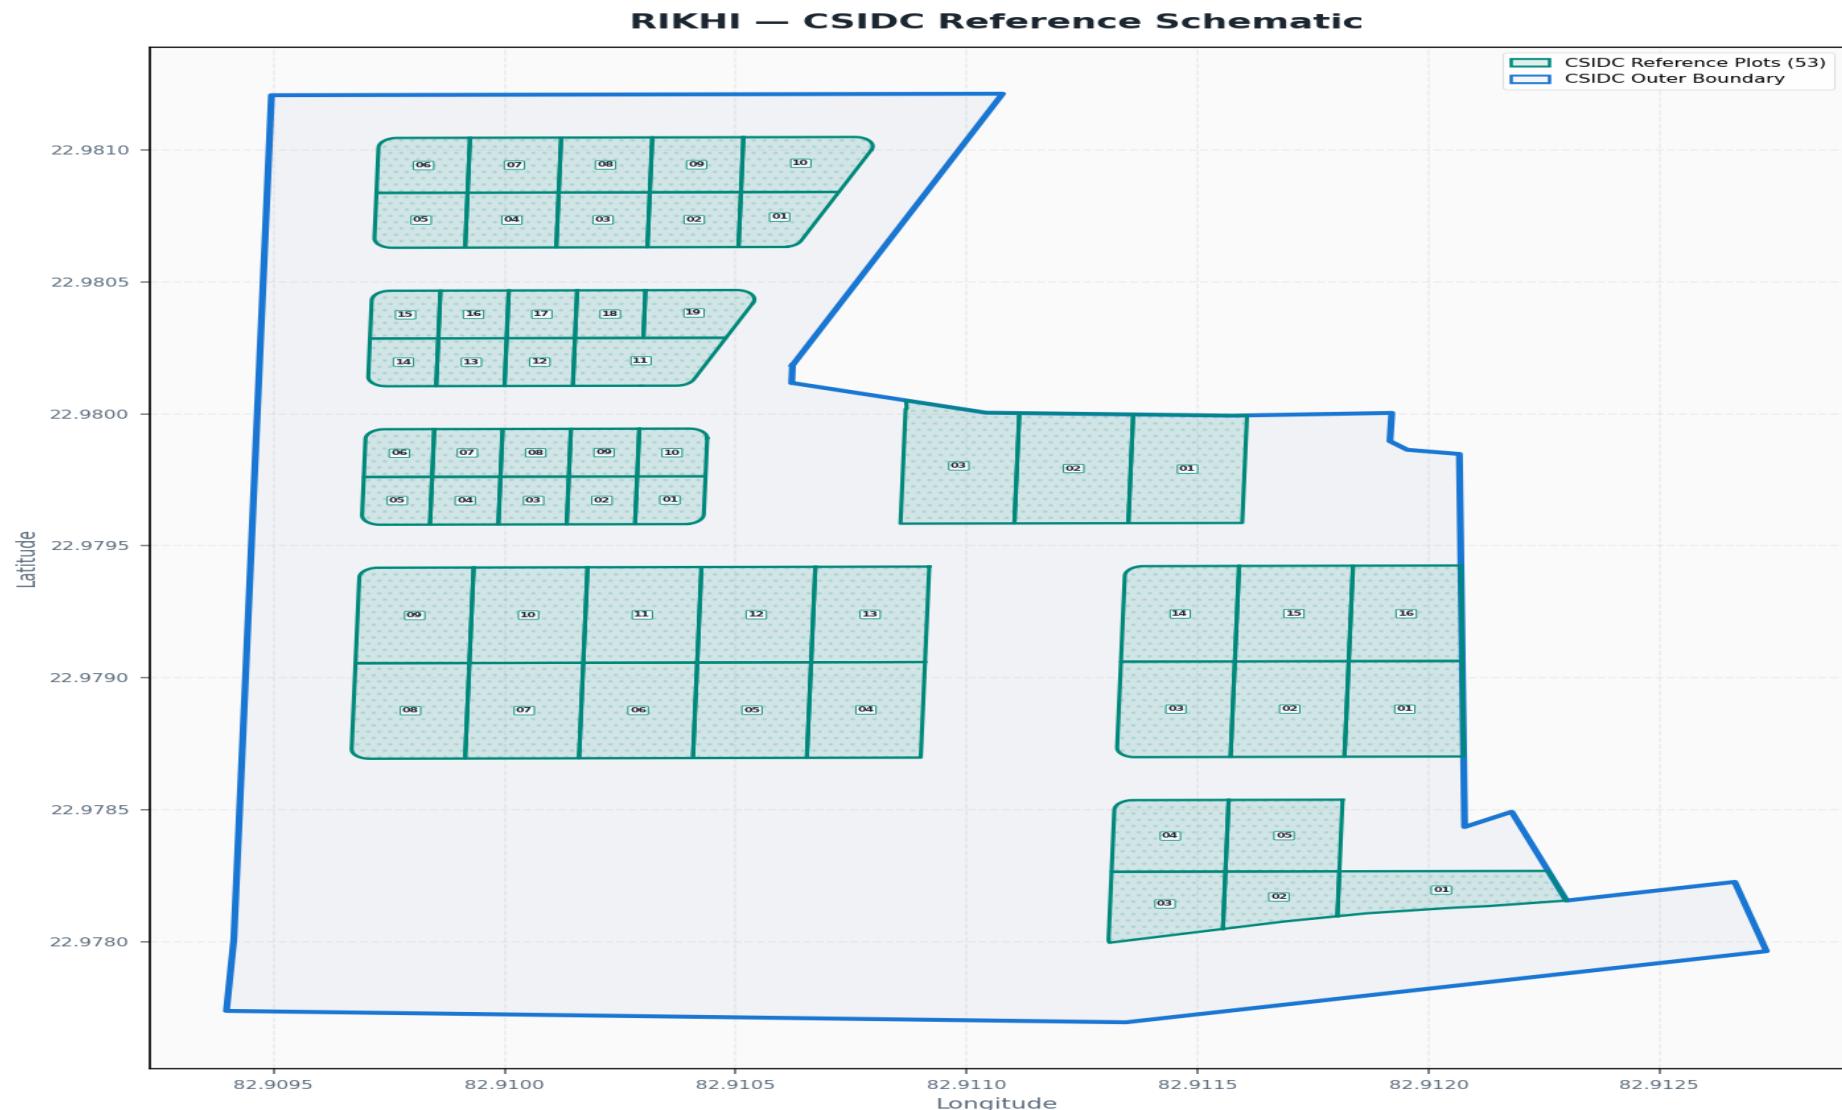
Schematic Map — CSIDC Reference Plots

CAD-style schematic of 53 official CSIDC reference plot boundaries as recorded in the GeoServer database.

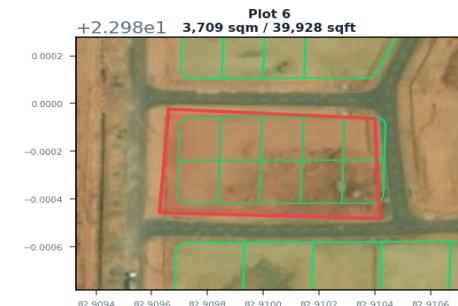
Individual Plot Details

Zoomed-in view of each detected plot showing boundary detail and measurements.

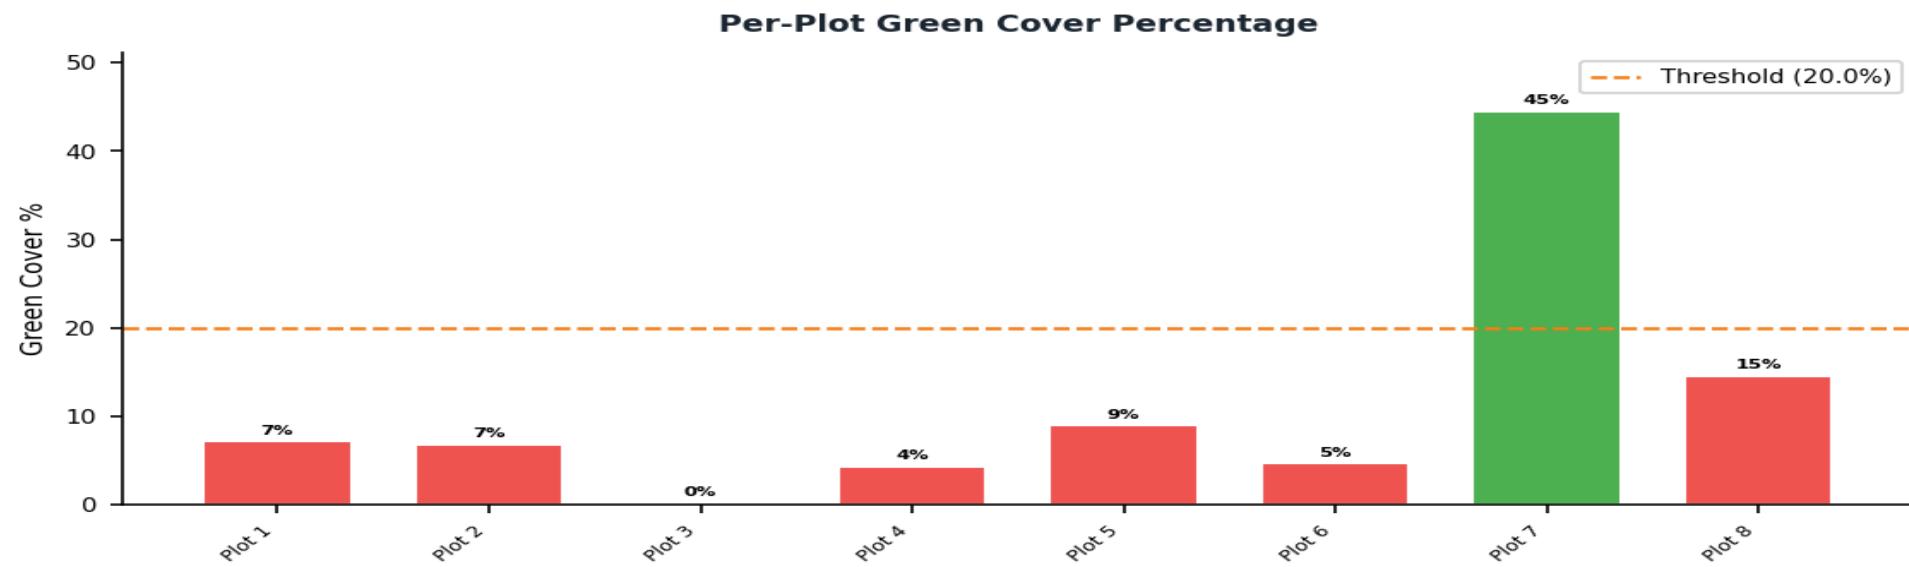
Green Cover Distribution

Metric	Value	Details
Total Plots Assessed	8	1 compliant, 7 non-compliant, 0 unchecked
Green Cover — Checked	8	1 compliant, 7 non-compliant (threshold: 20.0%)
Green Cover — Average	11.4%	Range: 0.3% – 44.5%
Construction Timeline — Checked	7	5 on track, 2 past deadline (2-year requirement)
