CHHATTISGARH STATE INDUSTRIAL
DEVELOPMENT CORPORATION

Drishti — Automated Land Monitoring Report

Project Name	Detection - RIKHI
Industrial Area	RIKHI
Report Date	13 February 2026, 17:18 UTC
Total Features Detected	8
Plot Features	8
Total Area Covered	37,855 sq.m (407,470 sq.ft)

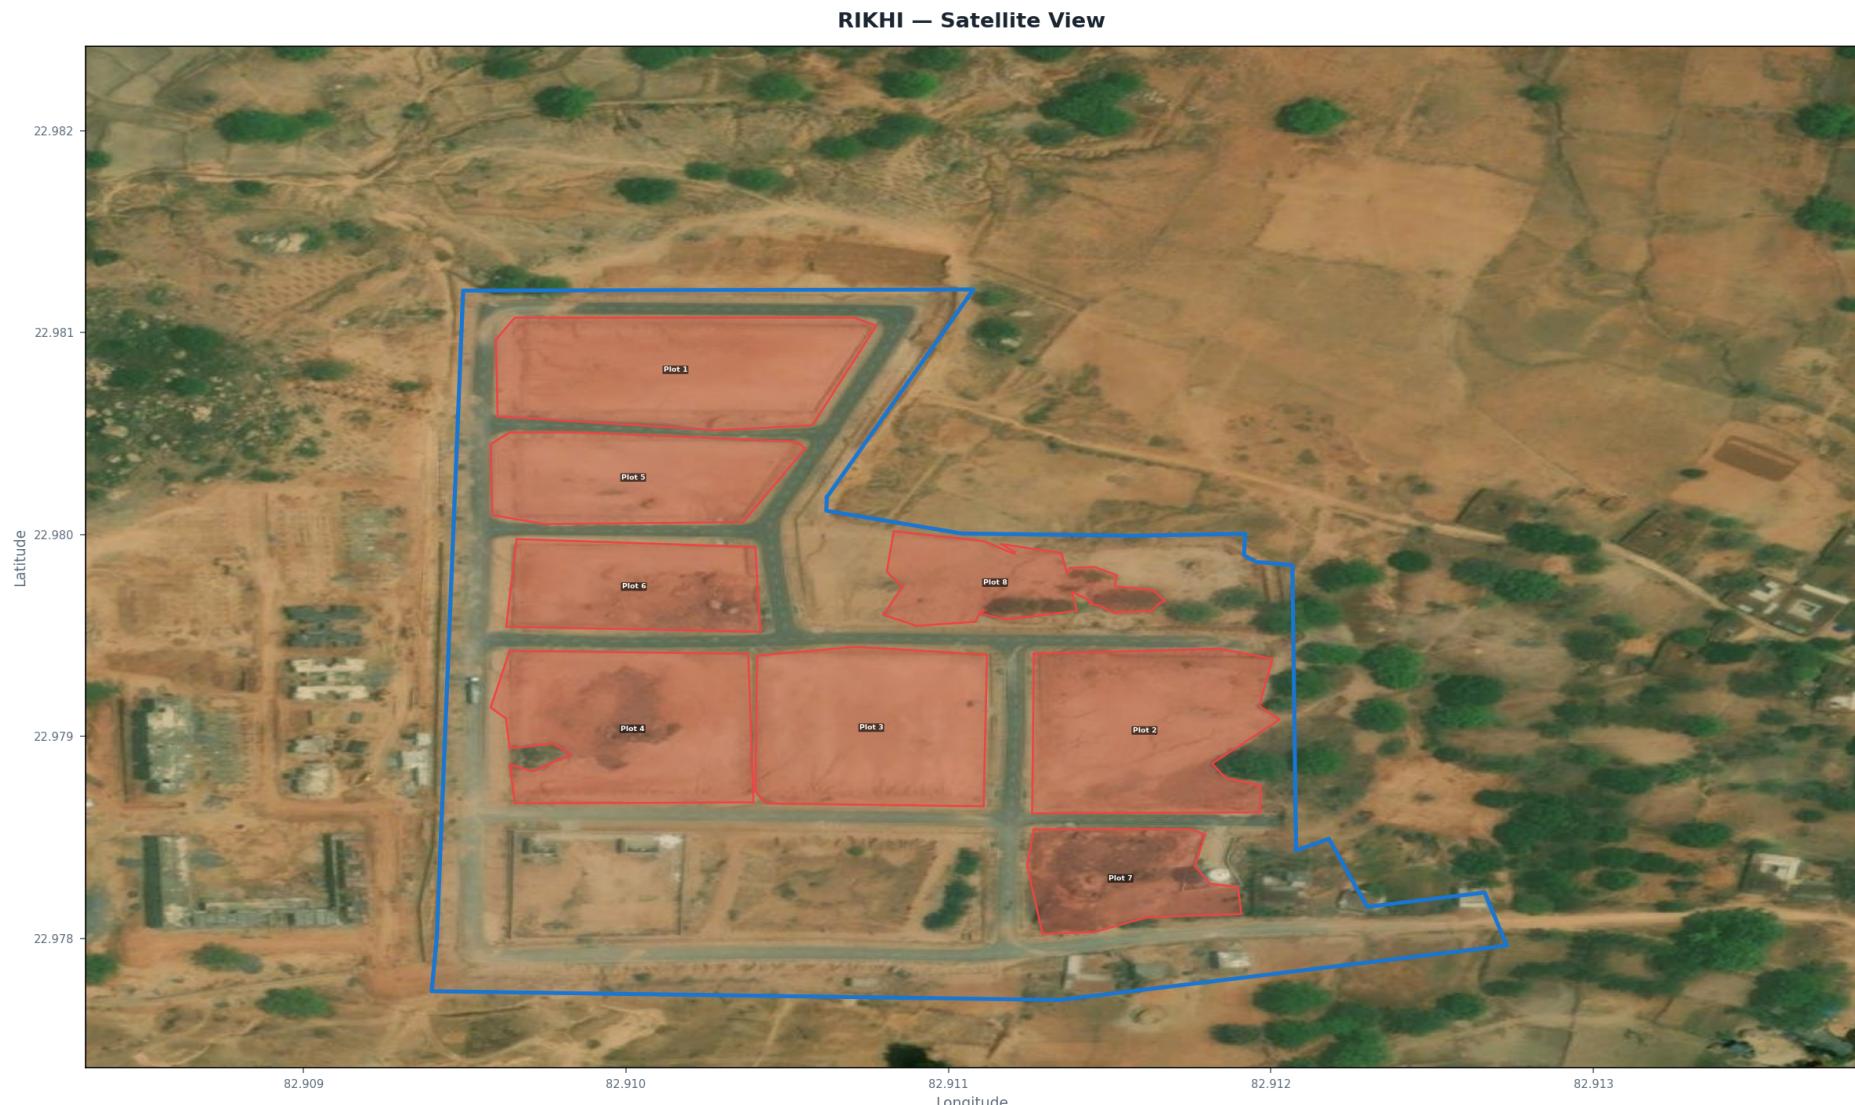
Satellite Imagery — Detected Boundaries

High-resolution satellite imagery with detected plot boundaries overlaid. Source: ESRI World Imagery.

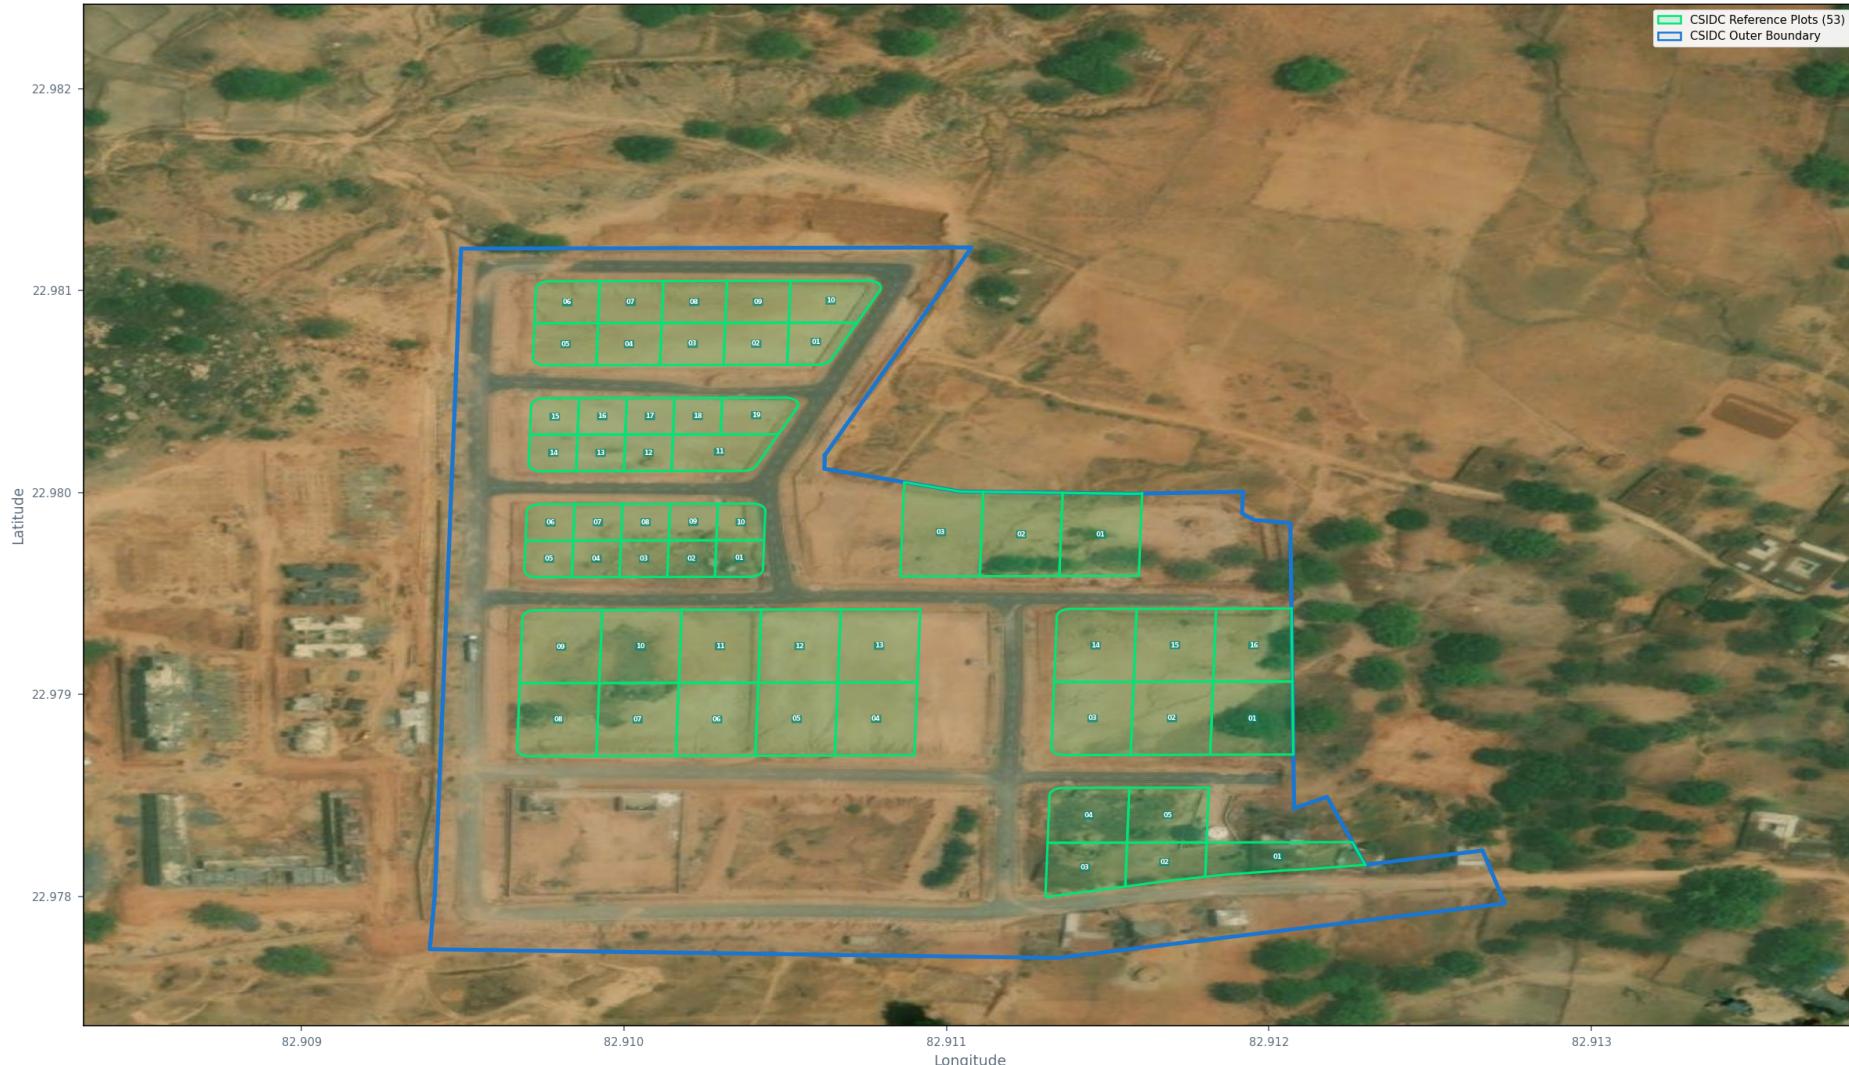
RIKHI — CSIDC Reference Plots

Official CSIDC reference plot boundaries (53 plots) overlaid on satellite imagery. These represent the allotted plot layout as recorded in the CSIDC GeoServer database.
