PDF ANALYSIS - ISSUES SUMMARY WITH COORDINATES

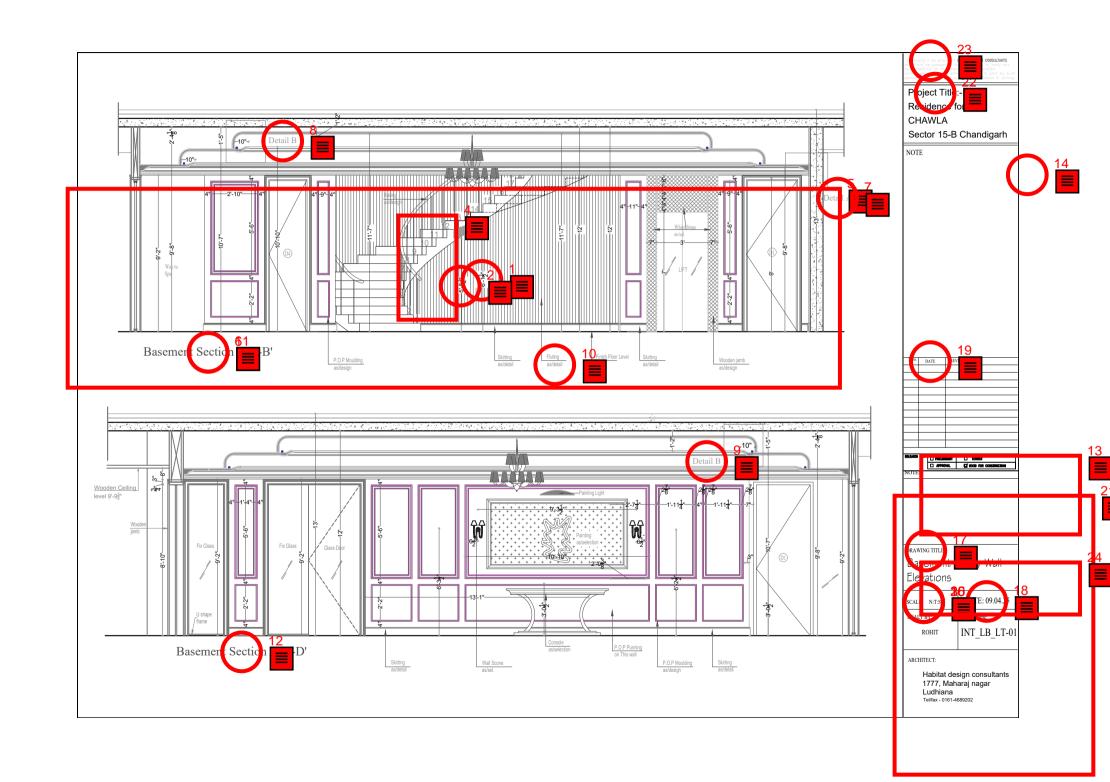
Dimension 6'-11' missing inch symbol

Dimension 5'-51' ambiguous Location: [354.8, 223.4] Coordinates: [354.8, 223.4]

Units note missing Location: [702.3, 460.6] Coordinates: [702.3, 460.6]

Grid system unclear (numeric stack 1·13) Location: [308.0, 170.0, 352.4, 249.1] Coordinates: [308.0, 170.0, 352.4, 249.1]

Missing overall elevation dimensions Location: [60.0, 150.0, 640.0, 300.0] Coordinates: [60.0, 150.0, 640.0, 300.0] Add overall width/height baselines

Datum levels not indicated clearly

Detail A missing sheet reference

Detail B (upper) missing sheet reference

Duplicate Detail B tag (lower) Location: [539.6, 354.8]

Generic ·as/detail· ambiguous Location: [425.7, 282.3] Coordinates: [425.7, 282.3]

Section B-B- lacks plan cross-ref

Section D-D- lacks plan cross-ref

Legend missing

North arrow missing Location: [780.0, 140.0] Coordinates: [780.0, 140.0]

Scale unacceptable for working drawing

N.T.S. punctuation nonstandard

Drawing title content incomplete

Date format inconsistent Location: [749.6, 459.7] Coordinates: [749.6, 459.7]

Revision table empty

Plotting scale unverifiable Location: [702.3, 460.6] Coordinates: [702.3, 460.6]

Sheet/plot info missing

Project title verification Location: [710.9, 78.8] Coordinates: [710.9, 78.8] Ensure exact contract title

Legal note formatting Location: [707.3, 54.5] Coordinates: [707.3, 54.5] Reformat to avoid crowding

DWG name not populated

Correct to 6'-11"

Correct to intended value (e.g., 5'-5" or 5'-5 1/2")

Add global units note in title block

Convert to proper grid or remove; provide clear chained dimensions

Add FFL/ceiling/lintel datums on sections

Add complete reference (e.g., A/INT_LB_LT-xx)

Location: [221.7, 114.7] Coordinates: [221.7, 114.7] Add complete reference

Rename uniquely (e.g., Detail C) with sheet ref

Replace with explicit detail reference

Add plan sheet/section cut reference

Location: [700.0, 350.0, 820.0, 410.0] Coordinates: [700.0, 350.0, 820.0, 410.0] Add legend for symbols/abbreviations

Add north arrow

Provide working scale (e.g., 1:25)

Use ·N.T.S.·

Populate with Basement Lobby Wall Elevations and drawing no.

Use ISO or office-standard format consistently

Coordinates: [707.3, 280.0] Populate revision entries

Provide scale and graphic scale bar

Location: [680.0, 380.0, 830.0, 590.0] Coordinates: [680.0, 380.0, 830.0, 590.0] Add sheet size and plotting instructions
