FIELD PHOTO FT-03 · LEVEL B1 · EAST SERVICE CORRIDOR · 2026-11-10 13:05

AS-BUILT ISOMETRIC — OVERHEAD MAINS — EAST SERVICE CORRIDOR

PROJECT: Sample Project — Mechanical Rough-In (DEMO-0142)			PREPARED BY: MIMETIC TECHNOLOGY	
DRAWING TITLE: AS-BUILT — OVERHEAD MAINS — EAST SERVICE CORRIDOR			LOCATION: Level B1 · East service corridor	
SOURCE PHOTO: FT-03 · 2026-11-10 13:05	DRAWN: FIELD TRACE AI	CHECKED: —	SCALE: N.T.S.	REV: A
STATUS: DRAFT — FOR REVIEW IN BLUEBEAM REVU 21.11			SHEET: FT-03

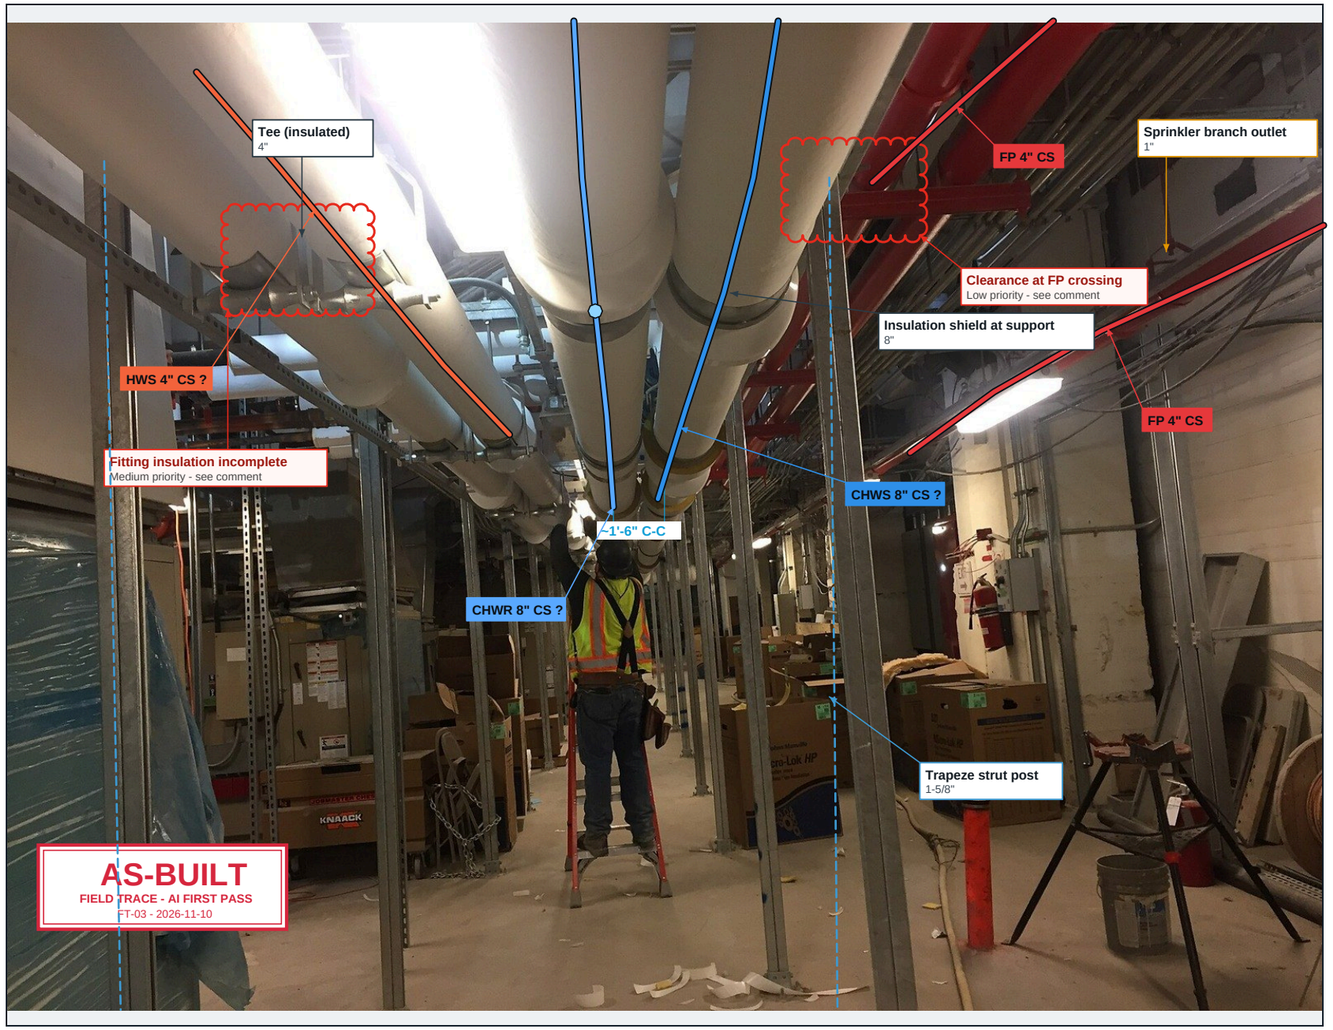
SUBJECT	LABEL	LAYER	STATUS	CONF.
Insulation shield at support	8" Insulation shield at support	Hangers & Supports	None	83%
Insulation shield at support	8" Insulation shield at support	Hangers & Supports	None	80%
Trapeze strut post	1-5/8" Trapeze strut post	Hangers & Supports	None	86%
Trapeze strut post	1-5/8" Trapeze strut post	Hangers & Supports	None	84%
Sprinkler branch outlet	1" Sprinkler branch outlet	Valves & Instruments	None	74%
Tee (insulated)	4" Tee (insulated)	Fittings	None	70%
Dimension	~1'-6" C-C	Dimensions	None	62%
Stamp	AS-BUILT — Draft	Labels	None	100%
Cloud+	Fitting insulation incomplete	Issues	None	71%
Cloud+	Clearance at FP crossing	Issues	None	66%

△1 Fitting insulation incomplete (Medium)
△2 Clearance at FP crossing (Low)
